Town of Merrimac, Massachusetts

PART A – Executive Summary

September 2021

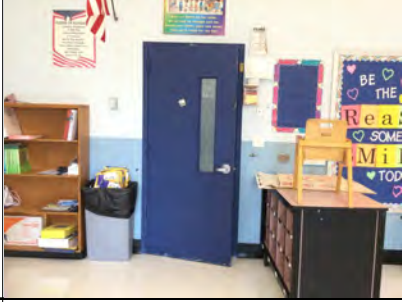
Maneuvering clearance(s) not provided	11"	Relocate furniture to provide 18" min. pull-side maneuvering clearance at door.	1	Labor	\$0
52	Special Ed. - All Grades	1	6	Doors, Doorways, & Gates	Classroom

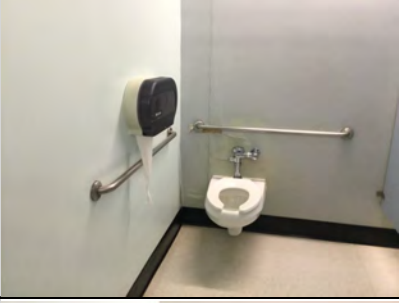
Flush control not on open side Non-compliant toilet paper dispenser	- -	Provide the flush control on the open side of the toilet (transfer side). Relocate toilet paper so that it is 24" min. high, located under the grab bar, and between 7" and 9" from the front of the toilet./Replace dispenser as it does not allow continuous paper flow.	1	630	\$630

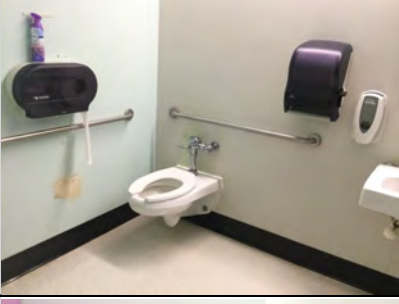
Flush control not on open side Non-compliant toilet paper dispenser Centerline < or > 18" (MAAB)	- - 16.75"	Provide the flush control on the open side of the toilet (transfer side). Relocate paper towel dispenser so it is not above the grab bar. Relocate toilet paper so that it is 24" min. high, located under the grab bar, and between 7" and 9" from the front of the toilet. Relocate toilet so the centerline is 18" from the side wall.	1	3714	\$3714
138	Women's Toilet Room Near Main Office	1		Toilet Compartment	Accessible Compartment

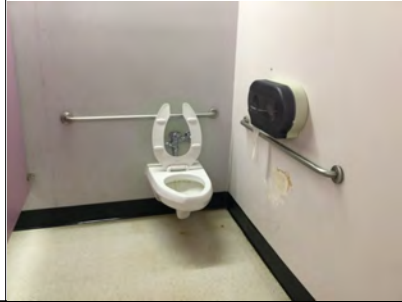
Non-compliant toilet paper dispenser	-	Relocate toilet paper so that it is 24" min. high, located under the grab bar, and between 7" and 9" from the front of the toilet/Replace dispenser as it does not allow continuous paper flow.	1	256	\$256	
Dispensers													
141	Boys' Toilet Room Near Room 24	1		Dispensers	Paper Towel Dispenser

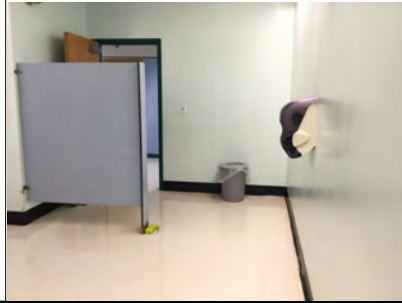
Dispenser acts as a protruding object	9"	Relocate dispenser out of the circulation path.	1	256		
142	Girls' Toilet Room Near Room 24	1		Dispensers	Paper Towel Dispenser

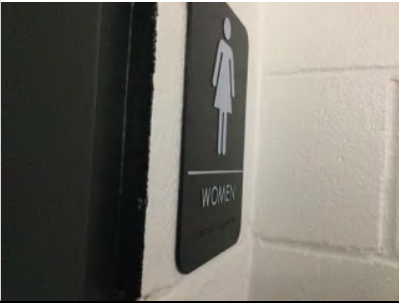
Signage is not provided	-	Once the men's toilet room has been made accessible, provide a sign at the current women's toilet room that indicates that, although it is not accessible, it is also available to "All-Genders".	1	232	\$232
6	Men's Toilet Room	1		Signage	Designation

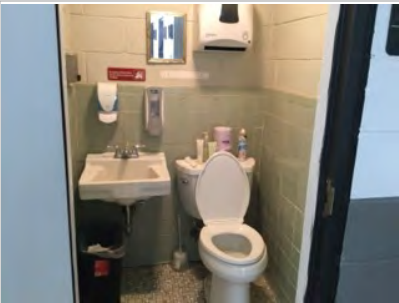
Turning space not provided Accessible plumbing fixtures or stalls not provided	- -	See recommendations regarding making the men's toilet room accessible and usable by all genders and regarding new signage at the men's and women's toilet rooms once that work is complete.	1	-	\$0

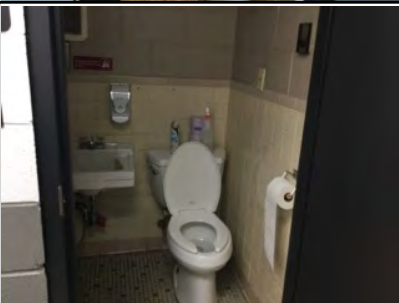
Turning space not provided Accessible plumbing fixtures or stalls not provided	- -	Renovate to provide an accessible single-user toilet room available to all genders.	1	24604	\$24604

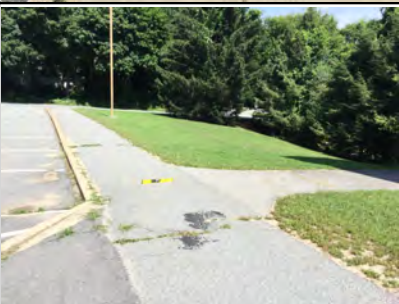
Surface openings > 1/2" Cross slope > 1:50 (2.00%)	3" 3.3%	Repair surface openings. Reduce cross slope to be no steeper than 1:50 (2.00%).	1	240	\$240

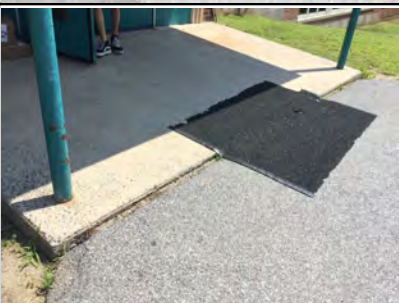
Surface openings > 1/2" Level changes > 1/4"	2.5" 1.5"	Repair surface opening. Alter change in level to be 1/4" high max. (Cost based on an asphalt patch.)	1	160	\$160
5	Upper Paved Play Area	Ext.		Exterior Access Route	Exterior

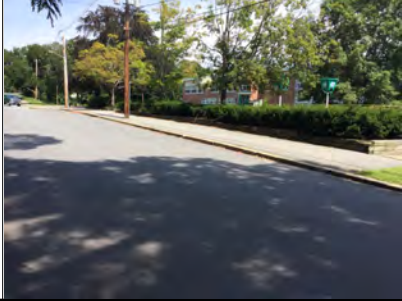
Access aisle not provided	-	Provide a marked access aisle that is at least 60" wide and that extends the full length of the vehicle at the drop-off area.	1	300	\$300
Entrance												
27	Entrance/Exit Door 5 (B3)	Ext.		Entrance	Other

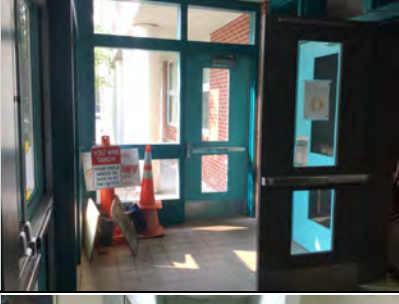
Tactile sign not provided at exit Illuminated Int. Symbol of Acc. not provided (MAAB)	- -	Provide tactile exit signs with raised characters and braille at exit doors. Mount signs between 48"- 60" above the finished floor located on the latch side of the door. If the exit sign is replaced with an illuminated exit sign, provide an illuminated International Symbol of Accessibility (ISA).	1	232	\$232
34	Exit Door 10 (D2) - Cafeteria	G		Emergency Exit	N/A

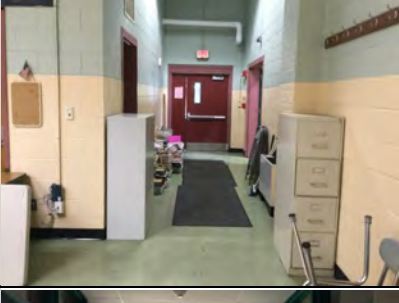
Tactile sign not provided at exit Illuminated Int. Symbol of Acc. not provided (MAAB)	- -	Provide tactile exit signs with raised characters and braille at exit doors. Mount signs between 48"- 60" above the finished floor located on the latch side of the door. If the exit sign is replaced with an illuminated exit sign, provide an illuminated International Symbol of Accessibility (ISA).	1	232	\$232

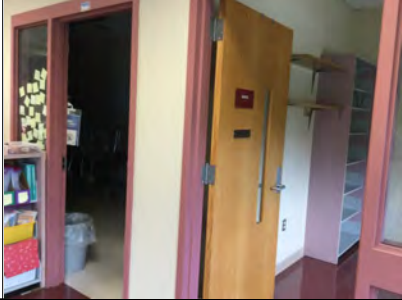
Obstructed by protruding objects	12"	Relocate shelves or provide a cane-detectable barrier.	1	Labor	\$0
Doors, Doorways, & Gates												
52	Special Needs, OT/PT Grades 3 - 6	2	7	Doors, Doorways, & Gates	Other

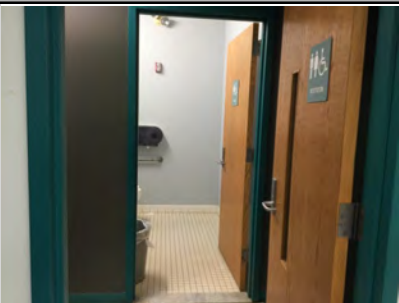
Sign not located on the latch side of the door	-	Locate sign at permanent rooms alongside the door on the latch side.	1	Labor	\$0
92	Boys' Toilet Room Near Room 2	G		Signage	Designation

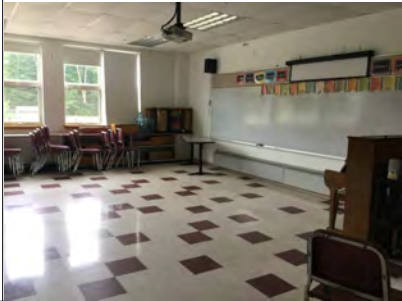
Assistive listening devices not provided	-	If audible communication is integral to the use of the space, provide an assistive listening system.	1	1214	\$1214
117	Speech Room for All Grades	1	23	Assembly Area	N/A

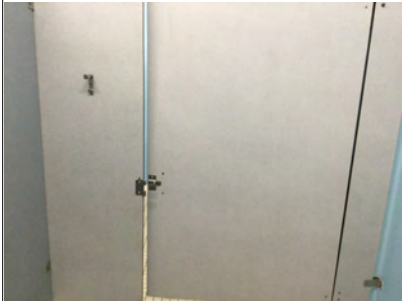
Door has non-compliant hardware Door has malfunctioning self-closing hinge	- -	Provide hardware that can be operable with one hand and not require tight grasping, pinching, or twisting of the wrist. Repair hinge.	1	70	\$70

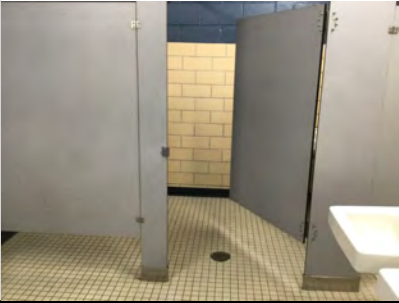
Door has non-compliant hardware Door has malfunctioning self-closing hinge	- -	Provide hardware that can be operable with one hand and not require tight grasping, pinching, or twisting of the wrist. (Door pull.) Repair hinge.	1	70	\$70
122	Girls' Toilet Room Near Room 18	1		Toilet Compartment	Accessible Compartment

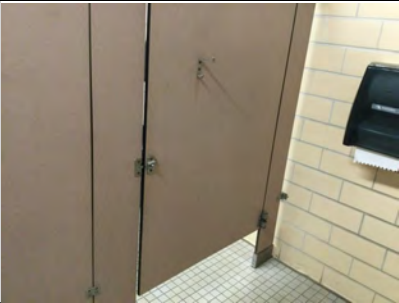
Door has non-compliant hardware Door has malfunctioning self-closing hinge	- -	Provide hardware that can be operable with one hand and not require tight grasping, pinching, or twisting of the wrist. (Door pull.) Repair hinge.	1	70	\$70

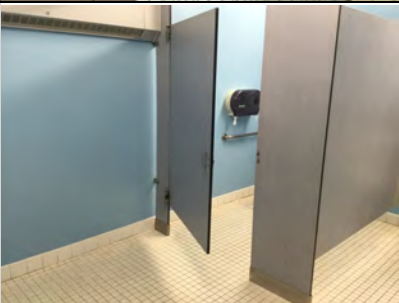
Door has malfunctioning self-closing hinge	-	Repair hinge.	1	Labor	\$0
124	Boys' Toilet Room Near Room 18	1		Toilet Compartment	Accessible Compartment

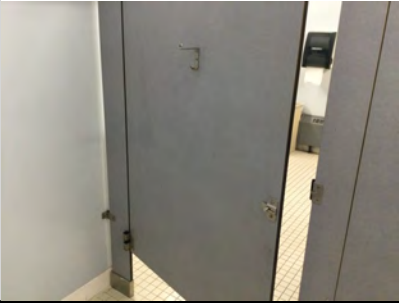
Door with malfunctioning self-closing hinge Coat hook not within reach range	53"	Repair self-closing hinge. Lower hook so that it is no higher than 36" high for children ages 3-4/40" for children ages 5-8/44" for children ages 9-12.	1	150	\$150
131	Toilet - Health	G		Toilet Compartment (Children)	Accessible Compartment

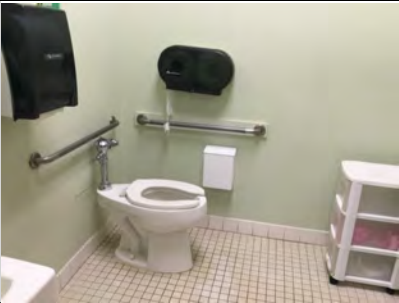
Toilet seat < 15" or > 17" high (Ages 9 - 12) Side or rear grab bar < 42" long Side or rear grab bar < 25" or > 27" high (Ages 9 - 12) Non-compliant toilet paper dispenser	19.5" 30" 31.75" -	Install a toilet with a seat between 15"- 17" high above the finished floor. Provide side/rear wall grab bars that are 42" long located 6" max. from the interior corner. Relocate grab bar to 25"- 27" above the floor. Relocate toilet paper dispenser between 14"- 19" above the floor and between 7"- 9" in front of the toilet. Ensure dispensers and other devices are not mounted above grab bars.	1	3832	\$3832

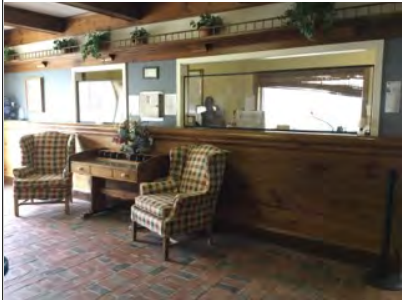
Counter > 36" high	47.75"	Provide a counter that is 36" max. above the ground or finished floor.	1	880	\$880
Operable Parts												
10	Light Bill After Hours Drop-off Mail Slot	1		Operable Parts	Other

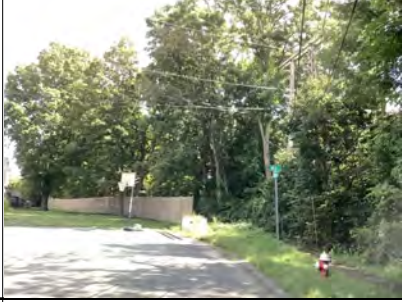
Accessible route not provided	-	Consider an accessible route of 5' min. width is provided along the street.	1	-	\$0
27	Mill Street	Ext.		Walking Surface	N/A

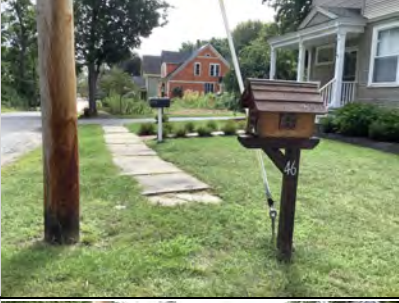
Accessible route not provided Level changes without bevels > 1/4" Route not maintained in operable working condition	- 3" - -	Recommend an accessible route to a curb ramp, 60" min. x 60" min. turning space, or signage at accessible route to street indicating the sidewalk terminates.	1	-	\$0
38	Grove Street	Ext.		Walking Surface	Sidewalk

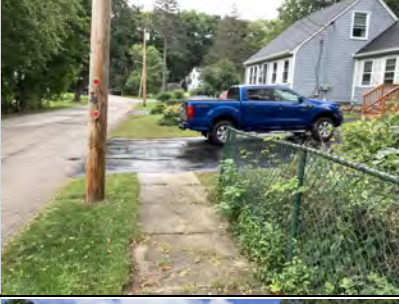
Accessible route not provided Route not maintained in operable working condition	- -	Ensure an accessible route is provided. Ensure route is maintained in operable working condition.	1		\$0

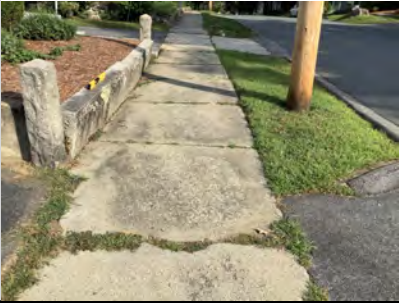
Level changes without bevels > 1/4" Surface not stable, firm and slip-resistant Route not maintained in operable working condition	1" - -	Alter change in level to be 1/4" high max. Repair surface. Ensure an accessible route of 4' min. (recommend 5' min.) width is provided. If the accessible route is less than 5' wide, ensure passing spaces of 60" min. by 60" min. at intervals of 200 feet max. are provided.	1	-	\$0
103	Intersection Woodland Street and Vendome Street House 30	Ext.		Walking Surface	Underpass

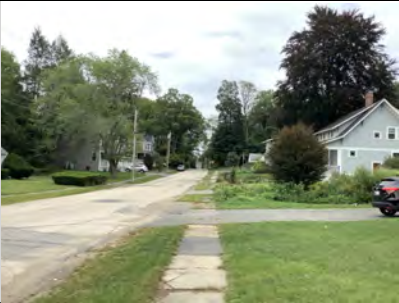
Level changes without bevels > 1/4" Does not prevent accumulation of water Route not maintained in operable working condition	2" - -	Alter change in level to be 1/4" high max. Repair surface. Ensure an accessible route of 4' min. (recommend 5' min.) width is provided. If the accessible route is less than 5' wide, ensure passing spaces of 60" min. by 60" min. at intervals of 200 feet max. are provided.	1	-	\$0

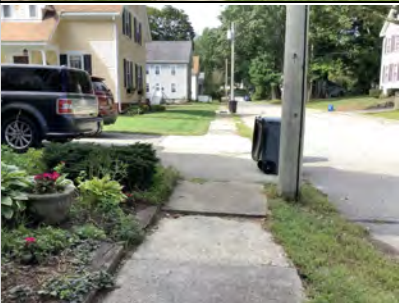
Level changes without bevels > 1/4" Does not prevent accumulation of water Route not maintained in operable working condition	3" - -	Alter change in level to be 1/4" high max. Repair surface. Ensure an accessible route of 4' min. (recommend 5' min.) width is provided. If the accessible route is less than 5' wide, ensure passing spaces of 60" min. by 60" min. at intervals of 200 feet max. are provided.	1	-	\$0
105	Woodland Street House 38	Ext.		Walking Surface	Sidewalk

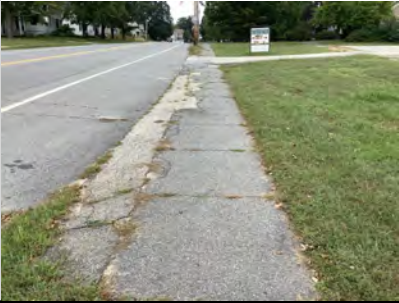
Route not maintained in operable working condition	-	Ensure an accessible route of 4' min. (recommend 5' min.) width is provided. If the accessible route is less than 5' wide, ensure passing spaces of 60" min. by 60" min. at intervals of 200 feet max. are provided.	1	-	\$0
143	Church Street Cemetery	Ext.		Walking Surface	Overpass

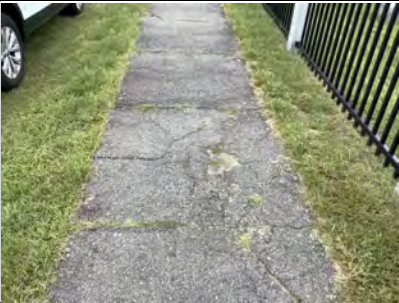
Route not maintained in operable working condition	-	Ensure an accessible route of 4' min. (recommend 5' min.) width is provided. If the accessible route is less than 5' wide, ensure passing spaces of 60" min. by 60" min. at intervals of 200 feet max. are provided.	1	-	\$0

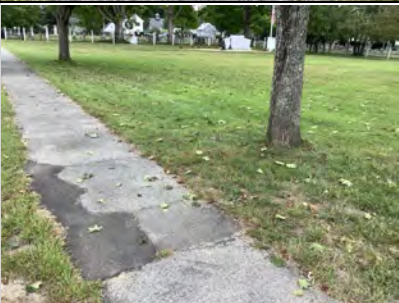
Route not maintained in operable working condition	-	Ensure an accessible route of 4' min. (recommend 5' min.) width is provided. If the accessible route is less than 5' wide, ensure passing spaces of 60" min. by 60" min. at intervals of 200 feet max. are provided.	1	-	\$0
145	Church Street Cemetery	Ext.		Walking Surface	Sidewalk

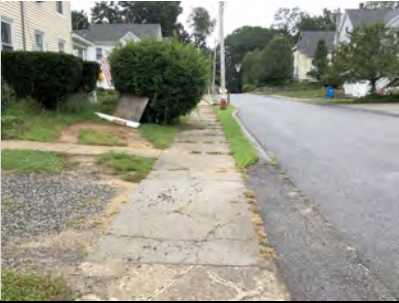
Route not maintained in operable working condition	-	Ensure an accessible route of 4' min. (recommend 5' min.) width is provided. If the accessible route is less than 5' wide, ensure passing spaces of 60" min. by 60" min. at intervals of 200 feet max. are provided.	1	-	\$0
163	Intersection Summer Street Vendome Street	Ext.		Walking Surface	Sidewalk

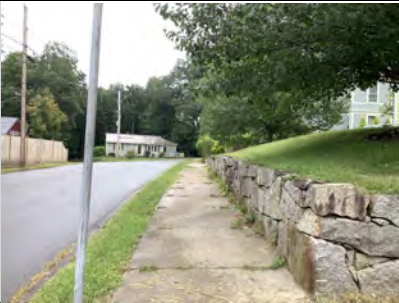
Route not maintained in operable working condition	-	Ensure an accessible route of 4' min. (recommend 5' min.) width is provided. If the accessible route is less than 5' wide, ensure passing spaces of 60" min. by 60" min. at intervals of 200 feet max. are provided.	1	-	\$0

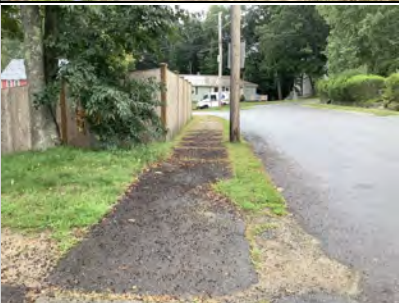
Route not maintained in operable working condition	-	Ensure an accessible route of 4' min. (recommend 5' min.) width is provided. If the accessible route is less than 5' wide, ensure passing spaces of 60" min. by 60" min. at intervals of 200 feet max. are provided.	1	-	\$0
165	Intersection Grove Street and Orchard Street	Ext.		Walking Surface	Sidewalk

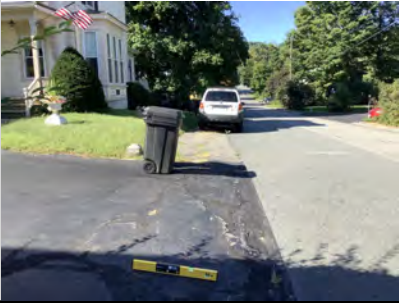
Route not maintained in operable working condition	10.2% -	Ensure an accessible route of 4' min. (recommend 5' min.) width is provided. If the accessible route is less than 5' wide, ensure passing spaces of 60" min. by 60" min. at intervals of 200 feet max. are provided.	1	-	\$0
168	Prospect Street House 8	Ext.		Walking Surface	Sidewalk

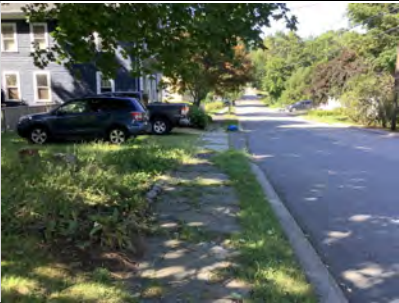
Route not maintained in operable working condition	-	Ensure an accessible route of 4' min. (recommend 5' min.) width is provided. If the accessible route is less than 5' wide, ensure passing spaces of 60" min. by 60" min. at intervals of 200 feet max. are provided.	1	-	\$0

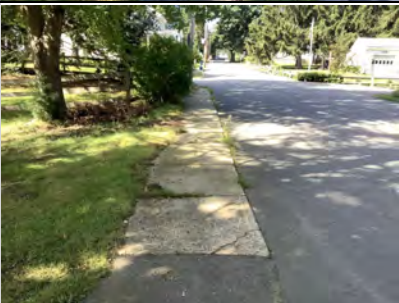
Route not maintained in operable working condition	-	Ensure an accessible route of 4' min. (recommend 5' min.) width is provided. If the accessible route is less than 5' wide, ensure passing spaces of 60" min. by 60" min. at intervals of 200 feet max. are provided.	1	-	\$0
170	Mechanic Street	Ext.		Walking Surface	Sidewalk

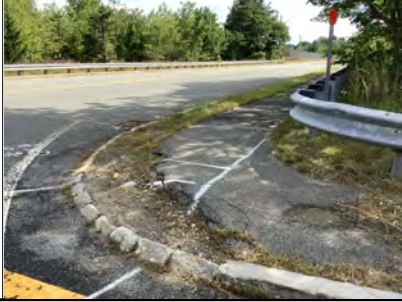
Curb ramp not provided	-	Provide a curb ramp at intersection.	1	-	\$0
Diagonal Curb Ramp												
252	Intersection Church Street and Mechanic Street	Ext.		Diagonal Curb Ramp	N/A

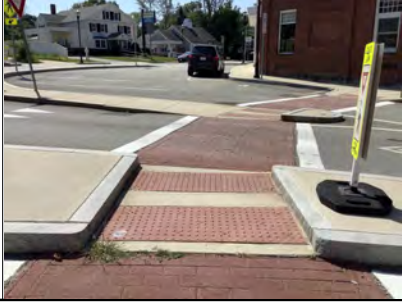
Transition from island to street not flush	-	Ensure transition from island to street is flush or free of changes in level.	1	-	\$0
Detectable Warnings												
292	Church Street West Parish	Ext.		Detectable Warnings	Perpendicular

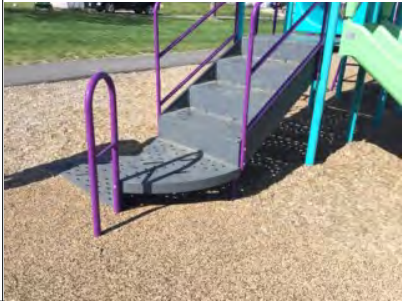
No compliant transfer system	9"	Adjust transfer system so it is between 11" and 18" above the ground.	1	Labor	\$0
Best Practice												
Bench												
5	Accessible Route Around the Playground	Ext.		Bench	N/A

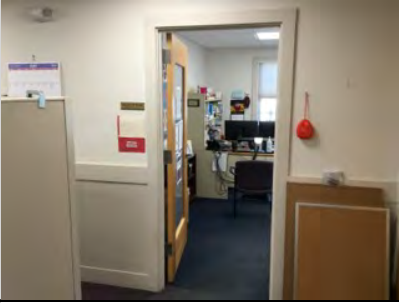
Raised characters not provided on sign Braille not provided on sign Sign not located on the latch side of the door	- - -	Provide text with raised characters duplicated in braille on sign. Locate sign at permanent rooms alongside the door on the latch side. Be sure there is clear floor space at the sign once it is relocated to the latch side.	1	232	\$232
25	Activity Room	2		Signage	Designation
