Town of Merrimac, Massachusetts

PART A – Executive Summary

September 2021

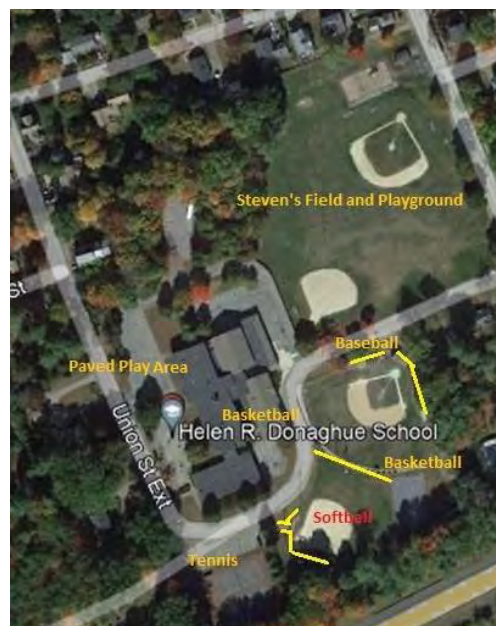
- Ensure there is an accessible route to all elements in the park/outdoor space an area of sport activity (baseball fields, basketball courts, playgrounds, picnic areas, toilet facilities, etc.). For example, the following image uses yellow lines to show proposed accessible routes between elements of sport activity at the Donaghue School:

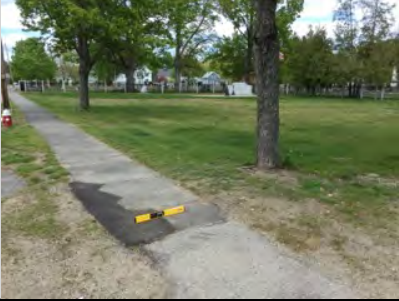
ID	Location	Floor	Room	Element	Type	Photo	Issues	Current Measure	Recommendations	Quantity	Price	Cost Estimation
Approach and Entrance												
Exterior Access Route												
1	Walkway From Cemetery Entrance to Veterans Memorial	Ext.		Exterior Access Route	Walkway

Cross slope > 1:50 (2.00%)	4%	Reduce cross slope to be no steeper than 1:50 (2.00%). (Cost based on 4'x10' of asphalt to reduce slope.)	1	400	\$400
2	Between Informal Car Path in Cemetery and Water Spigot	Ext.		Exterior Access Route	Exterior

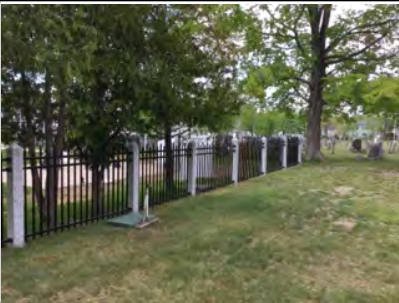
Accessible route not provided	-	Ensure an accessible route is provided to the water spigot. (Cost based on a 4' wide min. x 18' long stone dust path from the informal car route to the base of the water spigot.)	1	576	\$576
Best Practice												
Benches												
3	Informal Car Path Through the Cemetery	Ext.		Benches	N/A

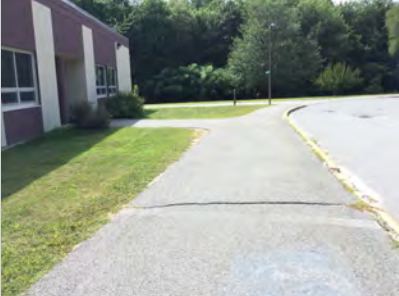
ID	Location	Floor	Room	Element	Type	Photo	Issues	Current Measure	Recommendations	Quantity	Price	Cost Estimation
Approach and Entrance												
Exterior Access Route												
1	Near Exit Door 19 (A1)	Ext.		Exterior Access Route	Sidewalk

Surface openings > 1/2"	1.75"	Repair surface.	1	240	\$240
2	Near Exit Door 19 (A1)	Ext.		Exterior Access Route

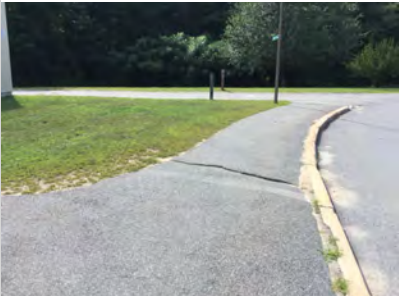
Surface openings > 1/2"	2.5"	Repair surface.	1	240	\$240
3	From Accessible Parking to Main Entrance/Exit - East of Front Parking Lot	Ext.		Exterior Access Route	Exterior

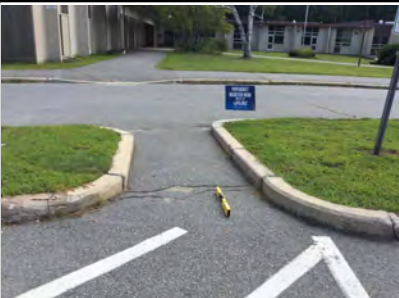
Running slope > 1:20 (5%) Surface is not stable, firm, and slip-resistant Does not prevent accumulation of water	7.8% - -	Reduce running slope to be no steeper than 1:20 (5%). Repair surface. Repair surface. (Cost based on asphalt to correct slope.)	1	240	\$240
4	Near Exit C9	Ext.		Exterior Access Route	Exterior

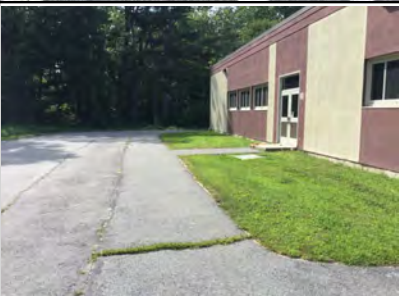
Route not maintained in operable working condition	-	Ensure the accessible route is maintained in operable working condition.	1	Labor	\$0

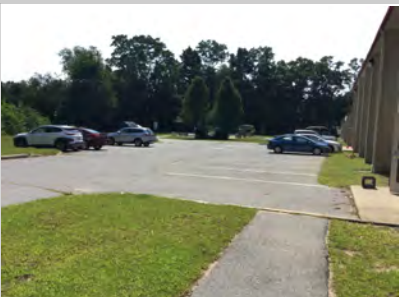
Off-Street Parking Lot or Garage												
5	East Parking Lot	Ext.		Off-Street Parking Lot or Garage	N/A

Total # of parking Total # of designated accessible parking spaces Total # of designated van accessible spaces Access aisle not provided Sign not provided	- - - - -	Provide a van accessible parking space 96" wide min. with a marked access aisle that is at least 96" wide. Provide a sign with the International Symbol of Accessibility (ISA) the bottom of the sign 60" min. above the ground and the top 96" max. above the ground. Add the words "Van Accessible" to the sign at the van accessible parking space.	1	1850	\$1850

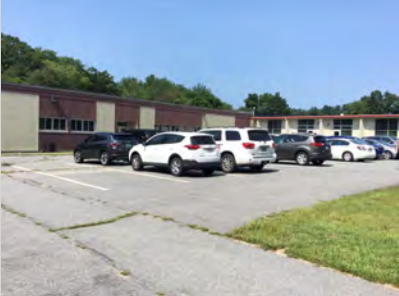
ID	Location	Floor	Room	Element	Type	Photo	Issues	Current Measure	Recommendations	Quantity	Price	Cost Estimation
6	South Parking Lot - Pre K Pick Up and Drop off	Ext.		Off-Street Parking Lot or Garage	N/A

Total # of parking Total # of designated accessible parking spaces Total # of designated van accessible spaces Access aisle not provided Sign not provided	20 - - - -	Provide a van accessible parking space 96" wide min. with a marked access aisle that is at least 96" wide. Provide a sign with the International Symbol of Accessibility (ISA) the bottom of the sign 60" min. above the ground and the top 96" max. above the ground. Add the words "Van Accessible" to the sign at the van accessible parking space.	1	1850	\$1850
7	Accessible Parking - East of Front Parking Lot	Ext.		Off-Street Parking Lot or Garage	N/A

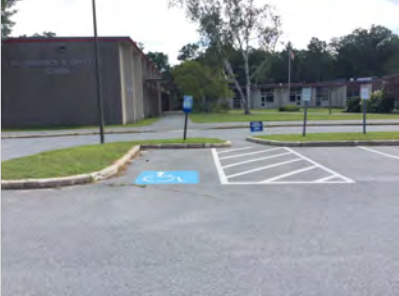
Vehicle space < 96" wide at car space Van space < 132" or <96" wide Sign bottom < 60" above finished grade	91" 95.5" 49"	Provide an accessible space that is at least 96" wide. Provide a van accessible space that is at least 96" wide. Locate sign with the bottom of the sign 60" min. and 96" max. above the ground.	1	600	\$600

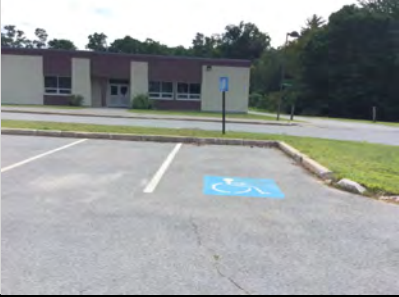
8	Accessible Parking - West of Front Parking Lot	Ext.		Off-Street Parking Lot or Garage	Visitor

Access aisle not provided Sign not maintained.	-	Provide a marked access aisle that is at least 96" wide. Replace sign.	1	800	\$800
9	Accessible Parking - East of Front Parking Lot	Ext.		Off-Street Parking Lot or Garage	N/A

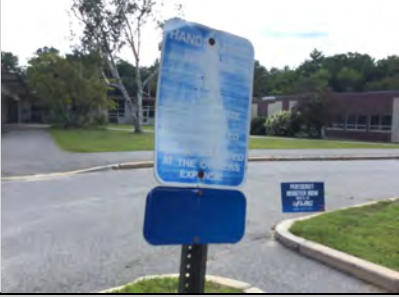
Sign not maintained in operable working condition.		Replace sign.	1	500	\$500
Entrance												
10	Entrance/Exit Door 5 (B2)	Ext.		Entrance	Other

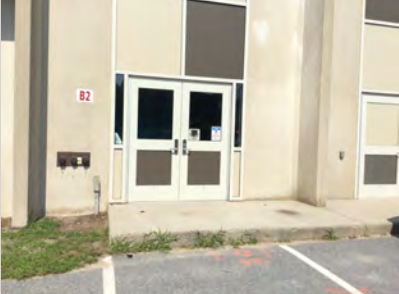
Directional sign to accessible entrance not provided	-	Provide a directional sign indicating the location of the nearest accessible entrance.	1	346	\$346

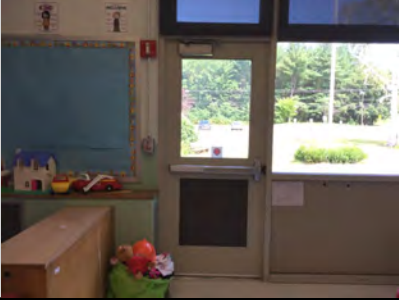
ID	Location	Floor	Room	Element	Type	Photo	Issues	Current Measure	Recommendations	Quantity	Price	Cost Estimation
16	Exit Door 20 (A2)	1	2	Emergency Exit	N/A

Tactile sign not provided at exit Directional sign to accessible emergency exit not provided	- -	Provide tactile exit signs with raised characters and braille at exit doors. Mount signs between 48"- 60" above the finished floor located on the latch side of the door. Provide a directional sign indicating the location of the nearest accessible emergency exit.	1	232	\$232
17	Exit Door 21 (A3) - Guidance - All Grades	1	1	Emergency Exit	N/A

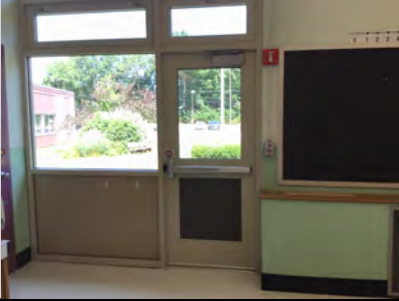
Tactile sign not provided at exit Directional sign to accessible emergency exit not provided	- -	Provide tactile exit signs with raised characters and braille at exit doors. Mount signs between 48"- 60" above the finished floor located on the latch side of the door. Provide a directional sign indicating the location of the nearest accessible emergency exit.	1	232	\$232

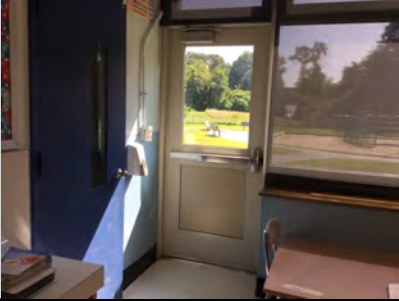
18	Exit Door 7 (B4) - Grade 1	1	11	Emergency Exit	N/A

Tactile sign not provided at exit Directional sign to accessible emergency exit not provided Door requires > 15 lbs. of force to open	- - 17 lbs.	Provide tactile exit signs with raised characters and braille at exit doors. Mount signs between 48"- 60" above the finished floor located on the latch side of the door. Provide a directional sign indicating the location of the nearest accessible emergency exit. Adjust closers of exterior doors so doors do not require more than 15 pounds of force.	1	232	\$232
19	Exit Door 8 (B5)	1	10	Emergency Exit	N/A

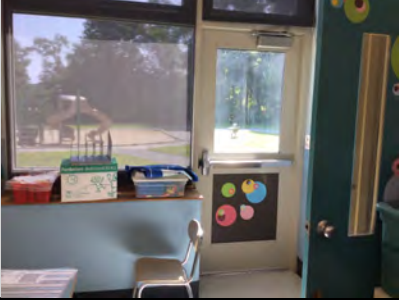
Tactile sign not provided at exit Directional sign to accessible emergency exit not provided Door requires > 15 lbs. of force to open	- - 17 lbs.	Provide tactile exit signs with raised characters and braille at exit doors. Mount signs between 48"- 60" above the finished floor located on the latch side of the door. Provide a directional sign indicating the location of the nearest accessible emergency exit. Adjust closers of exterior doors so doors do not require more than 15 pounds of force.	1	232	\$232

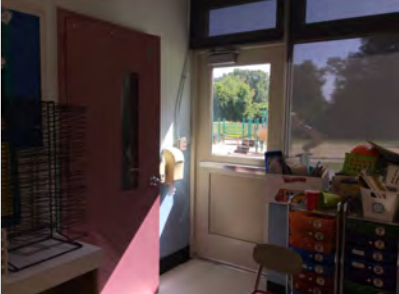
20	Exit Door 9 (B6)	1	9	Emergency Exit

Tactile sign not provided at exit Directional sign to accessible emergency exit not provided Door requires > 15 lbs. of force to open	- - 18 lbs.	Provide tactile exit signs with raised characters and braille at exit doors. Mount signs between 48"- 60" above the finished floor located on the latch side of the door. Provide a directional sign indicating the location of the nearest accessible emergency exit. Adjust closers of exterior doors so doors do not require more than 15 pounds of force.	1	232	\$232

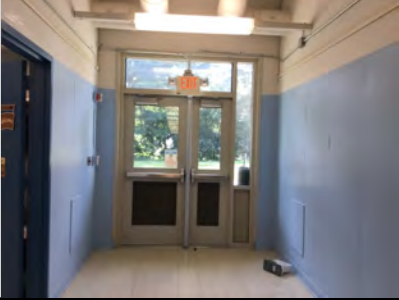
ID	Location	Floor	Room	Element	Type	Photo	Issues	Current Measure	Recommendations	Quantity	Price	Cost Estimation
21	Exit Door 10 (C1)	1		Emergency Exit	N/A

Tactile sign not provided at exit Directional sign to accessible emergency exit not provided Door requires > 15 lbs. of force to open	- - 18 lbs.	Provide tactile exit signs with raised characters and braille at exit doors. Mount signs between 48"- 60" above the finished floor located on the latch side of the door. Provide a directional sign indicating the location of the nearest accessible emergency exit. Adjust closers of exterior doors so doors do not require more than 15 pounds of force.	1	232	\$232
22	Exit Door 11 (C2)	1	8	Emergency Exit	N/A

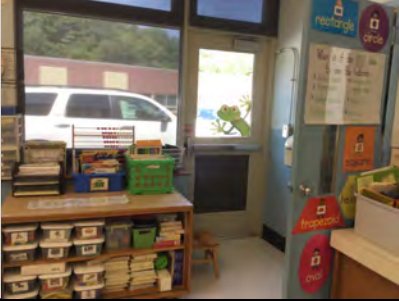
Tactile sign not provided at exit Directional sign to accessible emergency exit not provided Door requires > 15 lbs. of force to open	- - 17 lbs.	Provide tactile exit signs with raised characters and braille at exit doors. Mount signs between 48"- 60" above the finished floor located on the latch side of the door. Provide a directional sign indicating the location of the nearest accessible emergency exit. Adjust closers of exterior doors so doors do not require more than 15 pounds of force.	1	232	\$232

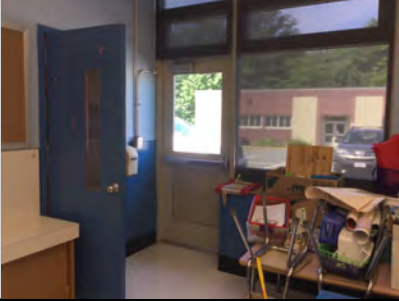
23	Exit Door 12 (C3)	1	7	Emergency Exit

Tactile sign not provided at exit Directional sign to accessible emergency exit not provided Door requires > 15 lbs. of force to open	- - 17 lbs.	Provide tactile exit signs with raised characters and braille at exit doors. Mount signs between 48"- 60" above the finished floor located on the latch side of the door. Provide a directional sign indicating the location of the nearest accessible emergency exit. Adjust closers of exterior doors so doors do not require more than 15 pounds of force.	1	232	\$232
24	Exit Door 13 (C4) - Special Ed. - All Grades	1	6	Emergency Exit	N/A

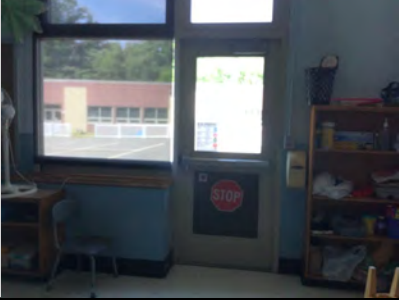
Tactile sign not provided at exit Directional sign to accessible emergency exit not provided Door requires > 15 lbs. of force to open	- - 20 lbs.	Provide tactile exit signs with raised characters and braille at exit doors. Mount signs between 48"- 60" above the finished floor located on the latch side of the door. Provide a directional sign indicating the location of the nearest accessible emergency exit. Adjust closers of exterior doors so doors do not require more than 15 pounds of force.	1	232	\$232

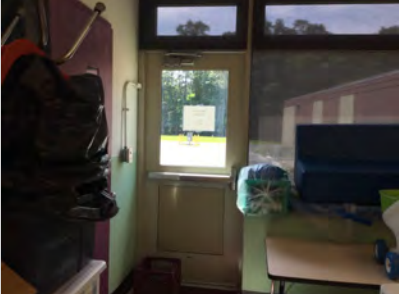
25	Exit Door 16 (C7)	1	3	Emergency Exit	N/A

Tactile sign not provided at exit Directional sign to accessible emergency exit not provided Door requires > 15 lbs. of force to open	- - 17 lbs.	Provide tactile exit signs with raised characters and braille at exit doors. Mount signs between 48"- 60" above the finished floor located on the latch side of the door. Provide a directional sign indicating the location of the nearest accessible emergency exit. Adjust closers of exterior doors so doors do not require more than 15 pounds of force. Note: Fire doors shall have a minimum opening	1	232	\$232

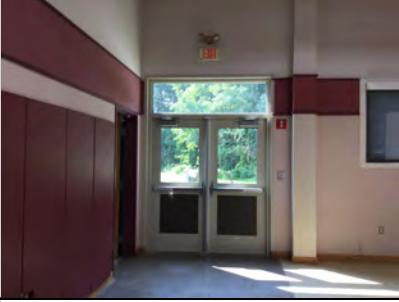
ID	Location	Floor	Room	Element	Type	Photo	Issues	Current Measure	Recommendations	Quantity	Price	Cost Estimation
26	Exit Door 18 (C9) - Play Room/ Gymnasium	1	20	Emergency Exit	N/A

Tactile sign not provided at exit Directional sign to accessible emergency exit not provided Door requires > 15 lbs. of force to open	- - 17 lbs.	Provide tactile exit signs with raised characters and braille at exit doors. Mount signs between 48"- 60" above the finished floor located on the latch side of the door. Provide a directional sign indicating the location of the nearest accessible emergency exit. Adjust closers of exterior doors so doors do not require more than 15 pounds of force.	1	232	\$232
27	Entrance/Exit Door 19 (A1)	1		Emergency Exit	N/A

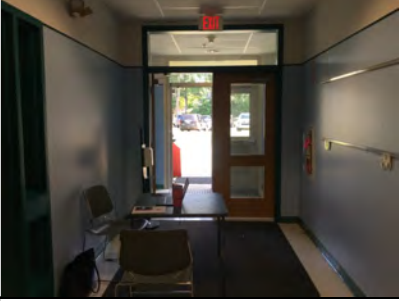
Tactile sign not provided at exit Illuminated Int. Symbol of Acc. not provided (MAAB)	- -	Provide tactile exit signs with raised characters and braille at exit doors. Mount signs between 48"- 60" above the finished floor located on the latch side of the door. If the exit sign is replaced with an illuminated exit sign, provide an illuminated International Symbol of Accessibility (ISA).	1	232	\$232

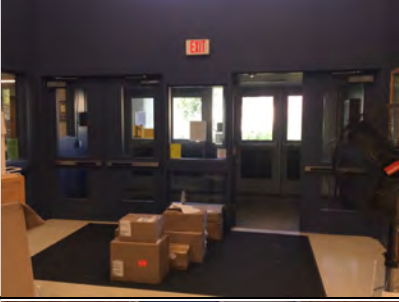
28	Main Entrance/Exit Door 1 (A4)	1		Emergency Exit	N/A

Tactile sign not provided at exit Illuminated Int. Symbol of Acc. not provided (MAAB)	- -	Provide tactile exit signs with raised characters and braille at exit doors. Mount signs between 48"- 60" above the finished floor located on the latch side of the door. If the exit sign is replaced with an illuminated exit sign, provide an illuminated International Symbol of Accessibility (ISA).	1	232	\$232
29	Exit Door 2 (A5)	1		Emergency Exit	N/A

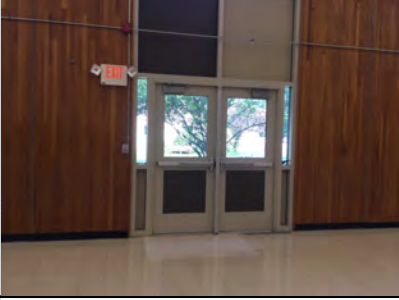
Tactile sign not provided at exit Illuminated Int. Symbol of Acc. not provided (MAAB)	- -	Provide tactile exit signs with raised characters and braille at exit doors. Mount signs between 48"- 60" above the finished floor located on the latch side of the door. If the exit sign is replaced with an illuminated exit sign, provide an illuminated International Symbol of Accessibility (ISA).	1	232	\$232

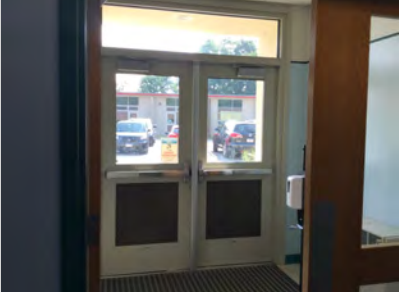
30	Exit Door 17 (C8)	1		Emergency Exit	N/A

Tactile sign not provided at exit Illuminated Int. Symbol of Acc. not provided (MAAB) Door requires > 15 lbs. of force to open	- - 17 lbs.	Provide tactile exit signs with raised characters and braille at exit doors. Mount signs between 48"- 60" above the finished floor located on the latch side of the door. If the exit sign is replaced with an illuminated exit sign, provide an illuminated International Symbol of Accessibility (ISA) Adjust closers of exterior doors so doors do not require more than 15 pounds of force.	1	232	\$232

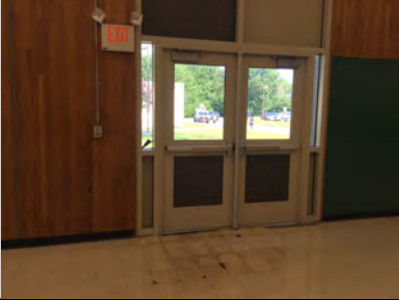
ID	Location	Floor	Room	Element	Type	Photo	Issues	Current Measure	Recommendations	Quantity	Price	Cost Estimation
31	Entrance/Exit Door 3(A6)	1		Emergency Exit	N/A

Illuminated Int. Symbol of Acc. not provided (MAAB) Tactile sign not provided at exit	- - 20 lbs	Provide tactile exit signs with raised characters and braille at exit doors. Mount signs between 48"- 60" above the finished floor located on the latch side of the door. If the exit sign is replaced with an illuminated exit sign, provide an illuminated International Symbol of Accessibility (ISA).	1	232	\$232
32	Entrance/Exit Door 19 (A1)	Ext.		Emergency Exit	N/A

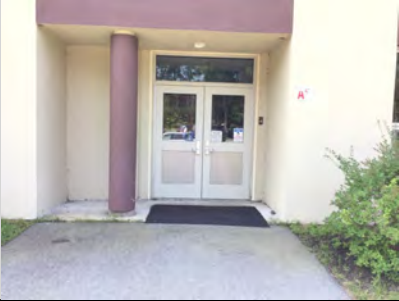
Threshold > 1/2" high	1.25"	Alter the threshold to be 1/2" high max.	1	150	\$150
33	Entrance/Exit Door 5 (B2)	1		Emergency Exit	N/A

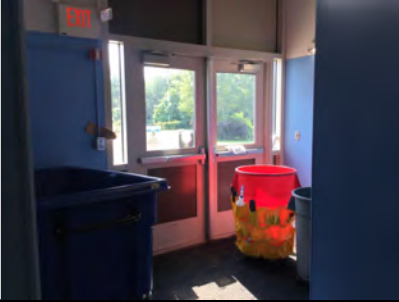
Door requires > 15 lbs. of force to open Tactile sign not provided at exit Directional sign to accessible emergency exit not provided Maneuvering clearance(s) not provided	- - - 18 lbs	Provide tactile exit signs with raised characters and braille at exit doors. Provide a directional sign indicating the location of the nearest accessible emergency exit. Remove stored items to provide maneuvering clearance at door. Adjust closers of exterior doors so doors do not require more than 15 pounds of force.	1	232	\$232

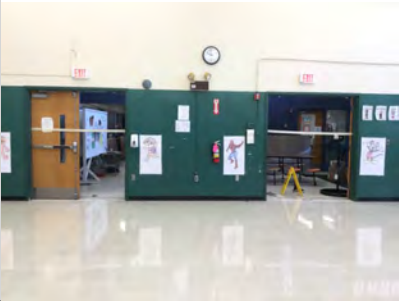
Access to Goods and Services												
Means of Egress												
34	From Cafeteria to Door 1 (A4)	1		Means of Egress	N/A

Tactile exit sign not provided	-	Ensure tactile exit signs with raised characters and braille are provided at exit doors. Mount signs between 48"- 60" above the finished floor located on the latch side of the door.	1	232	\$232
35	Ramp to Room 15 From Room 2	1	1	Means of Egress	N/A

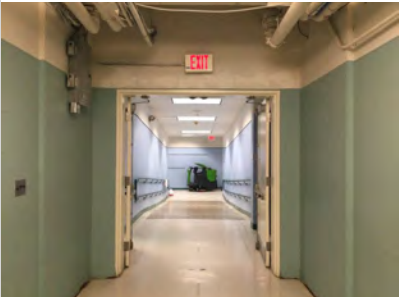
Tactile exit sign not provided	-	Ensure tactile exit signs with raised characters and braille are provided at exit doors. Mount signs between 48"- 60" above the finished floor located on the latch side of the door.	1	232	\$232

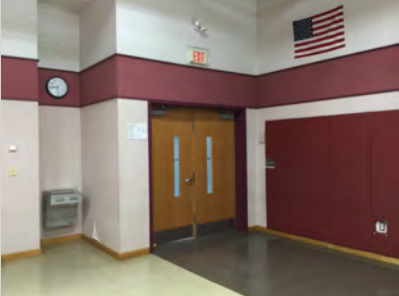
ID	Location	Floor	Room	Element	Type	Photo	Issues	Current Measure	Recommendations	Quantity	Price	Cost Estimation
36	Play Room/ Gymnasium	1	20	Means of Egress	N/A

Tactile exit sign not provided	-	Ensure tactile exit signs with raised characters and braille are provided at exit doors. Mount signs between 48"- 60" above the finished floor located on the latch side of the door.	1	232	\$232
37	Exit Door 17 (C8)	1		Means of Egress	N/A

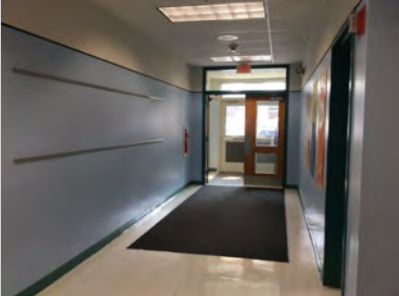
Tactile exit sign not provided Illuminated ISA symbol not provided (MAAB)	- -	Ensure tactile exit signs with raised characters and braille are provided at exit doors. Mount signs between 48"- 60" above the finished floor located on the latch side of the door. Provide an illuminated sign with the International Symbol of Accessibility.	1	232	\$232
38	Entrance/Exit Door 19 (A1)	1		Means of Egress	N/A

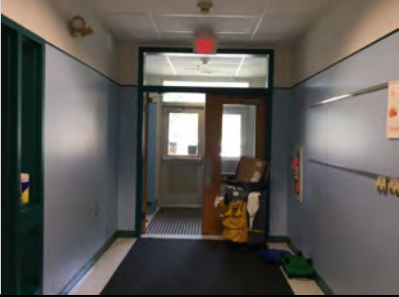
Tactile exit sign not provided Illuminated ISA symbol not provided (MAAB)	- -	Ensure tactile exit signs with raised characters and braille are provided at exit doors. Mount signs between 48"- 60" above the finished floor located on the latch side of the door. If the exit sign is replaced with an illuminated exit sign, provide an illuminated International Symbol of Accessibility (ISA).	1	232	\$232

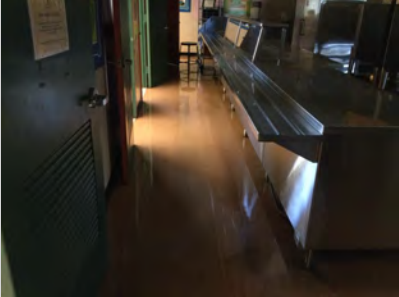
Interior Access Route												
39	Kitchen - Cafeteria	1		Interior Access Route	N/A

Route < 36" wide	30"	Ensure that a clear width of 36" min. is maintained at the accessible route.	1	Labor	\$0
40	To Principal/ Assistant Principal - Main Office	1		Interior Access Route	N/A

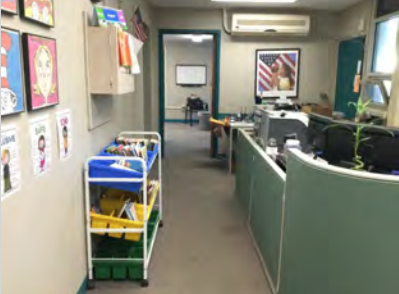
Obstructed by protruding objects	7.5"	If cart is moved from below cabinet, provide a cane-detectable barrier 27" max. above the ground.	1	306	\$306

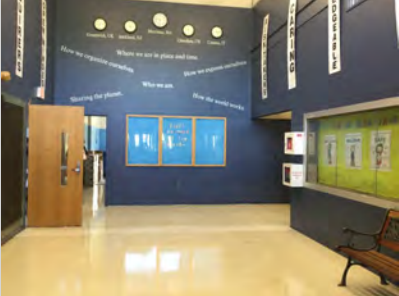
ID	Location	Floor	Room	Element	Type	Photo	Issues	Current Measure	Recommendations	Quantity	Price	Cost Estimation
41	Lobby Near Main Entrance/Exit Door 1 (A4)	1		Interior Access Route	N/A

Obstructed by protruding objects	7.5"	Provide a cane-detectable barrier below the bleeding control cabinet that is 27" max. above the finished floor.	1	306	\$306
42	Grade 1	1	11	Interior Access Route	N/A

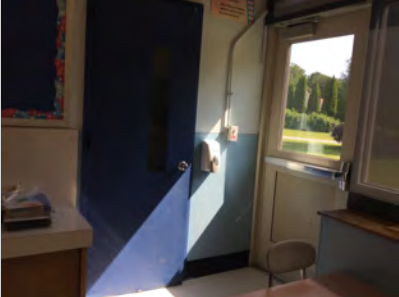
Obstructed by protruding objects	6"	Relocate sanitizer dispenser out of accessible route.	1	Labor	\$0
43	Women's Toilet Room Near Ramp	1	1	Interior Access Route	N/A

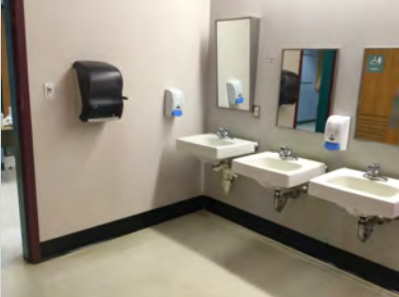
Obstructed by protruding objects	8.5"	Relocate paper towel dispenser out of circulation path.	1	256	\$256
44	Music Room	1	19	Interior Access Route	N/A

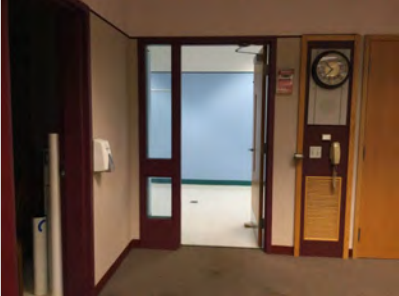
Obstructed by protruding objects	5.5"	Relocate hand sanitizer dispenser out of the accessible route.	1	256	\$256
45	Near Tray Drop Off - Cafeteria	1		Interior Access Route	N/A

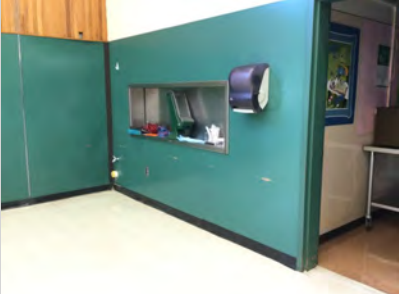
Obstructed by protruding objects Side reach > 54"	9" 57.5"	Relocate object out of the circulation path. Relocate paper towel dispenser so that controls are between 48" max. above the finished floor.	1	256	\$256

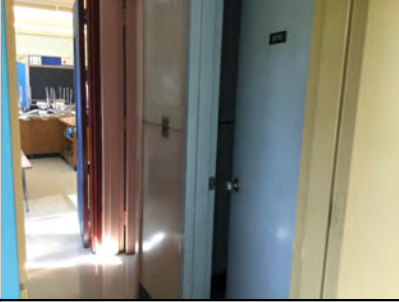
ID	Location	Floor	Room	Element	Type	Photo	Issues	Current Measure	Recommendations	Quantity	Price	Cost Estimation
Doors, Doorways, & Gates												
46	Boys' Toilet Near Room 12	1		Doors, Doorways, & Gates	Toilet Room

Clear width at door < 32" Hardware not operable with a closed fist	25" -	Widen the door so that there is 32" min. clear width. Provide hardware that can be operable with one hand and not require tight grasping, pinching, or twisting of the wrist. (Cost included in ID #140 when providing a new accessible single-user toilet room.)	1	-	\$0
47	To Toilets Between Room 12 & 11	1	11	Doors, Doorways, & Gates	Circulation

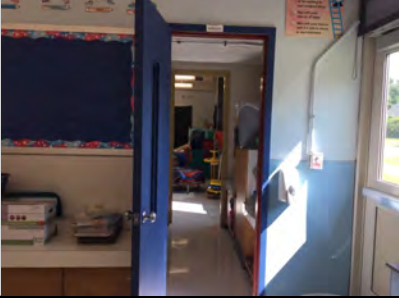
Clear width at door < 32" Hardware not operable with a closed fist	27.5" -	Widen the door so that there is 32" min. clear width. Provide hardware that can be operable with one hand and not require tight grasping, pinching, or twisting of the wrist.	1	3850	\$3850

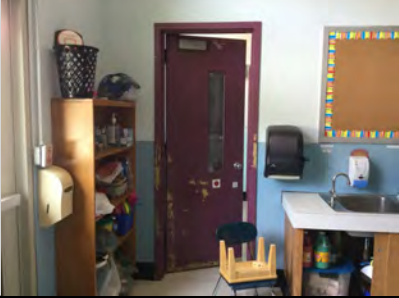
48	To Toilets Between Room 6 & 5	1	6	Doors, Doorways, & Gates	Circulation

Clear width at door < 32" Hardware not operable with a closed fist	27.5" -	Widen the door so that there is 32" min. clear width. Provide hardware that can be operable with one hand and not require tight grasping, pinching, or twisting of the wrist.	1	3850	\$3850
49	To Toilets Between Room 4 & Room 3	1	4	Doors, Doorways, & Gates	Circulation

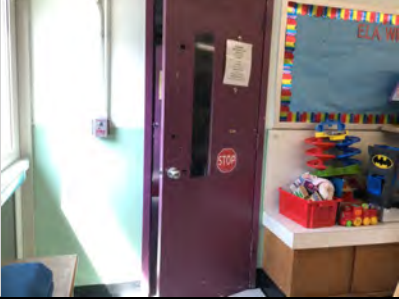
Clear width at door < 32" Hardware not operable with a closed fist	27.5" -	Widen the door so that there is 32" min. clear width. Provide hardware that can be operable with one hand and not require tight grasping, pinching, or twisting of the wrist.	1	3850	\$3850
50	Women's Toilet Room Near Main Office	1		Doors, Doorways, & Gates	Toilet Room

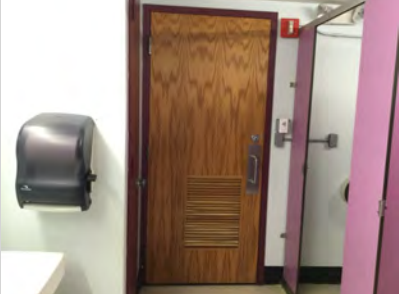
Maneuvering clearance(s) not provided	8.5"	Provide an automatic door opener.	1	3060	\$3060

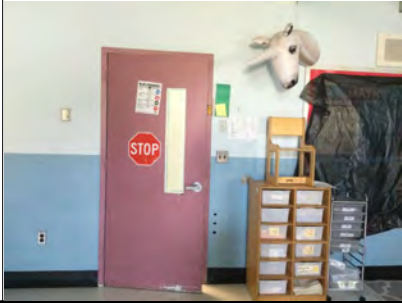
Maneuvering clearance(s) not provided	15.5"	Relocate furniture to provide 18" min. pull-side maneuvering clearance at door.	1	Labor	\$0
53	Special Ed Pre K	1	4	Doors, Doorways, & Gates	Classroom

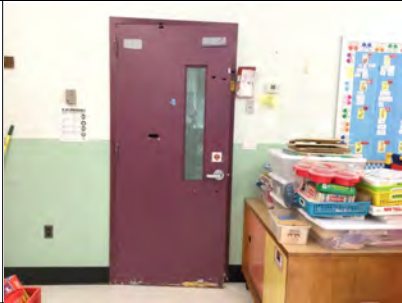
Maneuvering clearance(s) not provided	6.5"	Relocate furniture to provide 18" min. pull-side maneuvering clearance at door.	1	Labor	\$0
54	Guidance - All Grades	1	1	Doors, Doorways, & Gates	Classroom

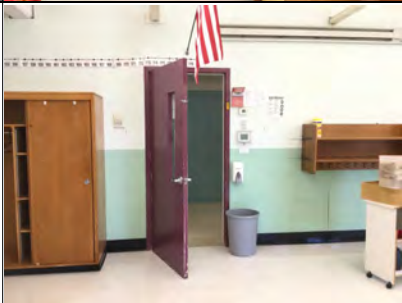
Maneuvering clearance(s) not provided	-	Remove trash container to provide 18" min. pull-side maneuvering clearance at door.	1	Labor	\$0

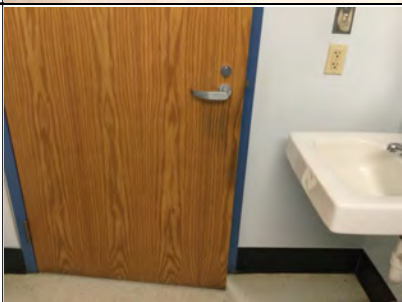
55	Single-User Toilet - Health/ Nurse's Office	1	1	Doors, Doorways, & Gates	Toilet Room

Maneuvering clearance(s) not provided	7"	Provide an automatic door opener.	1	3060	\$3060

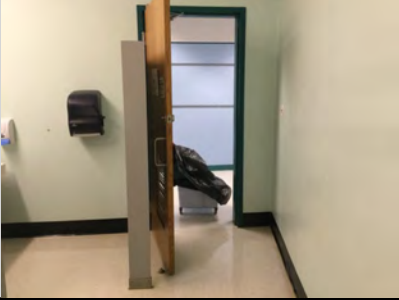
ID	Location	Floor	Room	Element	Type	Photo	Issues	Current Measure	Recommendations	Quantity	Price	Cost Estimation
56	Men's Toilet Room Near Ramp	1	1	Doors, Doorways, & Gates	Toilet Room

Maneuvering clearance(s) not provided	15"	Provide an automatic door opener.	1	3060	\$3060
57	Single-User Toilet Room Near Room 22 - Kindergarten	1	23	Doors, Doorways, & Gates	Toilet Room

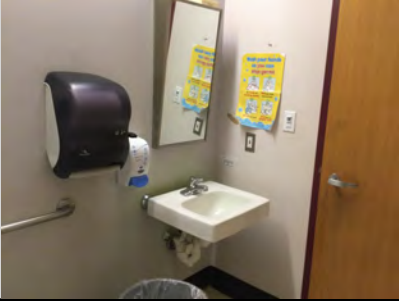
Maneuvering clearance(s) not provided	9"	Provide an automatic door opener.	1	3060	\$3060
58	To Toilets From Room 22	1	22	Doors, Doorways, & Gates	Classroom

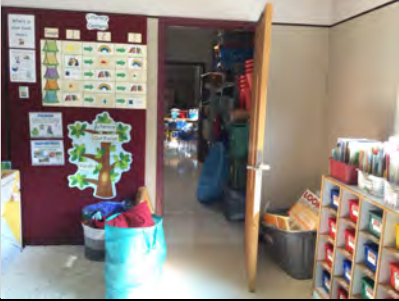
Maneuvering clearance(s) not provided	-	Relocate stored items to provide 18" min. pull-side maneuvering clearance at door.	1	Labor	\$0
59	Library - Temporary	1	21	Doors, Doorways, & Gates	Other

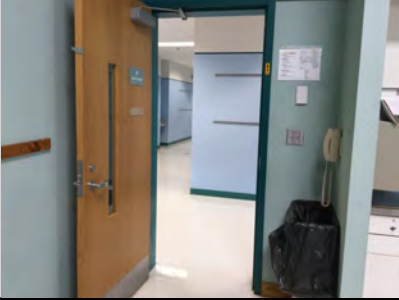
Maneuvering clearance(s) not provided	-	Relocate trash container to provide maneuvering clearance.	1	Labor	\$0
60	Computer Room	1	17	Doors, Doorways, & Gates	Classroom

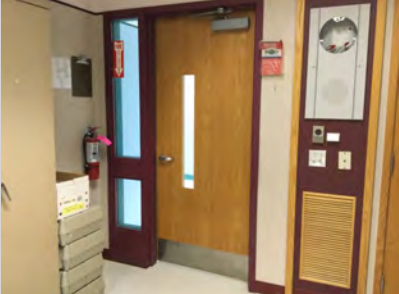
Maneuvering clearance(s) not provided Door requires > 5 lbs. of force to open	- 12 lbs.	Remove boxes to provide maneuvering clearance at door. Adjust closers so doors do not require more than 5 pounds of force to open.	1	Labor	\$0

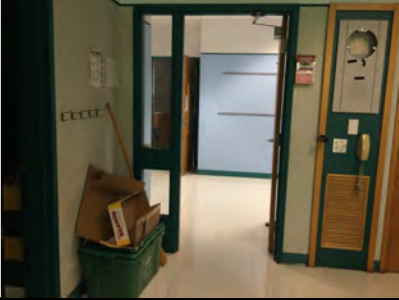
ID	Location	Floor	Room	Element	Type	Photo	Issues	Current Measure	Recommendations	Quantity	Price	Cost Estimation
66	Art Room	1	18	Doors, Doorways, & Gates	Classroom

Door requires > 5 lbs. of force to open	15 lbs.	Adjust closers so doors do not require more than 5 pounds of force to open.	1	Labor	\$0
67	Music Room	1	19	Doors, Doorways, & Gates	Classroom	 	Door requires > 5 lbs. of force to open	11 lbs.	Adjust closers so doors do not require more than 5 pounds of force to open.	1	Labor	\$0
68	Special Ed Grade 2	1	15	Doors, Doorways, & Gates	Classroom

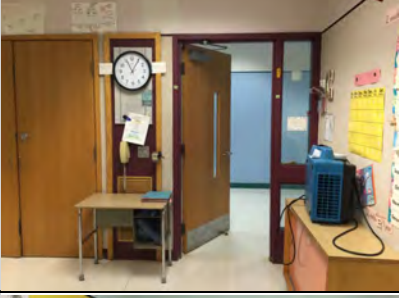
Door requires > 5 lbs. of force to open	10 lbs.	Adjust closers so doors do not require more than 5 pounds of force to open.	1	Labor	\$0
69	Grade 2	1	16	Doors, Doorways, & Gates	Classroom

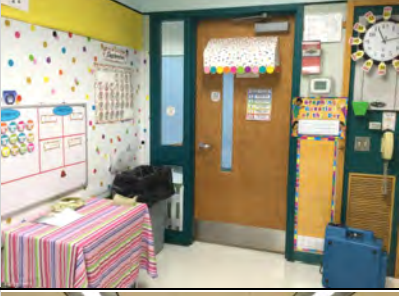
Door requires > 5 lbs. of force to open	12 lbs.	Adjust closers so doors do not require more than 5 pounds of force to open.	1	Labor	\$0
70	Library	1		Doors, Doorways, & Gates	Other

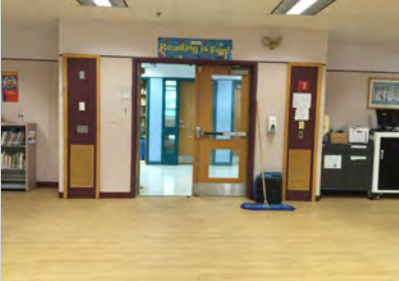
Door requires > 5 lbs. of force to open	15 lbs.	Adjust closers so doors do not require more than 5 pounds of force to open.	1	Labor	\$0

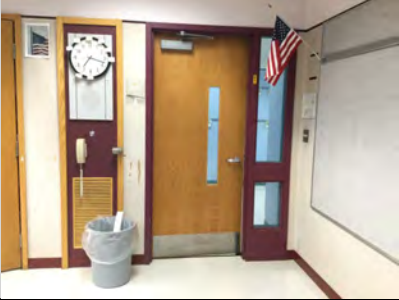
ID	Location	Floor	Room	Element	Type	Photo	Issues	Current Measure	Recommendations	Quantity	Price	Cost Estimation
71	Speech - All Grades	1	24	Doors, Doorways, & Gates	Other

Door requires > 5 lbs. of force to open	11 lbs.	Adjust closers so doors do not require more than 5 pounds of force to open.	1	Labor	\$0
72	Men's Toilet Room Near Main Office	1		Doors, Doorways, & Gates	Toilet Room

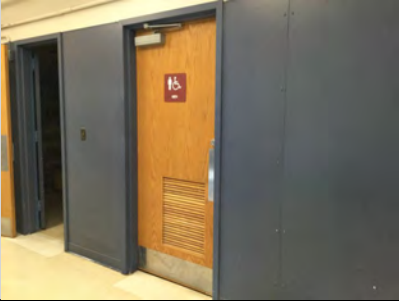
Door requires > 5 lbs. of force to open Sign not located on the latch side of the door	13 lbs.	Adjust closers so doors do not require more than 5 pounds of force to open. Locate sign at permanent rooms alongside the door on the latch side.	1	Labor	\$0
Ramps												
73	Ramp to Room 15	1	1	Ramps	Interior

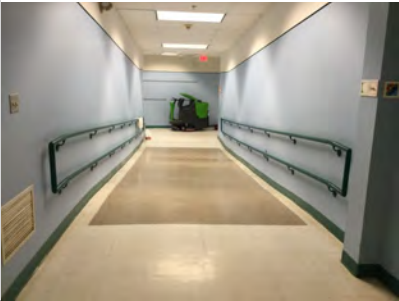
Running slope >1:12 (8.33%)	10%	Reduce running slope to be no steeper than 1:12 (8.33%)./Repair to this ramp might be technically infeasible.	1		\$0
Platform Lift or LULA Elevator												
74	Lift - Cafeteria	1.5		Platform Lift or LULA Elevator	Interior

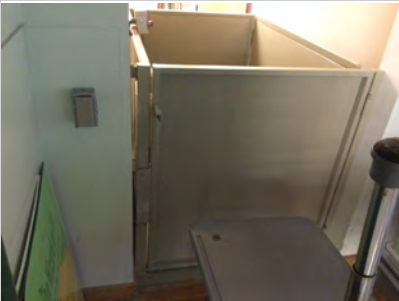
Not in operable working condition	-	Remove stored items that block access to lift door.	1	Labor	\$0

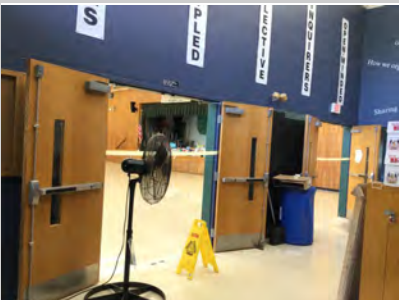
Signage												
75	Cafeteria	1		Signage	Designation

Signage is not provided	-	Locate compliant signage alongside the door on the latch side.	1	232	\$232

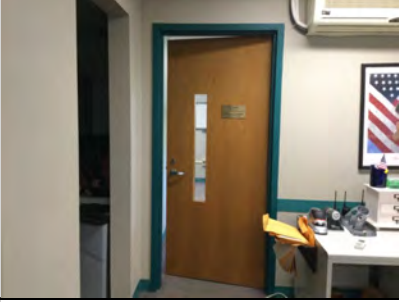
ID	Location	Floor	Room	Element	Type	Photo	Issues	Current Measure	Recommendations	Quantity	Price	Cost Estimation
76	Principal/ Assistant Principal	1		Signage	Designation

Raised characters not provided on sign Braille not provided on sign Sign not located on the latch side of the door	- - -	Provide text with raised characters duplicated in braille on sign. Locate sign at permanent rooms alongside the door on the latch side.	1	232	\$232
77	Boys' Toilet Near Room 12	1		Signage	Designation

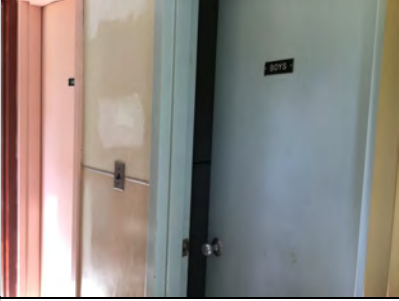
Raised characters not provided on sign Braille not provided on sign Sign not located on the latch side of the door	- - -	Provide text with raised characters duplicated in braille on sign. Locate sign at permanent rooms alongside the door on the latch side.	1	232	\$232
78	Girls' Toilet Near Room 11	1		Signage	Designation

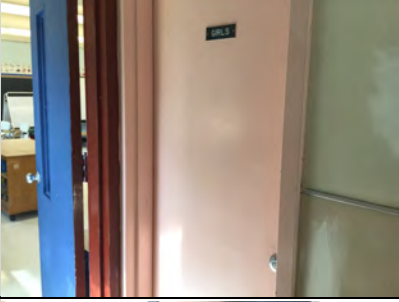
Raised characters not provided on sign Braille not provided on sign Sign not located on the latch side of the door	- - -	Provide text with raised characters duplicated in braille on sign. Locate sign at permanent rooms alongside the door on the latch side.	1	232	\$232

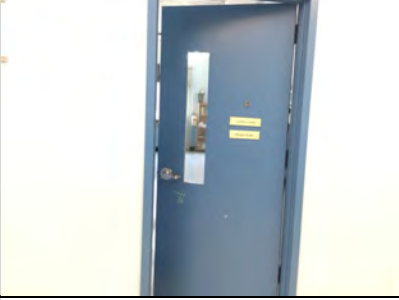
79	Special Ed. - All Grades	1	6	Signage	Designation

Raised characters not provided on sign Braille not provided on sign Sign not located on the latch side of the door	- - -	Provide text with raised characters duplicated in braille on sign. Locate signs at permanent rooms alongside the door on the latch side. (Room number sign.)	1	232	\$232
80	Single-User Toilets Between Rooms 6 & 5	2		Signage	Designation

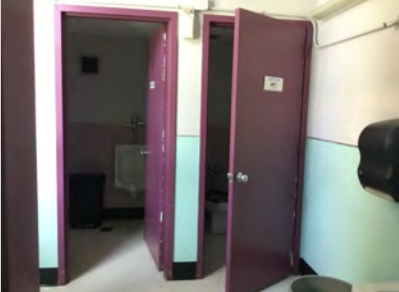
Raised characters not provided on sign Braille not provided on sign Sign not located on the latch side of the door	- - -	Provide text with raised characters duplicated in braille on sign. Locate sign at permanent rooms alongside the door on the latch side. Once accessible, include ISA sign at boys' toilet room and label toilet room all gender. Also label girls' toilet room all gender. Include sign directing users to to boys' toilet room for access to an accessible toilet room.	2	232	\$464

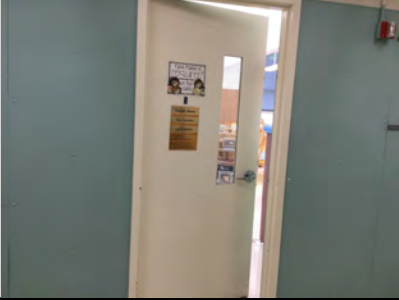
ID	Location	Floor	Room	Element	Type	Photo	Issues	Current Measure	Recommendations	Quantity	Price	Cost Estimation
81	ABA Pre K	1	5	Signage	Designation

Raised characters not provided on sign Braille not provided on sign Sign not located on the latch side of the door	- - -	Provide text with raised characters duplicated in braille on sign. Locate signs at permanent rooms alongside the door on the latch side. (Room number sign.)	1	232	\$232
82	Special Ed Pre K	1	4	Signage	Designation

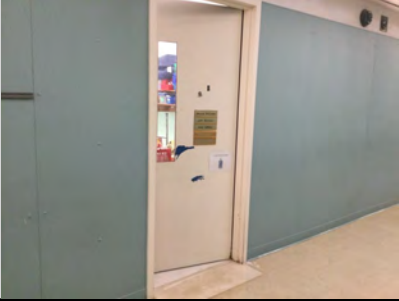
Raised characters not provided on sign Braille not provided on sign Sign not located on the latch side of the door	- - -	Provide text with raised characters duplicated in braille on sign. Locate signs at permanent rooms alongside the door on the latch side. (Room number sign.)	1	232	\$232
83	Guidance - All Grades	1	1	Signage	Designation

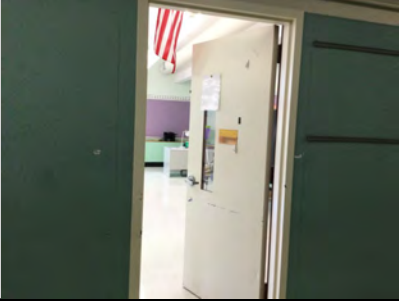
Raised characters not provided on sign Braille not provided on sign Sign not located on the latch side of the door	- - -	Provide text with raised characters duplicated in braille on sign. Locate sign at permanent rooms alongside the door on the latch side.	1	232	\$232

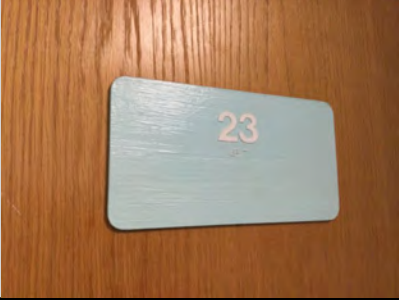
84	Kindergarten	1	23	Signage	Designation

Raised characters not provided on sign Braille not provided on sign Sign not located on the latch side of the door	- - -	Provide text with raised characters duplicated in braille on sign. Locate sign at permanent rooms alongside the door on the latch side.	1	232	\$232
85	Toilets - Kindergarten	1	23	Signage	Directional

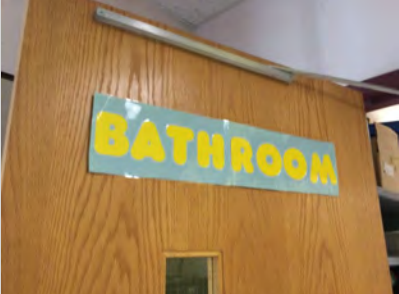
Raised characters not provided on sign Braille not provided on sign Sign not located on the latch side of the door	- - -	Provide text with raised characters duplicated in braille on sign. Locate sign at permanent rooms alongside the door on the latch side.	1	232	\$232

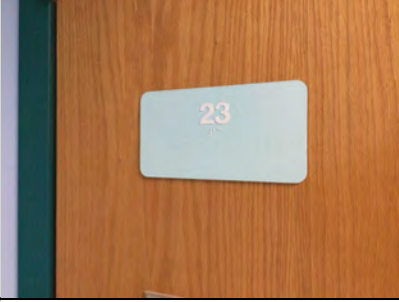
ID	Location	Floor	Room	Element	Type	Photo	Issues	Current Measure	Recommendations	Quantity	Price	Cost Estimation
86	Room 23 - Kindergarten	1	23	Signage	Designation

Raised characters not provided on sign Braille not provided on sign Sign not located on the latch side of the door	- - -	Provide text with raised characters duplicated in braille on sign. Locate sign at permanent rooms alongside the door on the latch side.	1	232	\$232
87	Special Ed Grade 1 & 2	1	2	Signage	Designation

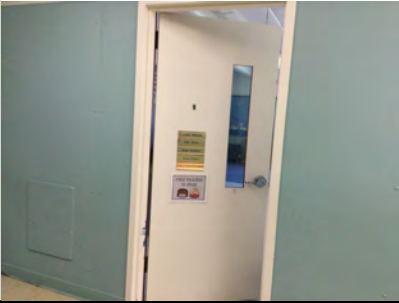
Braille not provided on sign Sign not located on the latch side of the door	- -	Provide braille on sign. Locate sign at permanent rooms alongside the door on the latch side. (Room number sign.)	1	232	\$232
88	Women's Toilet Room Near Main Office	1		Signage	Designation

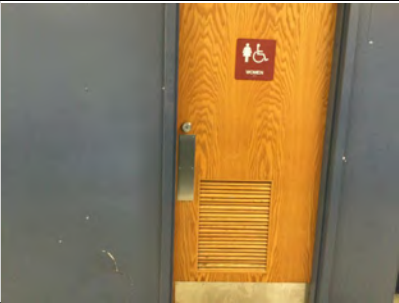
Sign not located on the latch side of the door	-	Locate sign at permanent rooms alongside the door on the latch side.	1	Labor	\$0
89	Conference	1		Signage	Designation

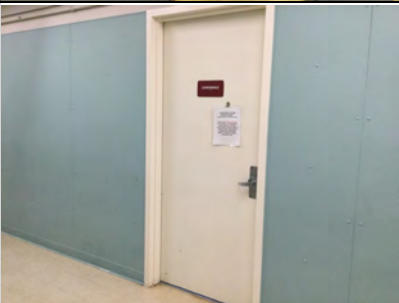
Sign not located on the latch side of the door	-	Locate sign at permanent rooms alongside the door on the latch side.	1	Labor	\$0

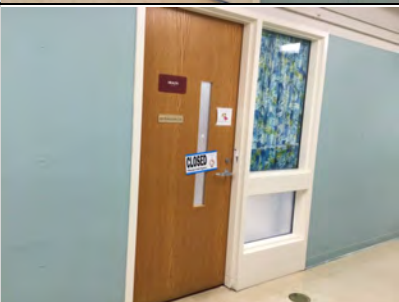
90	Health/Nurse	1		Signage	Designation

Sign not located on the latch side of the door	-	Locate sign at permanent rooms alongside the door on the latch side.	1	Labor	\$0

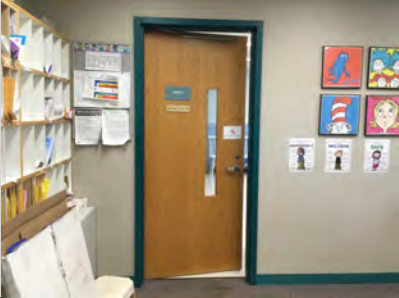
ID	Location	Floor	Room	Element	Type	Photo	Issues	Current Measure	Recommendations	Quantity	Price	Cost Estimation
91	Health/Nurse - Main Office	1	1	Signage	Designation

Sign not located on the latch side of the door	-	Locate sign at permanent rooms alongside the door on the latch side.	1	Labor	\$0
92	Men's Toilet Room Near Ramp	1	1	Signage	Designation

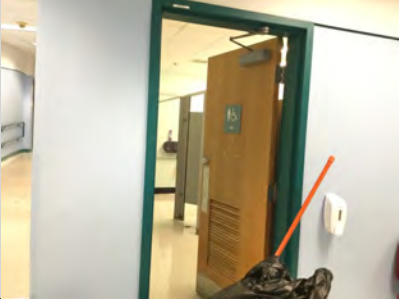
Sign not located on the latch side of the door	-	Locate sign at permanent rooms alongside the door on the latch side.	1	Labor	\$0
93	Women's Toilet Room Near Ramp	1	1	Signage	Designation

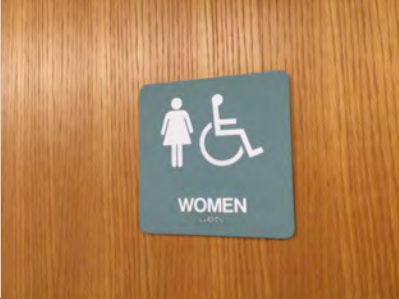
Sign not located on the latch side of the door	-	Locate sign at permanent rooms alongside the door on the latch side.	1	Labor	\$0
94	Library - Temporary	1	21	Signage	Designation

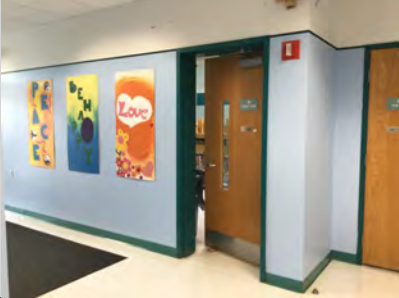
Sign not located on the latch side of the door	-	Locate sign at permanent rooms alongside the door on the latch side.	1	Labor	\$0
95	Play Room/ Gymnasium	1	20	Signage	Designation

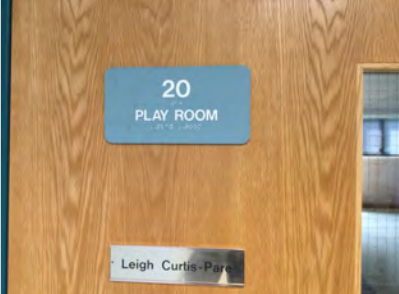
Sign not located on the latch side of the door	-	Locate sign at permanent rooms alongside the door on the latch side.	1	Labor	\$0

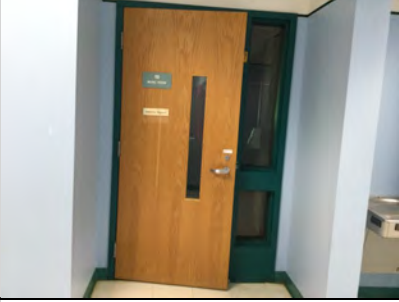
ID	Location	Floor	Room	Element	Type	Photo	Issues	Current Measure	Recommendations	Quantity	Price	Cost Estimation
96	Music Room	1	19	Signage	Designation

Sign not located on the latch side of the door	-	Locate sign at permanent rooms alongside the door on the latch side.	1	Labor	\$0
97	Art Room	1	18	Signage	Designation

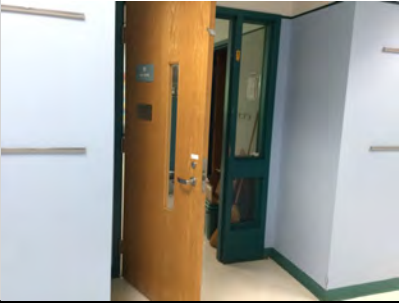
Sign not located on the latch side of the door	-	Locate sign at permanent rooms alongside the door on the latch side.	1	Labor	\$0
98	Computer Room	1	17	Signage	Designation

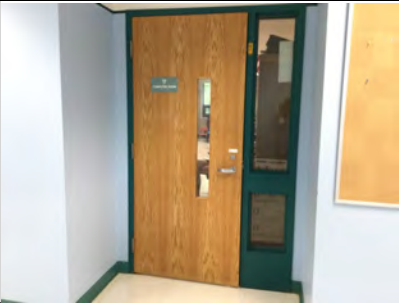
Sign not located on the latch side of the door	-	Locate sign at permanent rooms alongside the door on the latch side.	1	Labor	\$0
99	Special Ed Grade 2	1	15	Signage	Designation

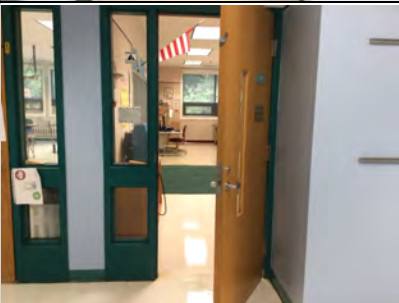
Sign not located on the latch side of the door	-	Locate sign at permanent rooms alongside the door on the latch side.	1	Labor	\$0
100	Grade 2	1	16	Signage	Designation

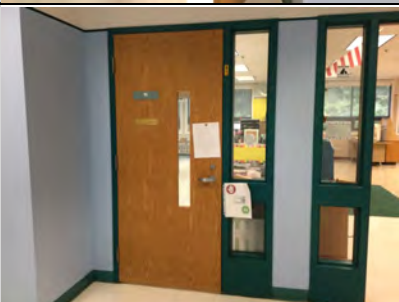
Sign not located on the latch side of the door	-	Locate sign at permanent rooms alongside the door on the latch side.	1	Labor	\$0

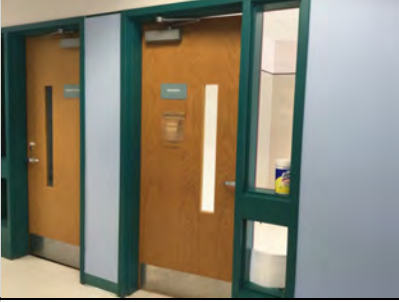
ID	Location	Floor	Room	Element	Type	Photo	Issues	Current Measure	Recommendations	Quantity	Price	Cost Estimation
101	Guidance Near Library	1		Signage	Designation

Sign not located on the latch side of the door	-	Locate sign at permanent rooms alongside the door on the latch side.	1	Labor	\$0
102	Library	1		Signage	Designation

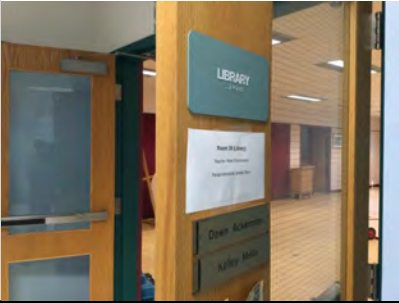
Sign not located on the latch side of the door	-	Locate sign at permanent rooms alongside the door on the latch side.	1	Labor	\$0
103	Speech - All Grades	1	24	Signage	Designation

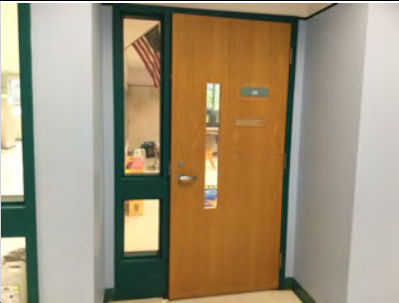
Sign not located on the latch side of the door	-	Locate sign at permanent rooms alongside the door on the latch side.	1	Labor	\$0
104	Literacy - All Grades	1	24	Signage	Designation

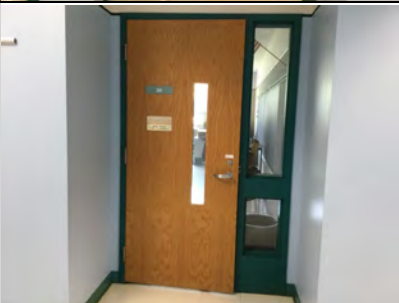
Sign not located on the latch side of the door	-	Locate sign at permanent rooms alongside the door on the latch side.	1	Labor	\$0
105	Boys' Toilet Room Near Room 24	1		Signage	Designation

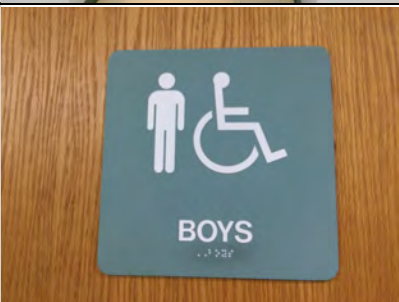
Sign not located on the latch side of the door	-	Locate sign at permanent rooms alongside the door on the latch side.	1	Labor	\$0

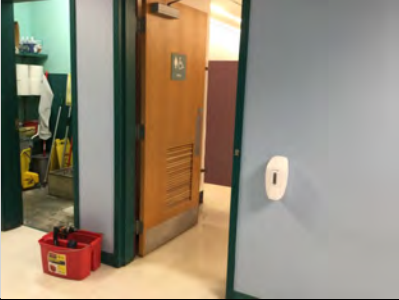
ID	Location	Floor	Room	Element	Type	Photo	Issues	Current Measure	Recommendations	Quantity	Price	Cost Estimation
106	Girls' Toilet Room Near Room 24	1		Signage	Designation

Sign not located on the latch side of the door	-	Locate sign at permanent rooms alongside the door on the latch side.	1	Labor	\$0
107	Grade 1	1	11	Signage	Designation

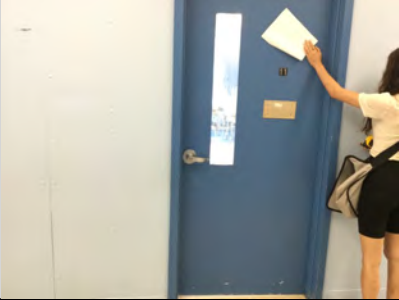
Sign not located on the latch side of the door Raised characters not provided on sign Braille not provided on sign	- - -	Provide text with raised characters duplicated in braille on sign. Locate signs at permanent rooms alongside the door on the latch side. (Room number sign.)	1	232	\$232
Service Counter												
108	Main Office	1		Service Counter	N/A

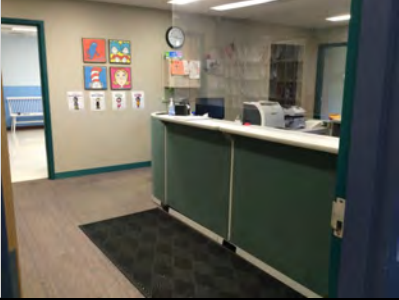
Counter > 36" high	42.25"	Provide a counter that is 36" max. above the ground or finished floor.	1	880	\$880
Operable Parts												
109	Women's Toilet Room Near Main Office	1		Operable Parts	Other

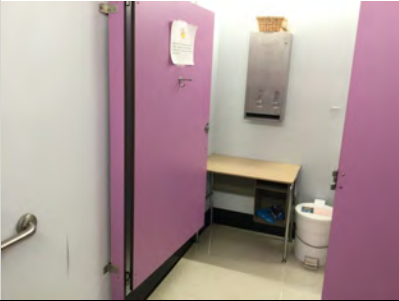
Element not on an accessible route	-	Ensure tampon dispenser is located on an accessible route. (Relocate small table.)	1	Labor	\$0

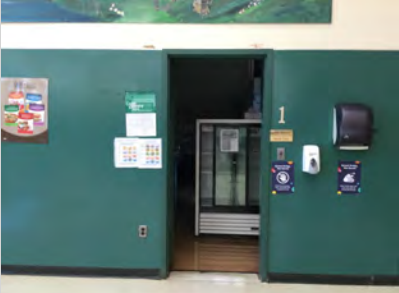
110	Near Kitchen - Cafeteria	1		Operable Parts	Other

Side reach > 54" Dispenser protrudes into the circulation path	57"	Relocate paper towel dispenser so that controls are between 15" - 48" above the finished floor.	1	256	\$256

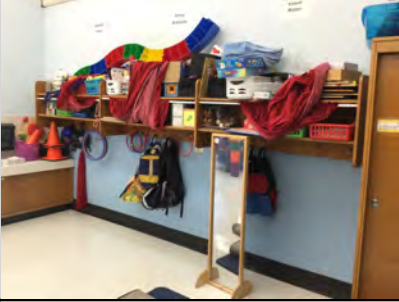
ID	Location	Floor	Room	Element	Type	Photo	Issues	Current Measure	Recommendations	Quantity	Price	Cost Estimation
Children's Reach Ranges												
111	OT/PT - All Grades	1	12	Children's Reach Ranges	N/A

Reach < 18" or > 40" (Ages 5 - 8)	45.75"	Provide at least one storage locker between 18" and 40" above the finished floor.	1	256	\$256
112	Grade 1	1	11	Children's Reach Ranges	N/A

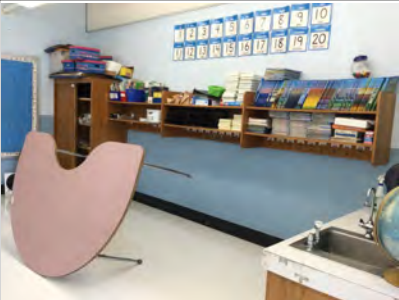
Reach < 18" or > 40" (Ages 5 - 8)	-	Provide at least one storage locker between 18" and 40" above the finished floor.	1	256	\$256
113	Special Ed. - All Grades	1	6	Children's Reach Ranges	N/A

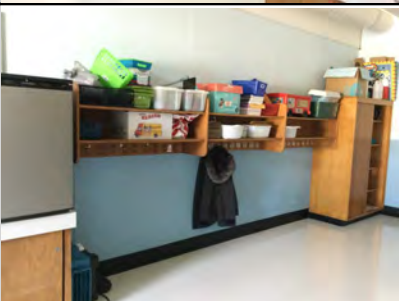
Reach < 18" or > 40" (Ages 5 - 8)	45"	Provide at least one storage locker between 18" and 40" above the finished floor.	1	Labor	\$0
114	ABA Pre K	1	5	Children's Reach Ranges

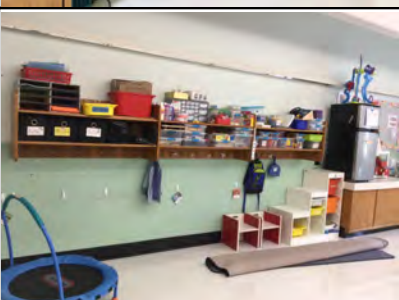
Reach < 18" or > 40" (Ages 5 - 8)	45"	Relocate so the operable part is between 18" and 40" above the finished floor.	1	256	\$256
115	Special Ed Pre K	1	4	Children's Reach Ranges	N/A

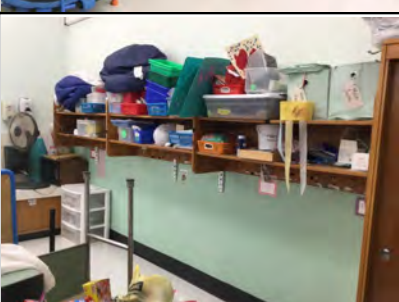
Reach < 18" or > 40" (Ages 5 - 8)	45"	Relocate so the operable part is between 18" and 40" above the finished floor.	1	256	\$256
