Town of Merrimac, Massachusetts

PART A – Executive Summary

September 2021

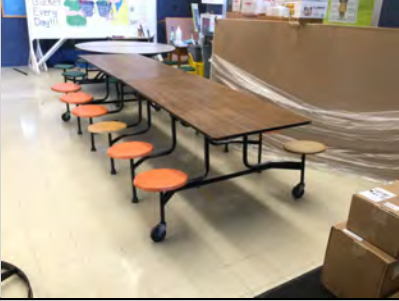
ID	Location	Floor	Room	Element	Type	Photo	Issues	Current Measure	Recommendations	Quantity	Price	Cost Estimation
Dining or Work Surfaces												
116	Dining Table - Cafeteria	1		Dining or Work Surfaces	Dining Surface

At least one or 5% accessible tables not provided	-	Ensure that at least 5% of dining or surfaces are accessible.	1	1100	\$1100
Assembly Area												
117	Stage - Cafeteria	1		Assembly Area	N/A

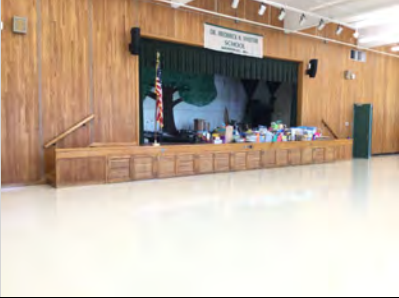
Assistive listening devices not provided	-	If audible communication is integral to the use of the space, provide an assistive listening system.	1	1214	\$1214
Picnic Tables												
118	Small Playground Near Rear Parking Lot	Ext.		Picnic Tables	N/A

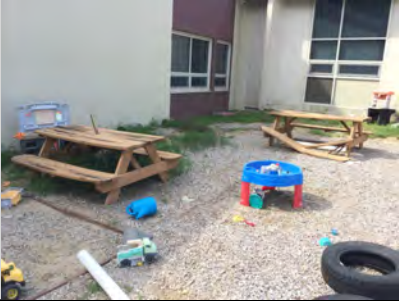
At least 5% accessible spaces not provided	-	Ensure that at least 5% (minimum one) of dining surfaces are accessible. (Cost based on an accessible picnic table for children.)	1	1200	\$1200
Exterior Benches												
119	Bench Near Main Entrance/Exit	Ext.		Exterior Benches	N/A

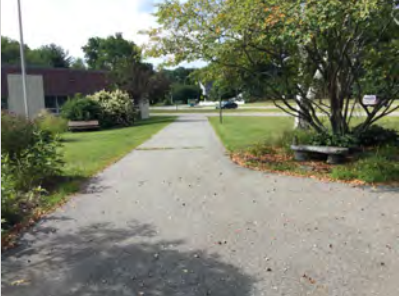
No accessible route to one bench in area	-	Provide an accessible route to 20% of benches in this area. (Cost based on a 4'x6' asphalt path from existing walkway to bench.)	1	240	\$240

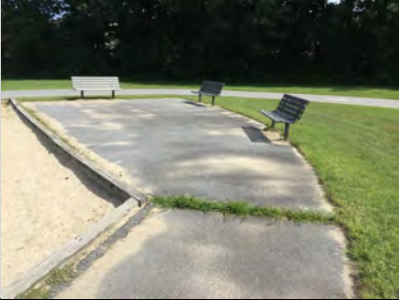
ID	Location	Floor	Room	Element	Type	Photo	Issues	Current Measure	Recommendations	Quantity	Price	Cost Estimation
120	Playground	Ext.		Exterior Benches	N/A

No accessible route to one bench in area (route not maintained.)	-	Maintain walkway surface.	1	Labor	\$0
Toilet & Bathing Rooms												
Overall Access												
121	Girls' Toilet Room Near Room 11	1		Overall Access	Toilet Room

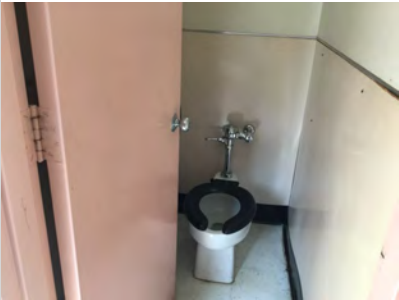
Sign to accessible toilet not provided	59"	Provide a directional sign indicating the location of the nearest accessible toilet room once the neighboring boys' single-user toilet room is made accessible and designated for all gender.	1	232	\$232
122	Girls' Single-User Toilet Room Between Room 6 & 5	1		Overall Access	Toilet Room

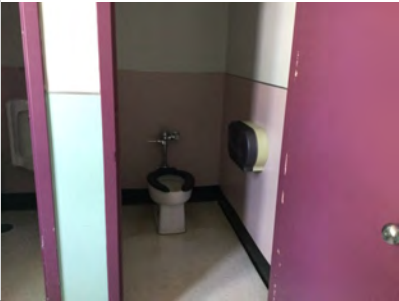
Sign to accessible toilet not provided	-	Provide a directional sign indicating the location of the nearest accessible toilet or bathing room (neighboring boys' single-user toilet room once made accessible and labeled all gender). Label this toilet room as all gender.	1	232	\$232

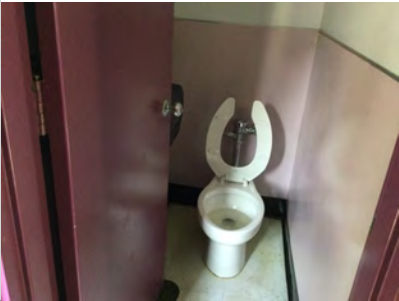
123	Girls' Toilet Room Between Room 4 & Room 3	1		Overall Access	Toilet Room

Sign to accessible toilet not provided	-	Provide a directional sign indicating the location of the nearest accessible toilet or bathing room (neighboring boys' single-user toilet room once made accessible and labeled all gender). Label this toilet room all gender.	1	232	\$232
124	Single-User Toilet Room Near Room 22 - Kindergarten	1	23	Overall Access	Toilet Room

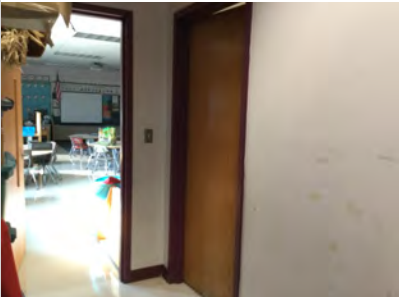
International Symbol of Acc. not provided	- -	Provide a sign with the International Symbol of Accessibility.	1	232	\$232

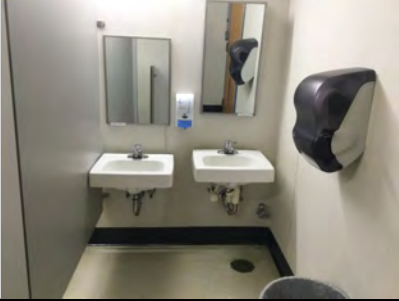
ID	Location	Floor	Room	Element	Type	Photo	Issues	Current Measure	Recommendations	Quantity	Price	Cost Estimation
Lavatory												
125	Men's Toilet Room Near Main Office	1		Lavatory	N/A

Toe or knee clearances not provided Plumbing underneath is exposed Mirror above lavatory w/reflective surface > 40"	23.75" - 43"	Provide at least one lavatory with knee and toe clearance positioned for a forward approach. Insulate or otherwise configure pipes to prevent contact for at least one lavatory. Lower mirror so that the bottom surface is at 40" max. above the finished floor.	1	2034	\$2034
126	Women's Toilet Room Near Main Office	1		Lavatory	N/A

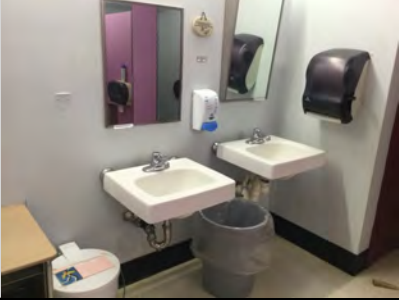
Toe or knee clearances not provided Mirror above lavatory w/reflective surface > 40" Dispensers not within reach range	24.25" 44" -	Provide at least one lavatory with knee and toe clearance positioned for a forward approach. Lower mirror so that the bottom surface is at 40" max. above the finished floor. Relocate paper towel dispenser out of the circulation path. Relocate the trash container that blocks access to the soap dispenser.	1	1748	\$1748

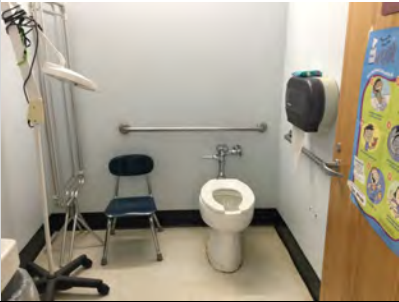
Single-User Toilet												
127	Single-User Toilet - Health/ Nurse's Office	1	1	Single-User Toilet	N/A

Clearance at toilet < 60" clear width Toilet paper dispenser is not compliant	- -	Relocate chair and stored items to ensure that there is 60" wide min. clear floor space at the toilet. Relocate toilet paper so that it is 24" min. high, located under the grab bar, and between 7" and 9" from the front of the toilet./Replace dispenser as it does not allow continuous paper flow.	1	256	\$256
128	Single-User Toilet Room Near Room 22 - Kindergarten	1	23	Single-User Toilet	N/A

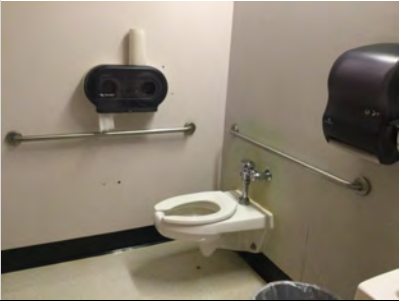
Toilet paper dispenser is not compliant	-	Relocate toilet paper so that it is 24" min. high, located under the grab bar, and between 7" and 9" from the front of the toilet./Replace dispenser as it does not allow continuous paper flow.	1	256	\$256
Toilet Compartment												
129	Men's Toilet Room Near Ramp	1	1	Toilet Compartment	Accessible Compartment

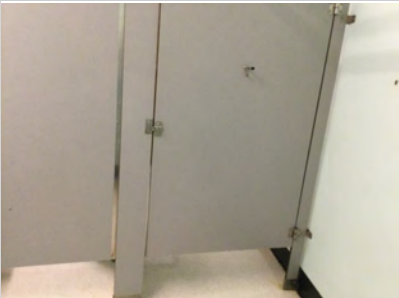
Door has non-compliant hardware	-	Provide hardware that can be operable with one hand and not require tight grasping, pinching, or twisting of the wrist. (Provide an accessible door pull.)	1	70	\$70

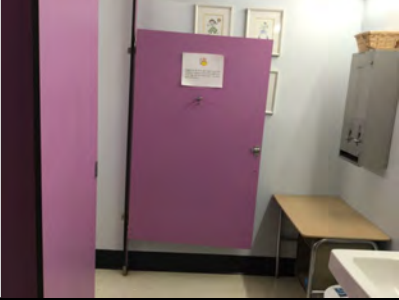
ID	Location	Floor	Room	Element	Type	Photo	Issues	Current Measure	Recommendations	Quantity	Price	Cost Estimation
130	Women's Toilet Room Near Main Office	1		Toilet Compartment	Accessible Compartment

Door has non-compliant hardware Door has malfunctioning self-closing hinge	- -	Provide hardware that can be operable with one hand and not require tight grasping, pinching, or twisting of the wrist. (Provide an accessible door pull on the inside of the compartment door.) Repair hinge.	1	70	\$70
131	Men's Toilet Room Near Main Office	1		Toilet Compartment	Accessible Compartment

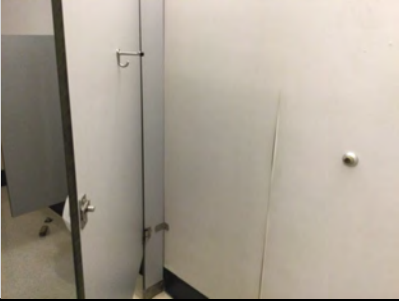
Door has non-compliant hardware Door has malfunctioning self-closing hinge	- -	Provide hardware that can be operable with one hand and not require tight grasping, pinching, or twisting of the wrist. (Provide an accessible door pull on both sides of stall door.) Repair hinge.	1	70	\$70
132	Women's Toilet Room Near Ramp	1	1	Toilet Compartment	Accessible Compartment

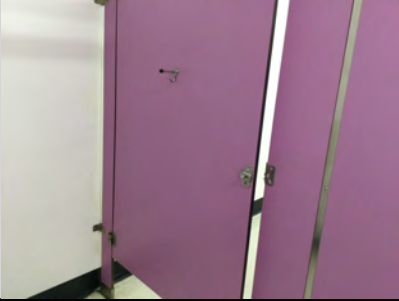
Door has malfunctioning self-closing hinge Door has non-compliant hardware	- -	Provide hardware that can be operable with one hand and not require tight grasping, pinching, or twisting of the wrist. (Provide an accessible door pull.) Repair hinge.	1	70	\$70

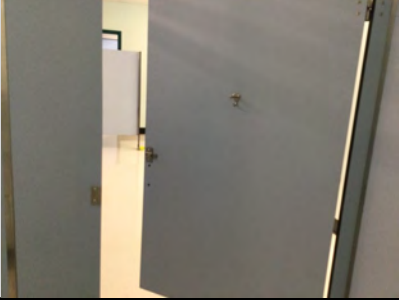
133	Boys' Toilet Room Near Room 24	1		Toilet Compartment	Accessible Compartment

Door has malfunctioning self-closing hinge Door has non-compliant hardware	- -	Provide hardware that can be operable with one hand and not require tight grasping, pinching, or twisting of the wrist. (Provide an accessible door pull on inside of door.) Repair hinge.	1	70	\$70
134	Girls' Toilet Room Near Room 24	1		Toilet Compartment	Accessible Compartment

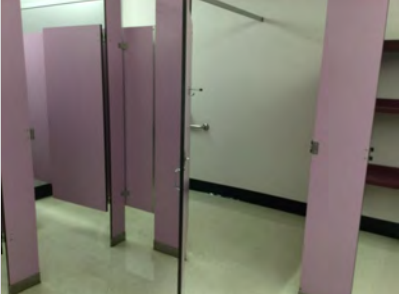
Door has malfunctioning self-closing hinge Door has non-compliant hardware	- -	Provide hardware that can be operable with one hand and not require tight grasping, pinching, or twisting of the wrist. (Provide an accessible door pull.) Repair hinge.	1	70	\$70

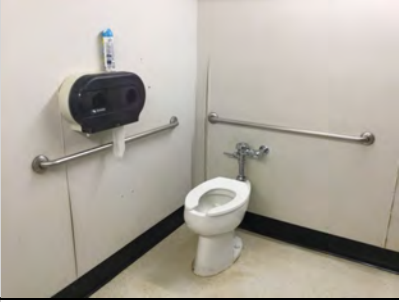
ID	Location	Floor	Room	Element	Type	Photo	Issues	Current Measure	Recommendations	Quantity	Price	Cost Estimation
135	Men's Toilet Room Near Main Office	1		Toilet Compartment	Accessible Compartment

Flush control not on open side Non-compliant toilet paper dispenser	- -	Provide the flush control on the open side of the toilet (transfer side). Relocate toilet paper so that it is 24" min. high, located under the grab bar, and between 7" and 9" from the front of the toilet./Replace dispenser as it does not allow continuous paper flow.	1	630	\$630
136	Boys' Toilet Room Near Room 24	1		Toilet Compartment	Accessible Compartment

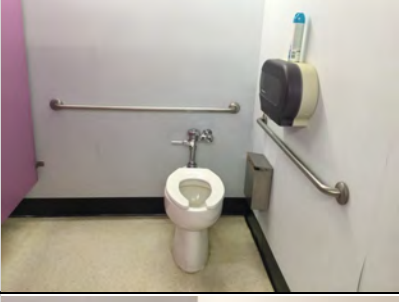
Non-compliant toilet paper dispenser	-	Relocate toilet paper so that it is 24" min. high, located under the grab bar, and between 7" and 9" from the front of the toilet./Replace dispenser as it does not allow continuous paper flow.	1	256	\$256
139	Women's Toilet Room Near Ramp	1	1	Toilet Compartment	Accessible Compartment

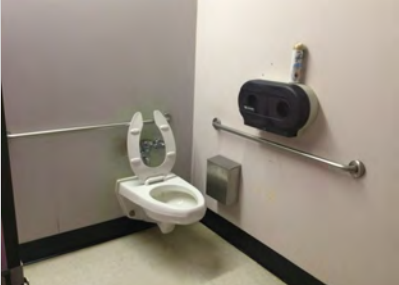
Non-compliant toilet paper dispenser	-	Relocate toilet paper so that it is 24" min. high, located under the grab bar, and between 7" and 9" from the front of the toilet./Replace dispenser as it does not allow continuous paper flow.	1	256	\$256

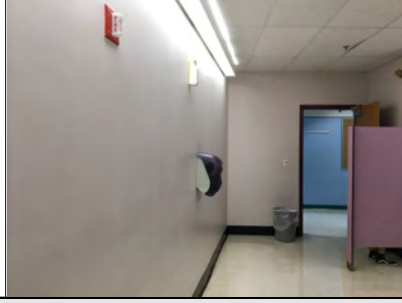
Dispenser acts as a protruding object	-	Relocate dispenser out of the circulation path.	1	256		\$256
Toilet Rooms for Children													
Single-User Toilet (Children)													
143	Boys' Toilet Near Room 12	1		Single-User Toilet (Children)	N/A

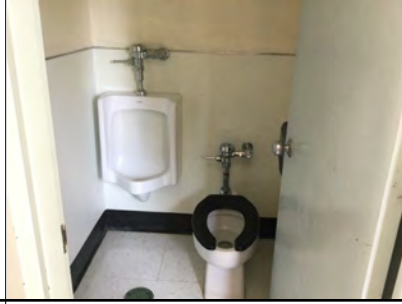
Clearance at toilet < 72" clear deep	47.5"	Provide a new accessible single-user toilet room with a toilet that has clear floor space at the toilet that is 72" deep min. Designate toilet room as all gender once it is made accessible.	1	24604	\$24604

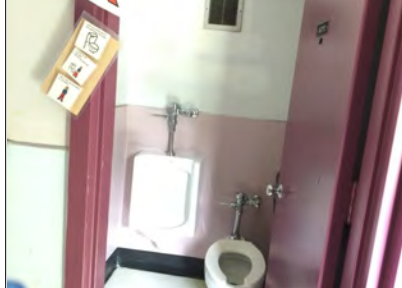
144	Boys' Toilet Room Between Room 4 & Room 3	1		Single-User Toilet (Children)	N/A

Clearance at toilet < 72" clear deep	58.5"	Provide a new accessible single-user toilet room with a toilet that has clear floor space at the toilet that is 72" deep min. Include sign with ISA once made accessible and label toilet room all gender.	1	24604		\$24604

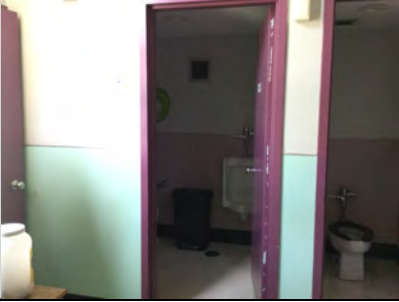
ID	Location	Floor	Room	Element	Type	Photo	Issues	Current Measure	Recommendations	Quantity	Price	Cost Estimation
145	Boys' Single-User Toilet Room Between Room 6 & 5	1		Single-User Toilet (Children)

Clearance at toilet < 72" clear deep Clear width at door < 32" Hardware not operable with a closed fist	60" 29" - -	Widen the door so that there is 32" min. clear width. Provide hardware that can be operable with one hand and not require tight grasping, pinching, or twisting of the wrist. Provide a new accessible single-user toilet room with a toilet that has clear floor space at the toilet that is 72" deep min. Designate toilet room as all gender.	1	24604	\$24604
146	Single-User Toilet - Special Ed Grade 1 & 2	1	2	Single-User Toilet (Children)	N/A

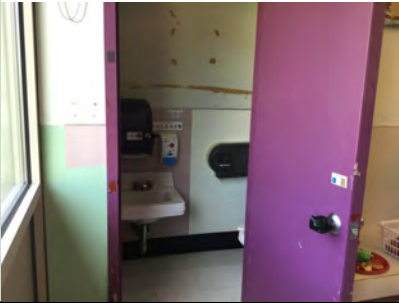
Clearance at toilet < 60" clear wide	38" -	Provide a new accessible single-user toilet room with a toilet that has clear floor space at the toilet that is 60" wide min.	1	24604	\$24604

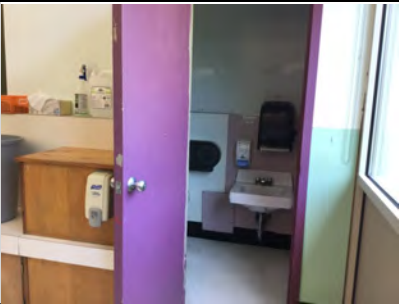
147	Single-User Toilet - Guidance - All Grades	1	1	Single-User Toilet (Children)	N/A

Clearance at toilet < 60" clear wide	38"	Provide a new accessible single-user toilet room with a toilet that has clear floor space at the toilet that is 60" wide min.	1	24604	\$24604
Lavatory (Children)												
148	Lavatory Outside Two Single-User Toilet Rooms Between Rooms 6 & 5	1		Lavatory (Children)	N/A

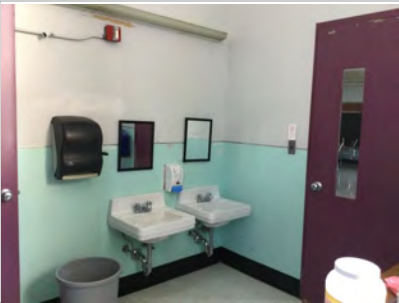
Toe or knee clearances not provided Mirror above lavatory w/reflective surface > 31"	20" 41"	Provide at least one lavatory with 25" min. knee clearance positioned for a forward approach. Ensure toe clearance is also provided. Lower mirror so that the bottom surface is at 31" above finished floor.	1	1942	\$1942
Additional Access												
Drinking Fountains												
149	Near Kitchen - Cafeteria	1		Drinking Fountains	N/A

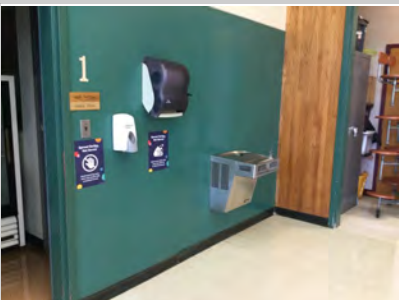
No drinking fountain provided for standing users	-	Provide an additional drinking fountain for standing users.	1	4028	\$4028

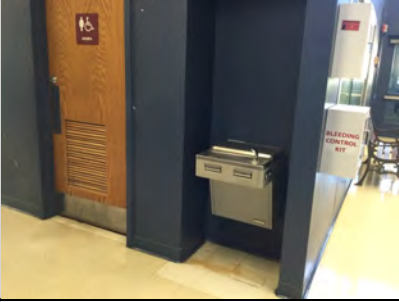
ID	Location	Floor	Room	Element	Type	Photo	Issues	Current Measure	Recommendations	Quantity	Price	Cost Estimation
150	Drinking Fountain Near Main Office	1		Drinking Fountains	Low

No drinking fountain provided for standing users	-	Provide an additional drinking fountain for standing users.	1	4028	\$4028
151	Play Room/ Gymnasium	1	20	Drinking Fountains	N/A

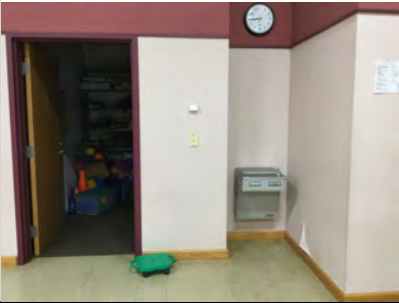
No drinking fountain provided for standing users	-	Provide an additional drinking fountain for standing users.	1	4028	\$4028
152	Drinking Fountain Near Music Room	1		Drinking Fountains	Low

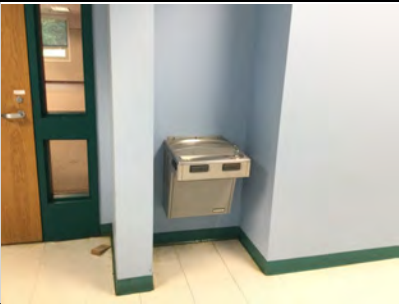
No drinking fountain provided for standing users	-	Provide an additional drinking fountain for standing users.	1	4028	\$4028
153	Drinking Fountain Near Room 25	1		Drinking Fountains	Low

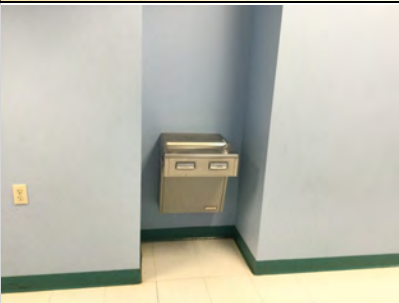
No drinking fountain provided for standing users	-	Provide an additional drinking fountain for standing users.	1	4028	\$4028
Sink												
154	Health/ Nurse's Office	1	1	Sink	616

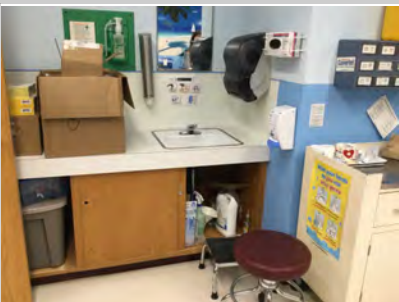
Toe and knee clearances not provided Exposed plumbing underneath sink	- -	Ensure there is a 27" knee clearance positioned for a forward approach. Insulate or otherwise configure pipes at sink.	1	1778	\$1778

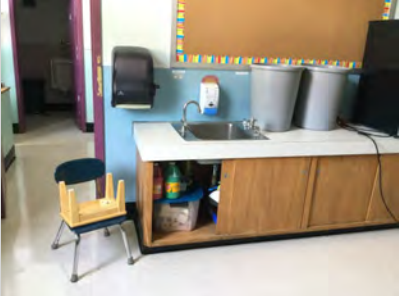
Rim or counter at sink > 30" Exposed plumbing underneath Knee or toe clearance not provided	32.25" - 24.5"	Relocate sink with the front of the rim or counter no higher than 30" above the finished floor. Insulate or otherwise configure pipes to prevent contact, for at least one sink. Provide at least one sink with 25" high knee and toe clearance positioned for a forward approach.	1	1778	\$1778
156	Art Room	1	18	Sinks for Children's Use	Classroom

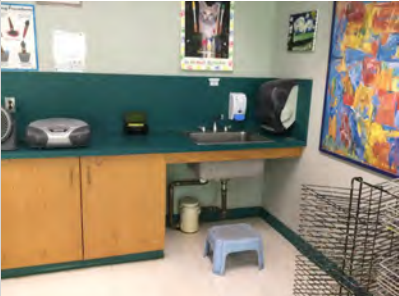
Rim or counter at sink > 30" Exposed plumbing underneath Knee or toe clearance not provided	34.5" - 22.5"	Relocate sink with the front of the rim or counter no higher than 30" above the finished floor. Insulate or otherwise configure pipes to prevent contact, for at least one sink. Provide at least one sink with 25" high knee and toe clearance positioned for a forward approach.	1	1778	\$1778

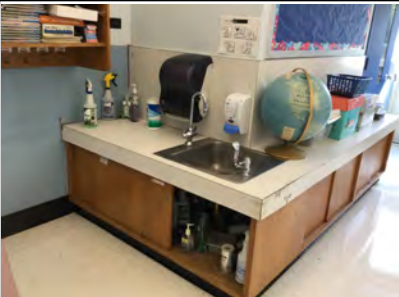
157	Grade 1	1	11	Sinks for Children's Use	Classroom

Exposed plumbing underneath Knee or toe clearance not provided	- -	Insulate or otherwise configure pipes to prevent contact, for at least one sink. Provide at least one sink with 25" high knee and toe clearance positioned for a forward approach.	1	1778	\$1778
158	Guidance - All Grades	1	1	Sinks for Children's Use	Classroom

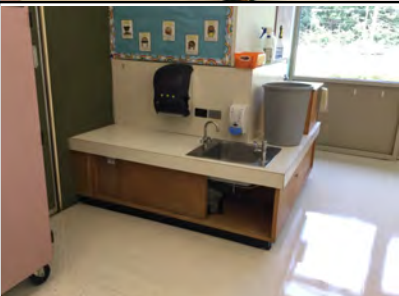
Exposed plumbing underneath Knee or toe clearance not provided	- -	Insulate or otherwise configure pipes to prevent contact, for at least one sink. Provide at least one sink with 25" high knee and toe clearance positioned for a forward approach.	1	1778	\$1778
159	Speech and Language - All Grades Near Room 2	1	1	Sinks for Children's Use	Other

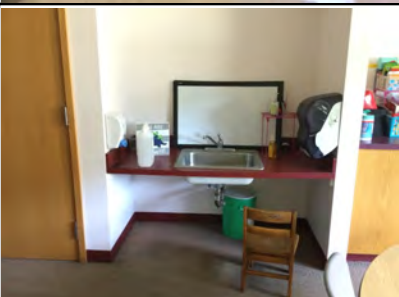
Exposed plumbing underneath Knee or toe clearance not provided	- 22"	Insulate or otherwise configure pipes to prevent contact, for at least one sink. Provide at least one sink with 25" high knee and toe clearance positioned for a forward approach.	1	1778	\$1778

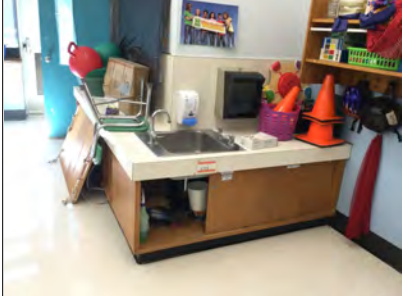
Knee or toe clearance not provided	-	Provide at least one sink with 25" high knee and toe clearance positioned for a forward approach.	1	1686	\$1686
161	Special Ed Pre K	1	4	Sinks for Children's Use	Classroom

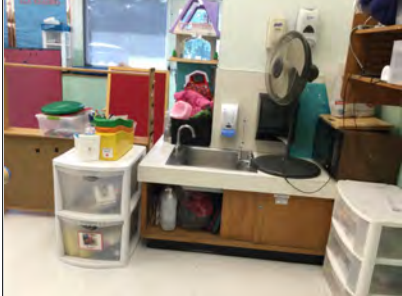
Knee or toe clearance not provided	-	Provide at least one sink with 25" high knee and toe clearance positioned for a forward approach.	1	1686	\$1686
162	Special Ed Grade 2	1	15	Sinks for Children's Use	Classroom

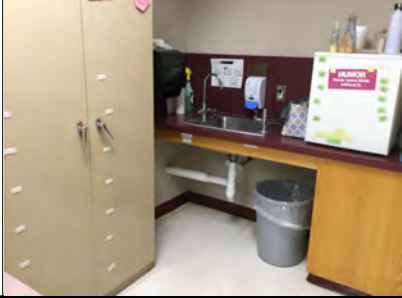
Knee or toe clearance not provided	-	Provide at least one sink with 25" high knee and toe clearance positioned for a forward approach.	1	1686	\$1686
163	Grade 2	1	16	Sinks for Children's Use	Classroom

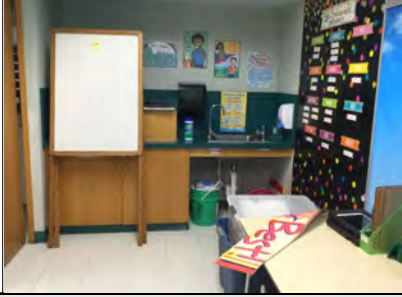
Knee or toe clearance not provided Sink not on an accessible route	- -	Provide at least one sink with 25" high knee and toe clearance positioned for a forward approach. Locate sink on an accessible route. (Relocate stored items and furniture.)	1	1686	\$1686

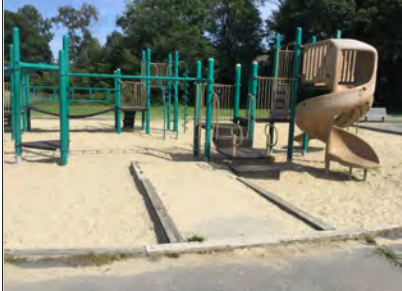
Play and Sport Areas												
Play Areas												
164	Playground	Ext.		Play Areas	N/A

Accessible route not provided to playground Accessible route not provided to play components	2" -	Install an accessible route to and around the playground. Provide a compliant impact-attenuating surface to and around the play components. (Cost estimate for 1200 sq. ft. of poured in place rubber surface.)	1	16800	\$16800

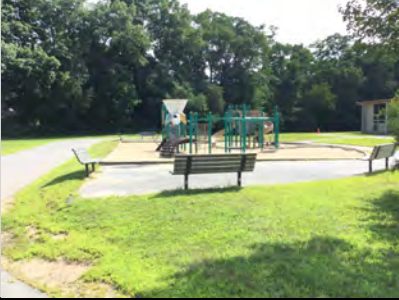
Accessible route not provided around playground	-	Provide an accessible route around the play area. (Cost estimate for 4'x60' of asphalt.)	1	2400	\$2400
166	Small Playground Near Rear Parking Lot	Ext.		Play Areas	N/A

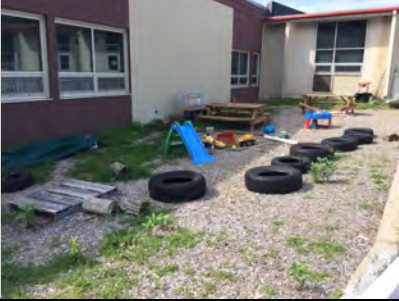
Accessible route not provided to play components	-	Provide a compliant impact-attenuating surface to and around the play components. (Cost estimate for 375 sq. ft. of poured in place rubber surface.)	1	5250	\$5250
Best Practice												
Examination Table												
167	Health/ Nurse's Office	1	1	Examination Table	N/A

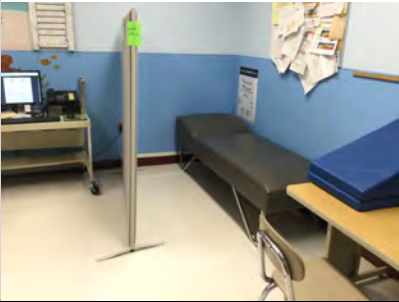
Recommend providing an adjustable table.	1	-	\$0
Stairs												
168	Stage - Cafeteria	1		Stairs	N/A

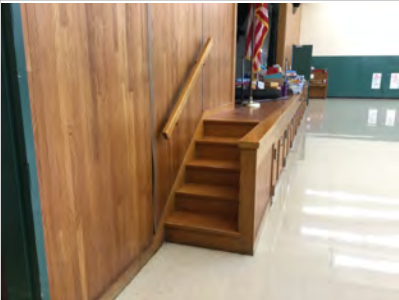
Recommend providing handrails on both sides that extend 12" beyond the top and bottom riser.	1		\$0

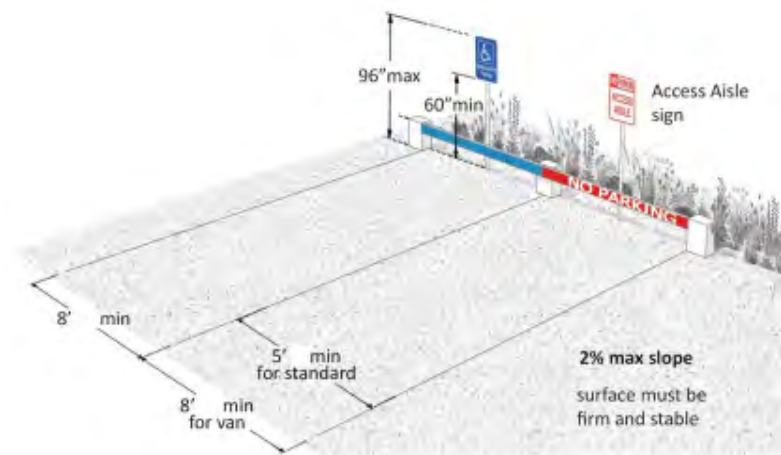
Figure 1: The following figure shows an example of how to identify and designate an accessible parking space at an unpaved parking lot.

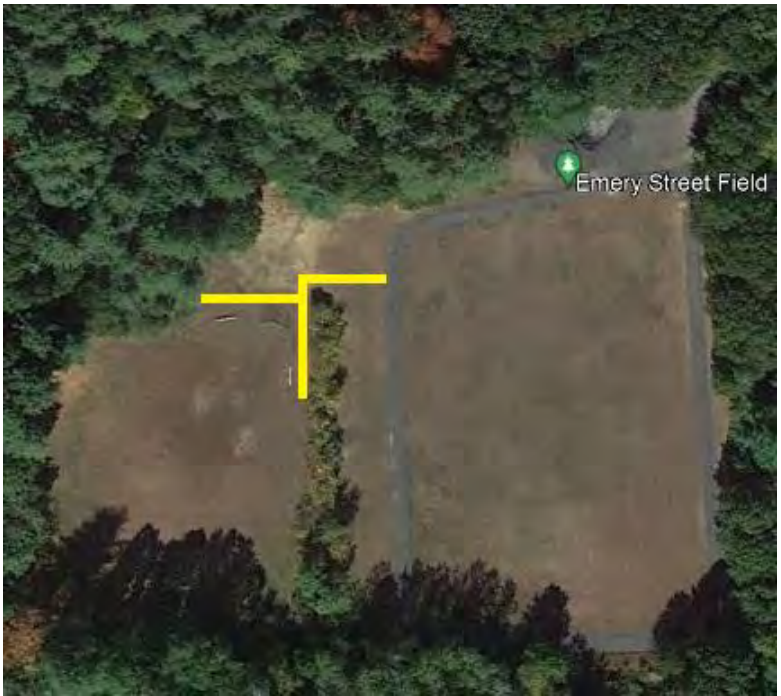
Figure 2: Yellow lines in the following figure show the approximate suggested location for an accessible route from the existing park path to the boundary of the area of sport activity and to team seating at the baseball field.

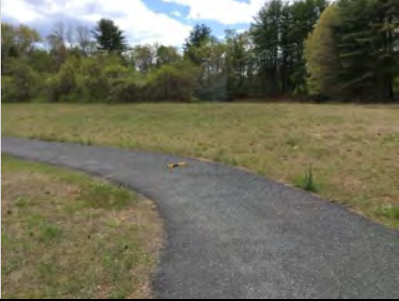
Cross slope > 1:50 (2.00%)	5.5%	Reduce cross slope to be no steeper than 1:50 (2.00%). (Cost based on asphalt to correct cross slope.)	1	240	\$240
2	Existing Route Around the Park	Ext.		Exterior Access Route	Walkway

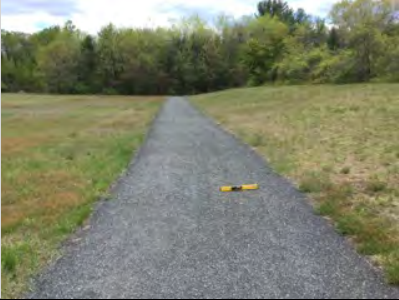
Cross slope > 1:50 (2.00%)	3.8%	Reduce cross slope to be no steeper than 1:50 (2.00%). (Cost based on asphalt to correct cross slope.)	1	240	\$240
3	Existing Route Around the Park	Ext.		Exterior Access Route	Walkway

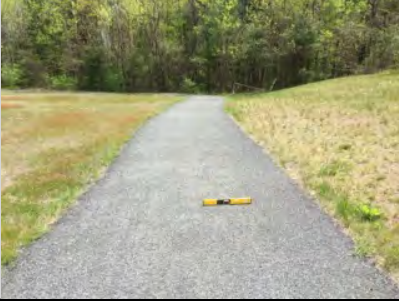
Cross slope > 1:50 (2.00%)	5.4%	Reduce cross slope to be no steeper than 1:50 (2.00%).	1	240	\$240
4	Existing Route Around the Park	Ext.		Exterior Access Route	Walkway

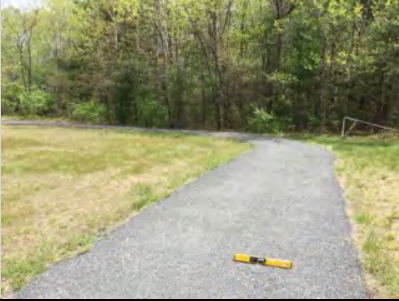
Cross slope > 1:50 (2.00%)	3.7%	Reduce cross slope to be no steeper than 1:50 (2.00%).	1	240	\$240

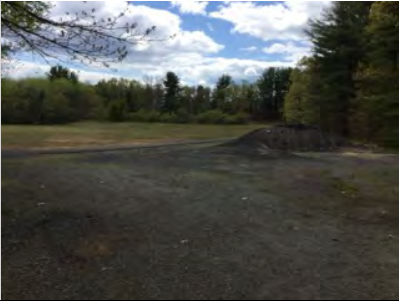
Off-Street Parking Lot or Garage												
5	Parking	Ext.		Off-Street Parking Lot or Garage	Visitor

Total # of parking Total # of designated accessible parking spaces Total # of designated van accessible spaces Access aisle not provided Sign not provided	20 - - - -	Provide a van accessible parking 96" wide min. space with a marked access aisle that is at least 96" wide. Provide a sign with the International Symbol of Accessibility with the bottom of the sign 60" min. above the ground and the top 96" max. above the ground. Add the words "Van Accessible" to the sign at the van accessible space. (See Figure 1 in the report narrative).	1	1850	\$1850

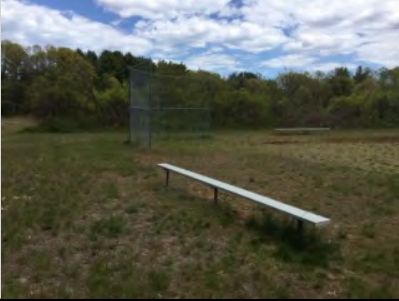
Accessible spaces are not provided at team seating Not connected to an accessible-route No accessible route to all areas of sport activity	<ul style="list-style-type: none">---	Provide a 36" x 48" stable, firm and slip resistant clear floor space at team seating. Provide an accessible route to the field. Install an accessible route between all areas of sports activity. (Cost estimate for a 4' wide min. x 180' long asphalt path from existing park path to boundary of sport activity at baseball and team seating area.) See Figure 2 in report narrative.	1	3600	\$3600

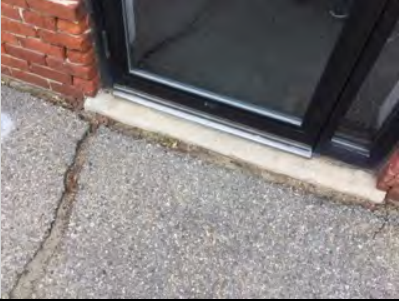
Surface openings > 1/2"	3"	Repair surface opening at threshold. (Cost for an asphalt patch.)	1	160	\$160
Off-Street Parking Lot or Garage												
2	Parking	Ext.		Off-Street Parking Lot or Garage	N/A

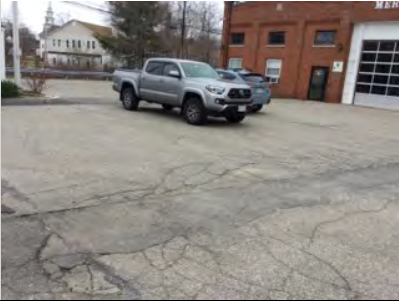
Total # of parking Total # of designated accessible parking spaces Total # of designated van accessible spaces Access aisle not provided Sign not provided Sign does not have the designation "Van Accessible"	5 - - - -	Provide a van accessible parking space at least 96" wide with a marked access aisle that is at least 96" wide. Provide an identification sign with the International Symbol of Accessibility with the bottom of the sign 60" min. above the ground and the top 96" max. above the ground. Add the designation "Van Accessible" to the sign located at the van accessible space.	1	1850	\$1850

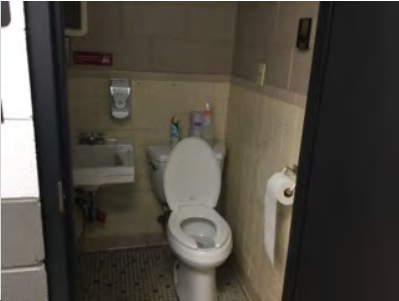
Access to Goods and Services												
Doors, Doorways, & Gates												
3	Men's Toilet Room	1		Doors, Doorways, & Gates	Toilet Room

Clear width at door < 32"	28"	Widen the door so that there is 32" min. clear width. (Cost included in ID #8.)	1	-	\$0
4	Entry/Exit to Chief's Office & Toilets	1		Doors, Doorways, & Gates	Circulation

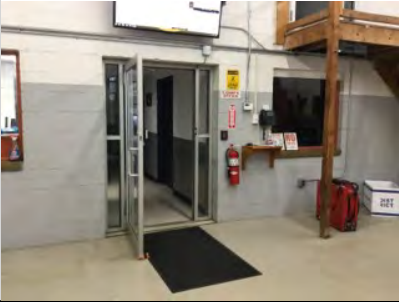
Door requires > 5 lbs. of force to open	15 lbs.	Adjust closers so doors do not require more than 5 pounds of force to open.	3	Labor	\$0

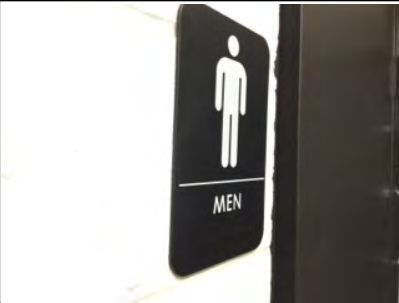
Signage is not provided	-	Once the men's toilet room has been made accessible, provide a sign with the International Symbol of Accessibility (ISA) and the words "All-Genders".	1	232	\$232
Toilet & Bathing Rooms												
Overall Access												
7	Women's Toilet Room	1		Overall Access	Toilet Room

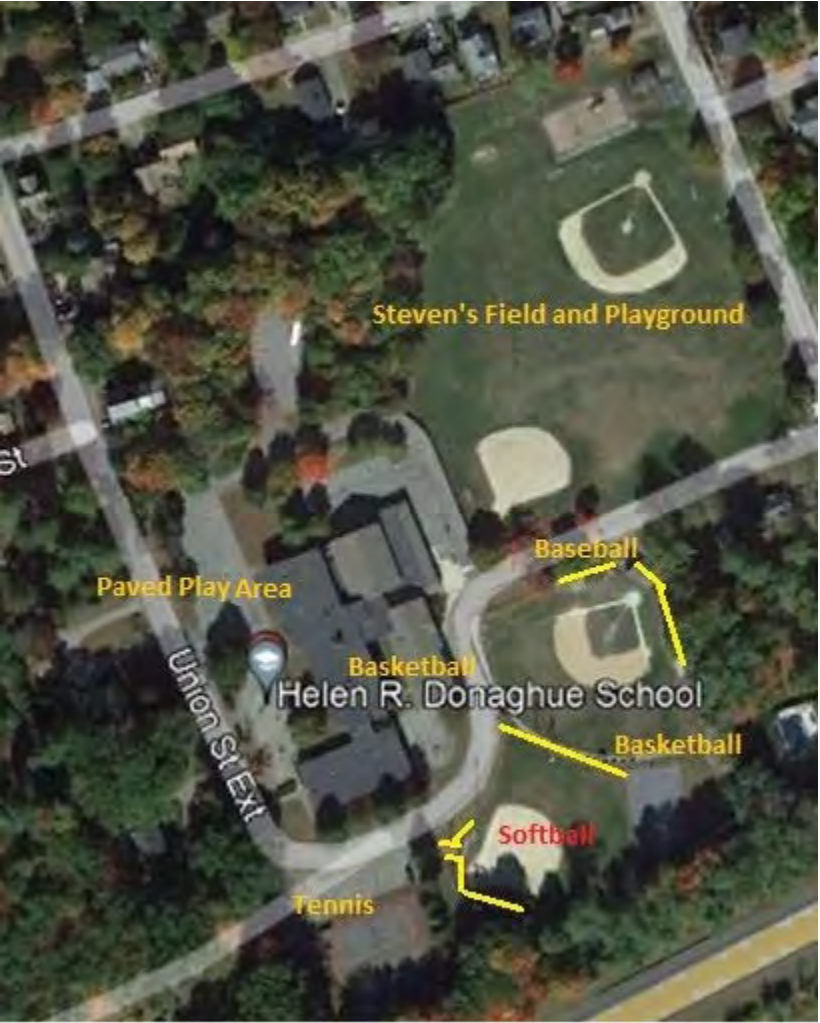
Figure 1: Yellow lines show the approximate location of suggested routes to the boundary of the area of sport activity, team and spectator (bleacher) seating:

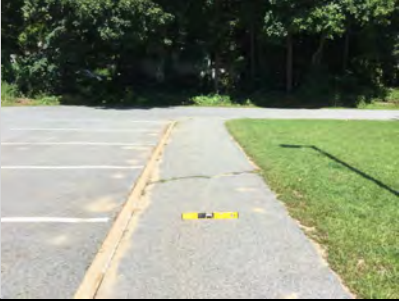
Surface openings > 1/2"	3.5"	Replace surface openings.	1	240	\$240
2	Near Exit Door 2 (A2)	Ext.		Exterior Access Route	Exterior

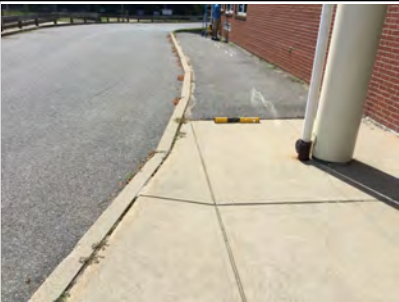
Surface openings > 1/2" Cross slope > 1:50 (2.00%)	2.5" 4.3%	Repair surface opening. Reduce cross slope to be no steeper than 1:50 (2.00%). (Cost based on concrete to correct cross slope and repair surface openings.)	1	348	\$348
3	Path Along Parking Lot Near Upper Paved Play Area	Ext.		Exterior Access Route	Walkway

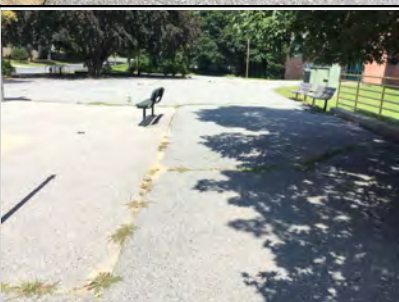
Surface openings > 1/2" Level changes > 1/4"	5.5" 1"	Replace surface openings in asphalt. Alter change in level to be 1/4" high max.	1	240	\$240

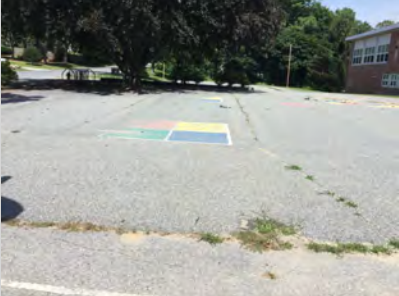
Surface openings > 1/2" Level changes > 1/4"	1.5" 1.25"	Replace surface openings in asphalt. Alter change in level to be 1/4" high max.	1	480	\$480
7	Accessible Parking to Main Entrance/Exit	Ext.		Exterior Access Route	Sidewalk

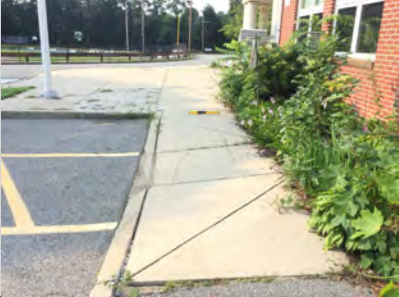
Cross slope > 1:50 (2.00%)	4.5%	Reduce cross slope to be no steeper than 1:50 (2.00%).	1	384	\$384
8	From Exit Door 11 Towards Exit Door 12 (D3)	Ext.		Exterior Access Route	Exterior

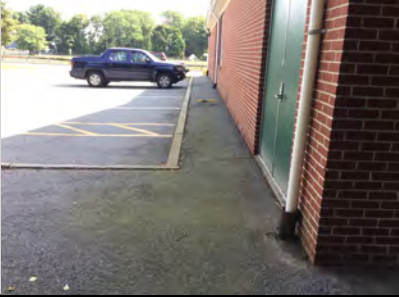
Cross slope > 1:50 (2.00%)	5.6%	Reduce cross slope to be no steeper than 1:50 (2.00%). (Cost based on asphalt to reduce cross slope.)	1	240	\$240
9	Front Parking Lot to Main Entrance/Exit Door 1 (A1)	Ext.		Exterior Access Route	Exterior

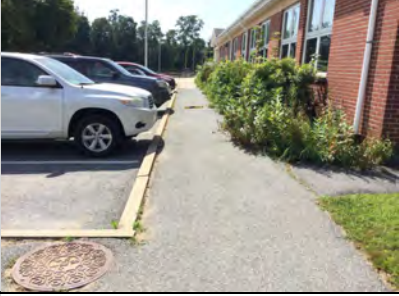
Cross slope > 1:50 (2.00%)	11.2%	Reduce cross slope to be no steeper than 1:50 (2.00%). (Cost based on asphalt to reduce cross slope.)	1	240	\$240

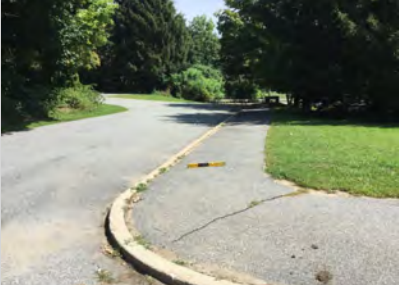
10	Path Along Parking Lot Near Upper Paved Play Area to North Upper Side Parking Lot	Ext.		Exterior Access Route	Walkway

Cross slope > 1:50 (2.00%)	8.6%	Reduce cross slope to be no steeper than 1:50 (2.00%).	1	240	\$240

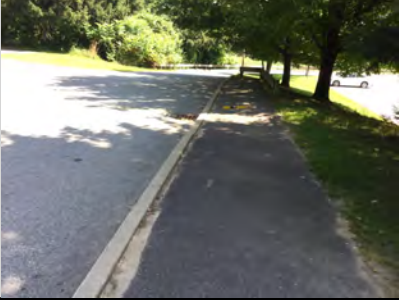
ID	Location	Floor	Room	Element	Type	Photo	Issues	Current Measure	Recommendations	Quantity	Price	Cost Estimation
11	Path Along Parking Lot Near Upper Paved Play Area to North Upper Side Parking Lot	Ext.		Exterior Access Route	Walkway

Cross slope > 1:50 (2.00%)	7.7%	Reduce cross slope to be no steeper than 1:50 (2.00%).	1	240	\$240
12	Near Exit Door 12 (D3)	Ext.		Exterior Access Route	Sidewalk

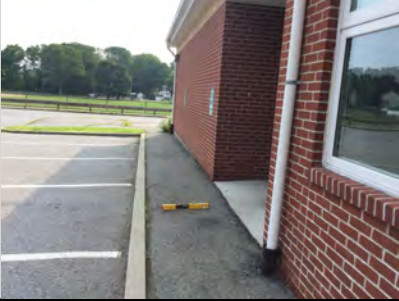
Cross slope > 1:50 (2.00%) Level changes > 1/4"	4.5% .5"	Reduce cross slope to be no steeper than 1:50 (2.00%). Alter change in level to be 1/4" high max.	1	240	\$240
13	Accessible Parking at Front Lot to Main Entrance/Exit Door 1 (A1)	Ext.		Exterior Access Route	Sidewalk

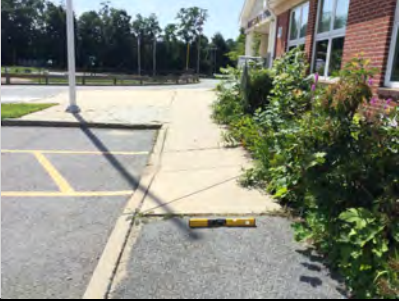
Cross slope > 1:50 (2.00%) Level changes > 1/4"	4.6% 1"	Reduce cross slope to be no steeper than 1:50 (2.00%). Alter change in level to be 1/4" high max. (Cost based on asphalt to reduce cross slope and correct change in level.)	1	240	\$240

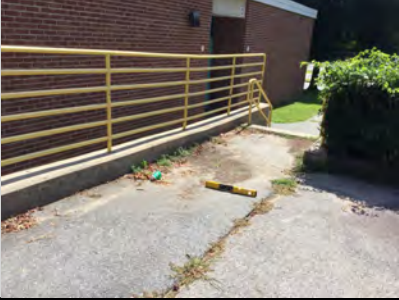
14	Stair Near Door 6 (C1)	Ext.		Exterior Access Route	Exterior

Cross slope > 1:50 (2.00%) Level changes > 1/4"	9.1% 1"	Reduce cross slope to be no steeper than 1:50 (2.00%). Alter change in level to be 1/4" high max. (Cost estimate for asphalt to repair surface leading to stairs including 1" change in level at start of stairs.)	1	480	\$480
15	Tennis Court Parking to Entrance/Exit	Ext.		Exterior Access Route	Exterior

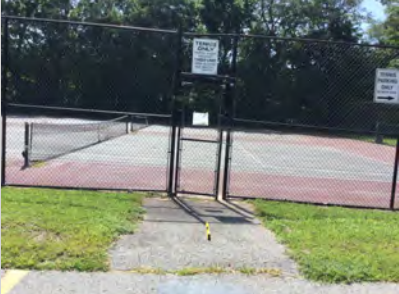
Running slope > 1:20 (5%)	7.7%	Reduce running slope to be no steeper than 1:20 (5%). (Cost based on asphalt to correct running slope.)	1	240	\$240

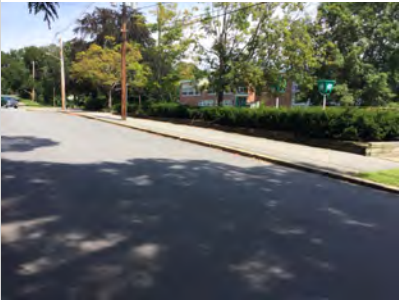
ID	Location	Floor	Room	Element	Type	Photo	Issues	Current Measure	Recommendations	Quantity	Price	Cost Estimation
Curb Ramp												
16	Bus Drop Off - West of School Along Union Street Extension	Ext.		Curb Ramp	N/A

Curb ramp not provided	-	Provide a curb ramp at drop-off area. (Cost estimate for a concrete curb ramp.)	1	2800	\$2800
17	Curb at Front Parking Lot	Ext.		Curb Ramp	N/A

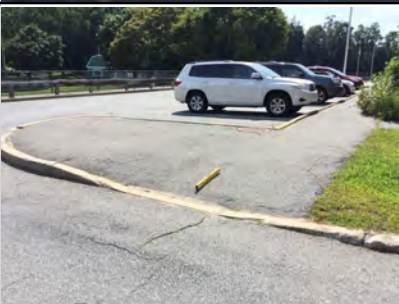
Running slope > 1:12 (8.33%)	13.7%	Reduce running slope to be no steeper than 1:12 (8.33%). (Cost estimate for a new concrete curb ramp.)	1	2800	\$2800
18	Curb to Main Entrance/Exit Door 1 (A1)	Ext.		Curb Ramp	N/A

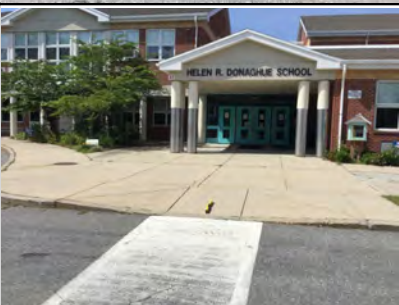
Running slope > 1:12 (8.33%)	10.8%	Reduce running slope to be no steeper than 1:12 (8.33%). (Cost estimate for a new concrete curb ramp.)	1	2800	\$2800
19	Curb From Parking Lot Near Upper Paved Play Area	Ext.		Curb Ramp	N/A

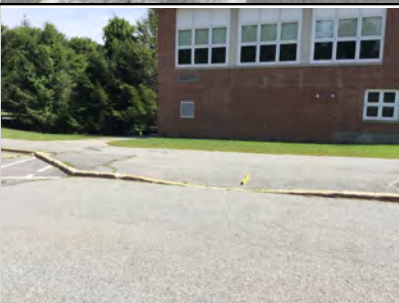
Transition from curb ramp to street not flush	.75"	Ensure transition from curb ramp to street is flush or free of changes in level.	1	170	\$170

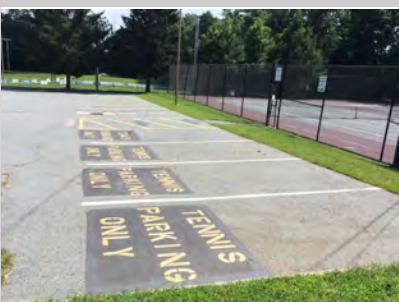
Off-Street Parking Lot or Garage												
20	Tennis Court Parking	Ext.		Off-Street Parking Lot or Garage	Visitor

Total # of parking Total # of designated accessible parking spaces Total # of designated van accessible spaces Access aisle not provided Sign not provided	13 - - - -	Provide a van accessible parking space and marked access aisle by tennis courts that are at least 96" wide. Provide a sign with International Symbol of Accessibility (ISA) with the bottom of the sign 60" min. above the ground and the top 96" max. above the ground. Add the words "Van Accessible" to the sign at the van accessible parking space.	1	1850	\$1850

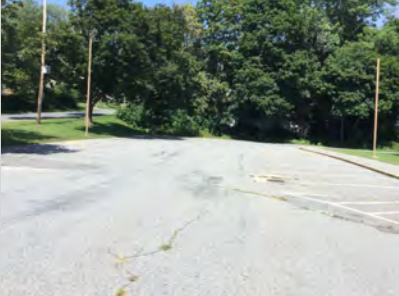
ID	Location	Floor	Room	Element	Type	Photo	Issues	Current Measure	Recommendations	Quantity	Price	Cost Estimation
21	Parking Lot Near Upper Playground	Ext.		Off-Street Parking Lot or Garage	N/A

Total # of parking Total # of designated accessible parking spaces Total # of designated van accessible spaces Access aisle not provided Sign not provided	23 - - - -	Provide a van accessible parking space and marked access aisle that are at least 96" wide. Provide a sign with International Symbol of Accessibility (ISA) with the bottom of the sign 60" min. above the ground and the top 96" max. above the ground. Add the words "Van Accessible" to the sign at the van accessible parking space.	1	1850	\$1850
22	North Upper Side Parking Lot	Ext.		Off-Street Parking Lot or Garage	N/A

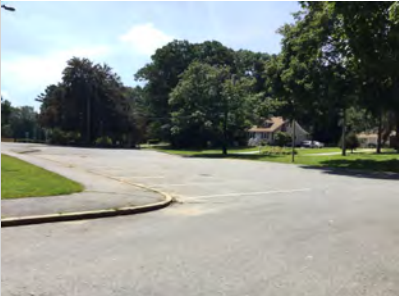
Total # of parking Total # of designated accessible parking spaces Total # of designated van accessible spaces Access aisle not provided Sign not provided	23 - - - -	Provide a van accessible parking space and marked access aisle that are at least 96" wide. Provide a sign with International Symbol of Accessibility (ISA) with the bottom of the sign 60" min. above the ground and the top 96" max. above the ground. Add the words "Van Accessible" to the sign at the van accessible parking space.	1	1850	\$1850

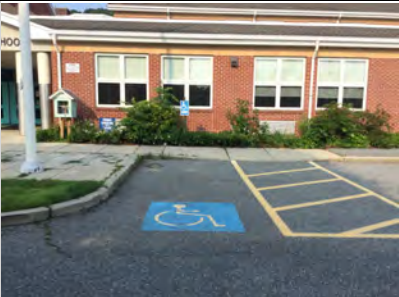
23	Accessible Parking at Main Entrance/Exit Door 1 (A1)	Ext.		Off-Street Parking Lot or Garage	N/A

Total # of designated accessible parking spaces Sign bottom < 60" above finished grade	2 34.75"	Locate sign with the bottom of the sign 60" above the ground.	1	Labor	\$0
24	Accessible Parking Near Exit Door 11	Ext.		Off-Street Parking Lot or Garage	Visitor

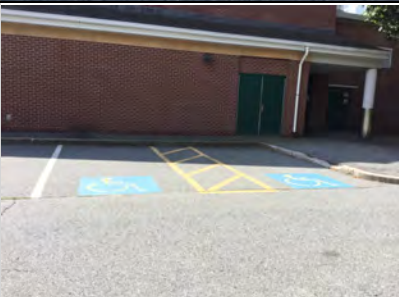
Access aisle < 60" wide at car/van space Sign not provided	46" -	Provide a marked access aisle that is at least 60" wide. Provide a sign with the bottom of the sign 60" min. above the ground and the top 96" max. above the ground.	1	800	\$800
25	Accessible Parking at Main Entrance/Exit Door 1 (A1)	Ext.		Off-Street Parking Lot or Garage	N/A

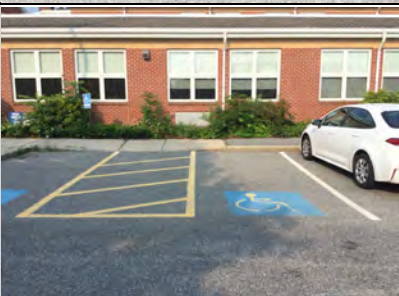
Access aisle < 96" wide at van space Sign not provided Sign does not have the designation "Van Accessible"	84" - -	Provide a marked access aisle that is at least 96" wide. Provide a sign with the bottom of the sign 60" min. and the top of the sign 96" max. above the ground and the top 96" max. above the ground. Add the designation "Van Accessible" to the sign located at the van accessible space.	1	800	\$800

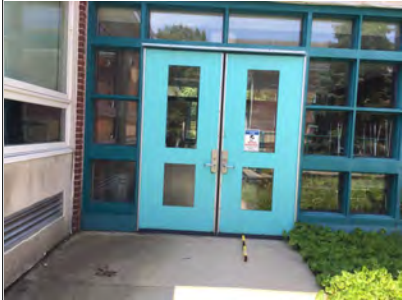
Directional sign to accessible entrance not provided	-	Provide a directional sign indicating the location of the nearest accessible entrance.	1	346	\$346
28	Entrance/Exit Door 7 (C2)	Ext.		Entrance	Secondary Entrance

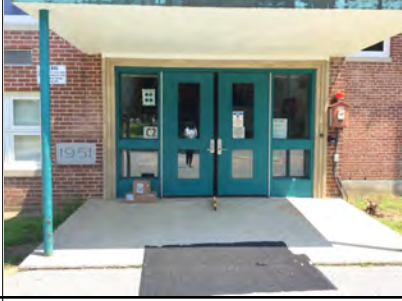
Directional sign to accessible entrance not provided Maneuvering clearance is not provided Door requires > 15 lbs. of force to open	- 5.7% 18 lbs	Provide a directional sign indicating the location of the nearest accessible entrance. Reduce slope at door landing to 2.00% in all directions. Adjust closers so doors do not require more than 15 pounds of force.	1	538	\$538

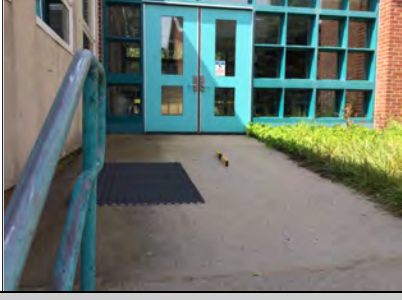
29	Entrance/Exit Door 5 (B3)	Ext.		Entrance	Secondary Entrance

Maneuvering clearance is not provided	7.6%	Reduce slope at door landing to 2.00% max. in all directions. (Cost based on concrete to correct door landing slope.)	1	384	\$384
Emergency Exit												
30	Exit Door 8 (D1) - Stair Near Room 10	G		Emergency Exit	N/A

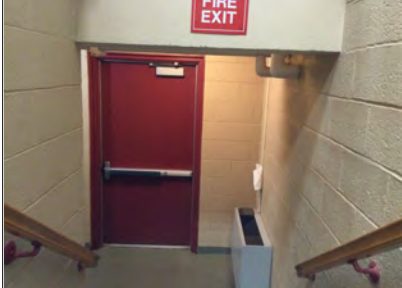
Tactile sign not provided at exit Directional sign to accessible emergency exit not provided Door requires > 15 lbs. of force to open	- - 17 lbs	Provide tactile exit signs with raised characters and braille at exit doors. Mount signs between 48"- 60" above the finished floor located on the latch side of the door. Provide a directional sign indicating the location of the nearest accessible emergency exit. Adjust closers of exterior doors so doors do not require more than 15 pounds of force.	1	232	\$232

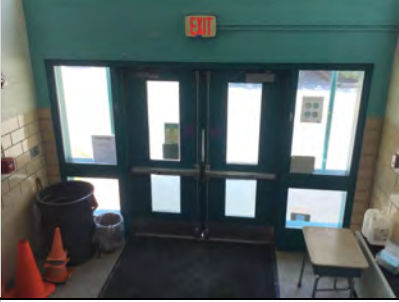
ID	Location	Floor	Room	Element	Type	Photo	Issues	Current Measure	Recommendations	Quantity	Price	Cost Estimation
31	Entrance/Exit Door 7 (C2)	2		Emergency Exit	N/A

Tactile sign not provided at exit Directional sign to accessible emergency exit not provided Door requires > 15 lbs. of force to open	- - 20 lbs	Provide tactile exit signs with raised characters and braille at exit doors. Mount signs between 48"- 60" above the finished floor located on the latch side of the door. Provide a directional sign indicating the location of the nearest accessible emergency exit. Adjust closers of exterior doors so doors do not require more than 15 pounds of force.	1	232	\$232
32	Entrance/Exit Door 5 (B3)	1		Emergency Exit	N/A

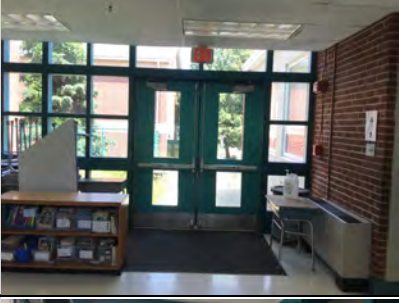
Tactile sign not provided at exit Directional sign to accessible emergency exit not provided Door requires > 15 lbs. of force to open	- - 18 lbs	Provide tactile exit signs with raised characters and braille at exit doors. Mount signs between 48"- 60" above the finished floor located on the latch side of the door. Provide a directional sign indicating the location of the nearest accessible emergency exit. Adjust closers of exterior doors so doors do not require more than 15 pounds of force.	1	232	\$232

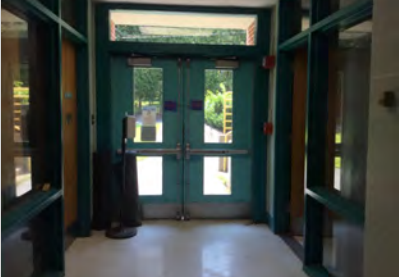
35	Exit Door 6 (C1)	1		Emergency Exit	N/A

Tactile sign not provided at exit Illuminated Int. Symbol of Acc. not provided (MAAB)	- -	Provide tactile exit signs with raised characters and braille at exit doors. Mount signs between 48"- 60" above the finished floor located on the latch side of the door. If the exit sign is replaced with an illuminated exit sign, provide an illuminated International Symbol of Accessibility (ISA).	1	232	\$232

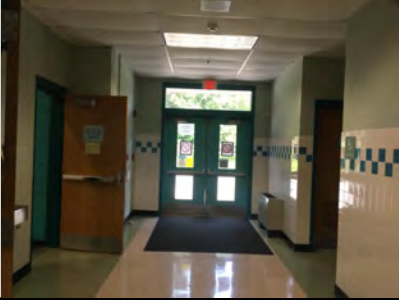
ID	Location	Floor	Room	Element	Type	Photo	Issues	Current Measure	Recommendations	Quantity	Price	Cost Estimation
36	Exit Door 12 (D3)	G		Emergency Exit	N/A

Tactile sign not provided at exit Illuminated Int. Symbol of Acc. not provided (MAAB) Door requires > 15 lbs. of force to open	- - 20 lbs	Provide tactile exit signs with raised characters and braille at exit doors. Mount signs between 48"- 60" above the finished floor located on the latch side of the door. If the exit sign is replaced with an illuminated exit sign, provide an illuminated International Symbol of Accessibility (ISA). Adjust closers of exterior doors so doors do not require more than 15 pounds of force.	1	232	\$232
37	Exit Door 11	G		Emergency Exit	N/A

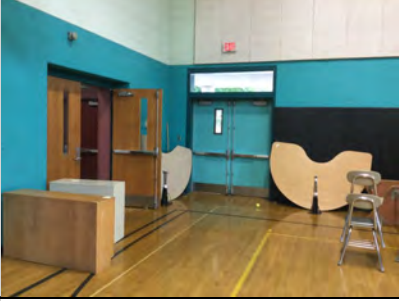
Tactile sign not provided at exit Illuminated Int. Symbol of Acc. not provided (MAAB) Door requires > 15 lbs. of force to open	- - 18 lbs	Provide tactile exit signs with raised characters and braille at exit doors. Mount signs between 48"- 60" above the finished floor located on the latch side of the door. If the exit sign is replaced with an illuminated exit sign, provide an illuminated International Symbol of Accessibility (ISA).. Adjust closers of exterior doors so doors do not require more than 15 pounds of force.	1	232	\$232

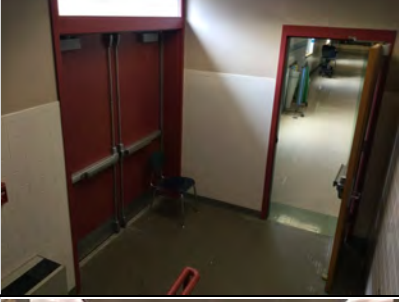
38	Exit Door 3 (B1)	G		Emergency Exit	N/A

Tactile sign not provided at exit Door requires > 15 lbs. of force to open Directional sign to accessible emergency exit not provided	- - 20 lbs	Provide tactile exit signs with raised characters and braille at exit doors. Mount signs between 48"- 60" above the finished floor located on the latch side of the door. Provide a directional sign indicating the location of the nearest accessible emergency exit. Adjust closers of exterior doors so doors do not require more than 15 pounds of force.	1	232	\$232
39	Main Entrance/Exit Door 1 (A1)	G		Emergency Exit	N/A

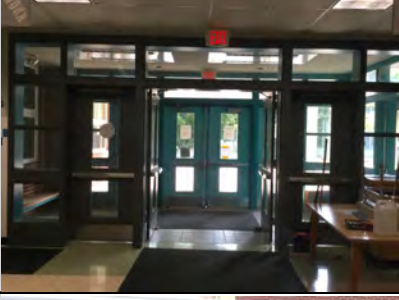
International Symbol of Accessibility not provided Tactile sign not provided at exit Illuminated Int. Symbol of Acc. not provided (MAAB)	- -	Provide a sign with the International Symbol of Accessibility (ISA). Provide tactile exit signs with raised characters and braille at exit doors. Mount signs between 48"- 60" above the finished floor located on the latch side of the door. Provide an illuminated sign with the International Symbol of Accessibility.	1	578	\$578

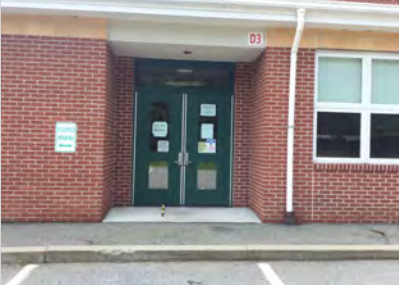
40	Exit Door 12 (D3)	Ext.		Emergency Exit	N/A

Maneuvering clearance at emergency door > 1:50 (2.00%)	6.2%	Alter so that the slope in all directions is no greater than 1:50 (2.00%)./Provide an automatic door opener. (Cost based on a concrete patch to correct slope.)	1	192	\$192
