Town of Merrimac, Massachusetts

PART A – Executive Summary

September 2021

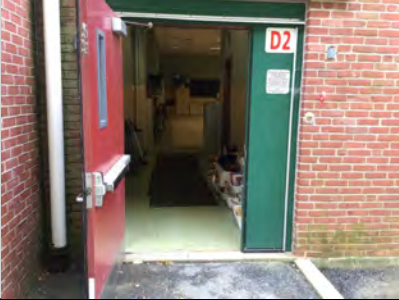
ID	Location	Floor	Room	Element	Type	Photo	Issues	Current Measure	Recommendations	Quantity	Price	Cost Estimation
41	Exit Door 10 (D2) - Cafeteria	Ext.		Emergency Exit	N/A

Threshold > 3/4" high	1"	Alter the threshold to be 3/4" high max.	1	150	\$150
42	Exit Door 6 (C1)	Ext.		Emergency Exit	N/A

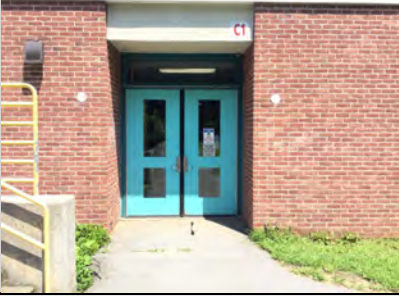
Threshold > 3/4" high	1.25"	Alter the threshold to be 3/4" high max.	1	150	\$150
Access to Goods and Services												
Means of Egress												
43	Exit Door 12 (D3)	G		Means of Egress	N/A

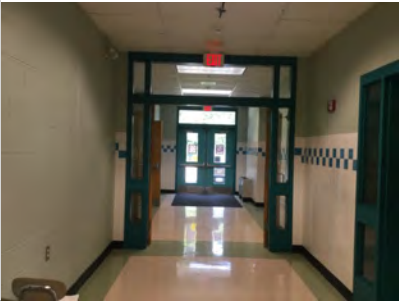
Tactile exit sign not provided	-	Ensure tactile exit signs with raised characters and braille are provided at exit doors. Mount signs between 48"- 60" above the finished floor located on the latch side of the door.	1	232	\$232
44	Entrance/Exit to Hallway Near Elevator From Gymnasium	G		Means of Egress	N/A

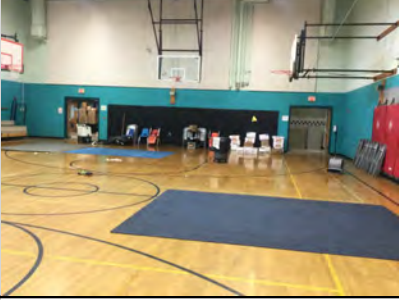
Tactile exit sign not provided	-	Ensure tactile exit signs with raised characters and braille are provided at exit doors. Mount signs between 48"- 60" above the finished floor located on the latch side of the door.	2	232	\$464

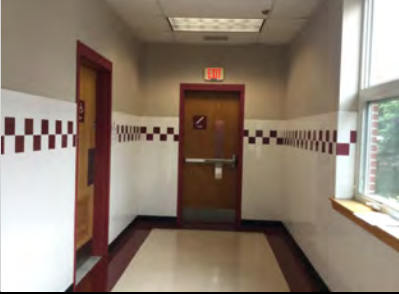
45	From Girls' Toilet Room to Stair Near Music Room	2		Means of Egress	N/A

Tactile exit sign not provided Floor level designation not provided	- -	Ensure tactile exit signs with raised characters and braille are provided at exit doors. Mount signs between 48"- 60" above the finished floor located on the latch side of the door. Provide a sign on the interior of the stairway enclosure indicating the floor level.	1	232	\$232

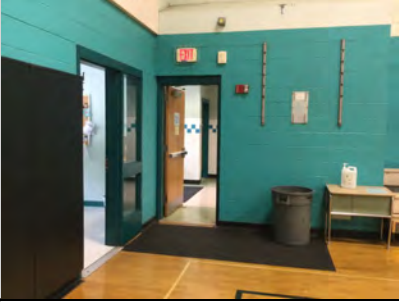
ID	Location	Floor	Room	Element	Type	Photo	Issues	Current Measure	Recommendations	Quantity	Price	Cost Estimation
46	Gymnasium Near Exit Door 12 (D3)	G		Means of Egress	N/A

Tactile exit sign not provided Illuminated ISA symbol not provided (MAAB)	- -	Ensure tactile exit signs with raised characters and braille are provided at exit doors. Mount signs between 48"- 60" above the finished floor located on the latch side of the door. If the exit sign is replaced with an illuminated exit sign, provide an illuminated International Symbol of Accessibility (ISA).	1	232	\$232
47	Cafeteria	G		Means of Egress	N/A

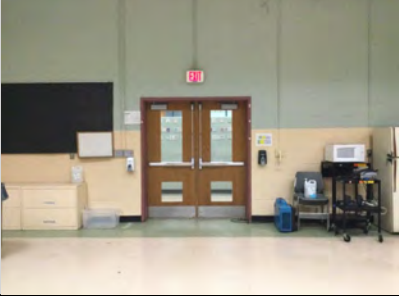
Tactile exit sign not provided Illuminated ISA symbol not provided (MAAB)	- -	Ensure tactile exit signs with raised characters and braille are provided at exit doors. Mount signs between 48"- 60" above the finished floor located on the latch side of the door. If the exit sign is replaced with an illuminated exit sign, provide an illuminated International Symbol of Accessibility (ISA).	1	232	\$232

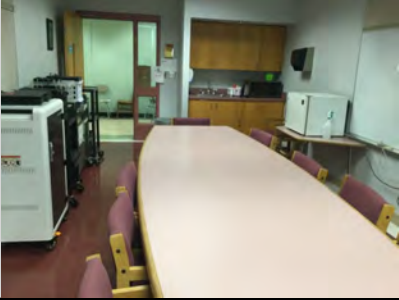
Interior Access Route												
48	Conference	G		Interior Access Route	N/A

Route < 36" wide	27.5"	Ensure that a clear width of 36" min. is maintained at the accessible route.	1	Labor	\$0
49	STEAM Grades 3-6	2	4	Interior Access Route	N/A

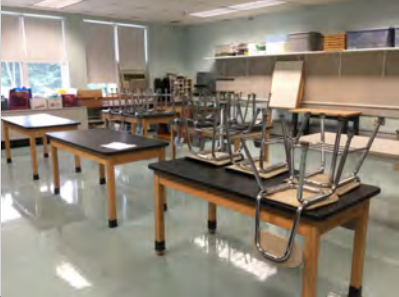
Route < 36" wide	26"	Ensure that a clear width of 36" min. is maintained at the accessible route. (Reposition tables.)	1	Labor	\$0
50	Fire Extinguisher Near Exit Door 12 (D3)	G		Interior Access Route	N/A

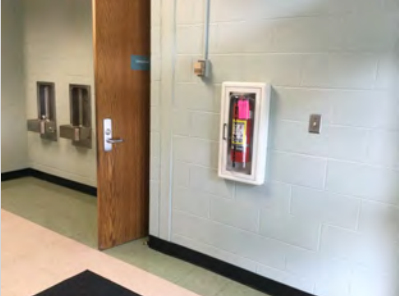
Obstructed by protruding objects	7"	Provide a cane-detectable barrier 27" max. above the ground.	1	306	\$306

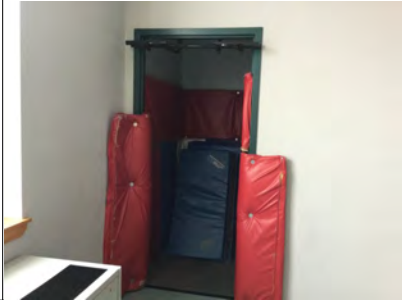
Clear width at door < 32"	30"	Ensure a clear width of 32 inches. (Reposition padding at entry.)	1	Labor	\$0
53	Toilet - Health	G		Doors, Doorways, & Gates	Toilet Room

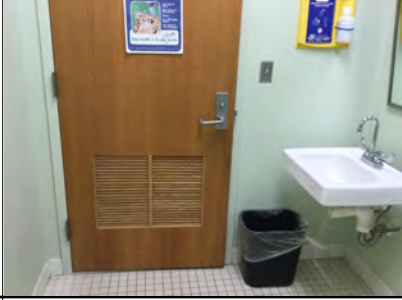
Maneuvering clearance(s) not provided	11"	Provide an automatic door opener.	1	3060	\$3060
54	Girls' Toilet Room Near Room 2	G		Doors, Doorways, & Gates	Toilet Room

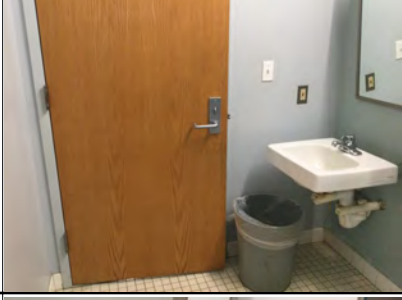
Maneuvering clearance(s) not provided	9.5"	Provide an automatic door opener.	1	3060	\$3060
55	Boys' Toilet Room Near Room 2	G		Doors, Doorways, & Gates	Toilet Room

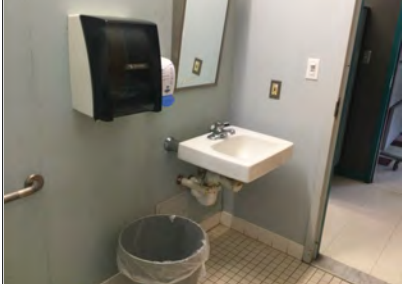
Maneuvering clearance(s) not provided	7"	Provide an automatic door opener.	1	3060	\$3060

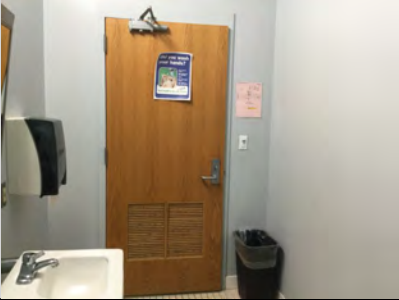
ID	Location	Floor	Room	Element	Type	Photo	Issues	Current Measure	Recommendations	Quantity	Price	Cost Estimation
56	Sp.Ed Toilet Room	3		Doors, Doorways, & Gates	Toilet Room

Maneuvering clearance(s) not provided	16"	Provide an automatic door opener.	1	3060	\$3060
57	Sp.Ed Toilet Room for Room 12	3		Doors, Doorways, & Gates	Toilet Room

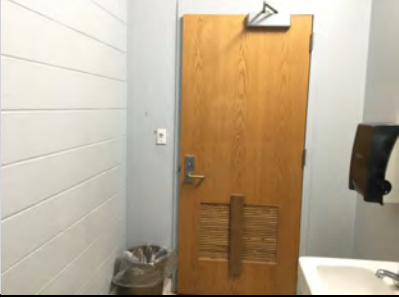
Maneuvering clearance(s) not provided	16"	Provide an automatic door opener.	1	3060	\$3060
58	Grade 3 Sp. Ed	3	11	Doors, Doorways, & Gates	Classroom

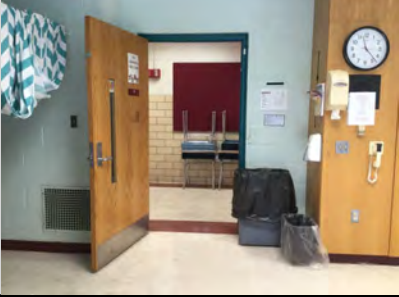
Maneuvering clearance(s) not provided	-	Remove trash containers to provide maneuvering clearance at door.	1	Labor	\$0
59	Sp.Ed Grade 3 - 6	3	12	Doors, Doorways, & Gates	Classroom

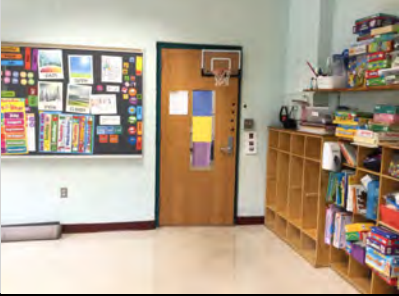
Maneuvering clearance(s) not provided	15"	Reposition stored items to provide 18" min. pull-side maneuvering clearance at the door.	1	Labor	\$0
60	Sp.Ed Grade 4	3	16	Doors, Doorways, & Gates	Classroom

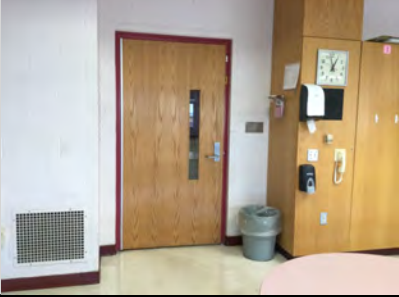
Maneuvering clearance(s) not provided	-	Remove trash container to provide 18" min. pull-side maneuvering clearance at door.	1	Labor	\$0

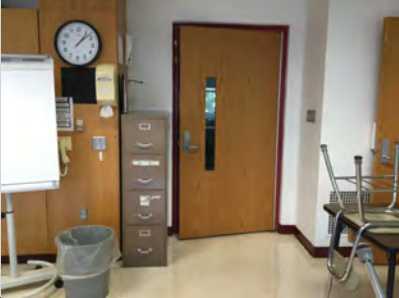
ID	Location	Floor	Room	Element	Type	Photo	Issues	Current Measure	Recommendations	Quantity	Price	Cost Estimation
61	Grade 4	3	15	Doors, Doorways, & Gates	Classroom

Maneuvering clearance(s) not provided	-	Remove file cabinet to provide 18" min. pull-side maneuvering clearance at door.	1	Labor	\$0
62	Sp.Ed Grade 6	1	24	Doors, Doorways, & Gates	Classroom

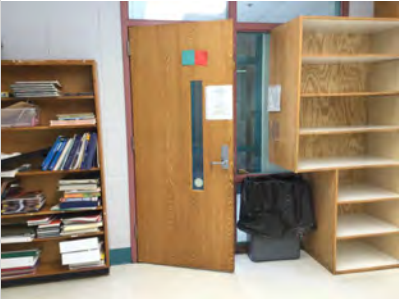
Maneuvering clearance(s) not provided	15"	Remove trash container and reposition storage unit to provide 18" min. pull-side maneuvering clearance at door.	1	Labor	\$0
63	Speech Room for All Grades	1	23	Doors, Doorways, & Gates	Classroom

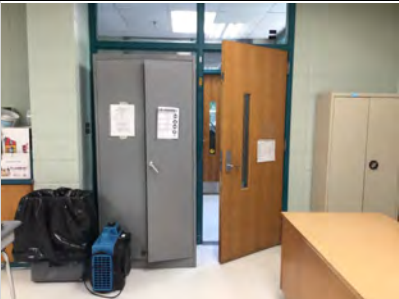
Maneuvering clearance(s) not provided	-	Remove storage unit to provide 18" min. pull-side maneuvering clearance at door.	1	Labor	\$0
64	Grade 5	1	18	Doors, Doorways, & Gates	Classroom

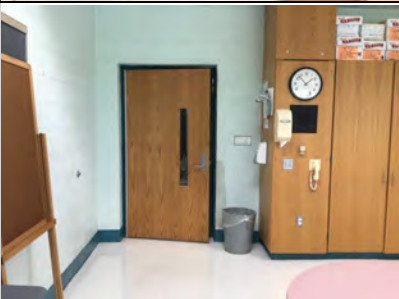
Maneuvering clearance(s) not provided	-	Remove trash container to provide 18" min. pull-side maneuvering clearance at door.	1	Labor	\$0

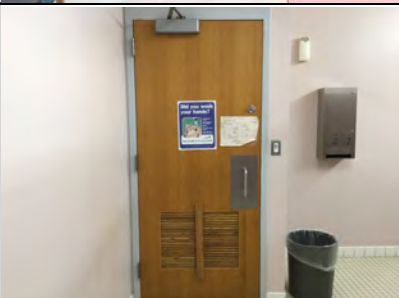
65	Women's Toilet Room Near Exit Door 12 (D3)	G		Doors, Doorways, & Gates	Toilet Room

Maneuvering clearance(s) not provided Door requires > 5 lbs. of force to open	8" 12 lbs	Relocate trash can from clear floor space at tampon dispenser. Adjust closers so doors do not require more than 5 pounds of force to open.	1	Labor	\$0

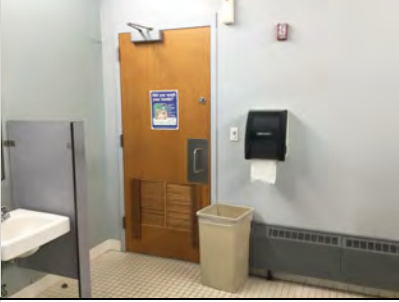
ID	Location	Floor	Room	Element	Type	Photo	Issues	Current Measure	Recommendations	Quantity	Price	Cost Estimation
66	Boys' Toilet Room Near Library	2		Doors, Doorways, & Gates	Toilet Room

Maneuvering clearance(s) not provided Door requires > 5 lbs. of force to open	- 13 lbs	Remove trash container.	1	Labor	\$0
67	Exit Door 8 (D1) - Stair Near Room 10	Ext.		Doors, Doorways, & Gates	Emergency Egress

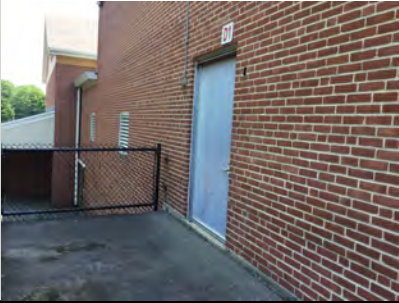
Threshold > 1/2" high	2"	Alter the threshold to be 1/2" high max.	1	150	\$150
68	Conference From Hallway	G		Doors, Doorways, & Gates	Meeting Room

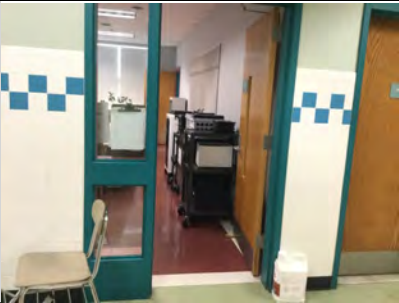
Door requires > 5 lbs. of force to open	13 lbs	Adjust closers so doors do not require more than 5 pounds of force to open.	1	Labor	\$0
69	Guidance	G		Doors, Doorways, & Gates	N/A

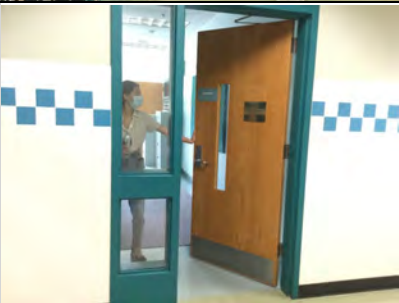
Door requires > 5 lbs. of force to open	12 lbs	Adjust closers so doors do not require more than 5 pounds of force to open.	1	Labor	\$0
70	Men's Toilet Room Near Exit Door 12 (D3)	G		Doors, Doorways, & Gates	Toilet Room

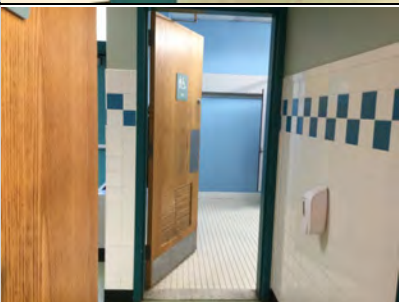
Door requires > 5 lbs. of force to open	13 lbs	Adjust closers so doors do not require more than 5 pounds of force to open.	1	Labor	\$0

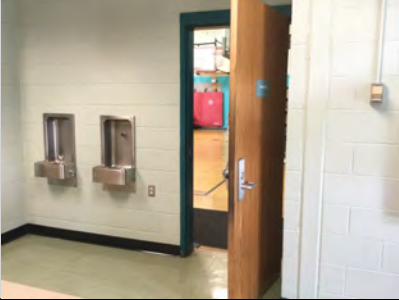
ID	Location	Floor	Room	Element	Type	Photo	Issues	Current Measure	Recommendations	Quantity	Price	Cost Estimation
71	Gymnasium Near Exit Door 12 (D3)	G		Doors, Doorways, & Gates	N/A

Door requires > 5 lbs. of force to open	20"	Adjust closers so doors do not require more than 5 pounds of force to open.	1	Labor	\$0
72	Girls' Toilet Room Near Library	2		Doors, Doorways, & Gates	Toilet Room

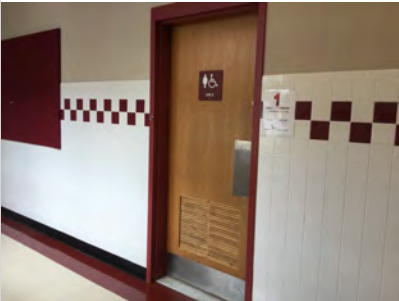
Door requires > 5 lbs. of force to open	11 lbs	Adjust closers so doors do not require more than 5 pounds of force to open.	1	Labor	\$0
73	Sp.Ed Toilet Room for Room 12	3		Doors, Doorways, & Gates	Toilet Room

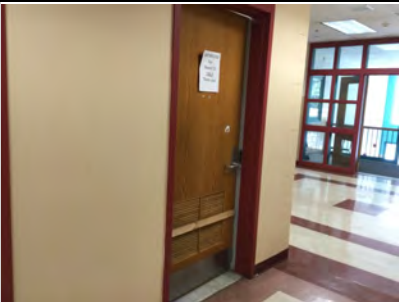
Door requires > 5 lbs. of force to open	12 lbs	Adjust closers so doors do not require more than 5 pounds of force to open.	1	Labor	\$0
Elevator												
74	Elevator	2		Elevator	Exterior

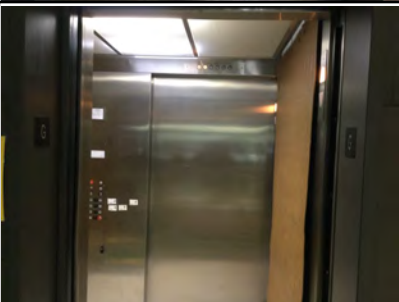
75	Elevator	G		Elevator	Exterior

Hoistway signs < 48" > 60" Handrail not provided	62" -	Install hoistway signs on the inside of the door frame 60" above the finished floor. Install handrails on at least one wall of the elevator located between 32" and 36" above the car floor.	1	96	\$96

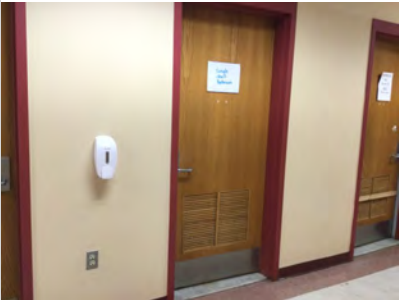
ID	Location	Floor	Room	Element	Type	Photo	Issues	Current Measure	Recommendations	Quantity	Price	Cost Estimation
Signage												
76	Sp.Ed Single-User Toilet Room	3		Signage	Designation

Raised characters not provided on sign Braille not provided on sign Sign not located on the latch side of the door	- - - 15 lbs	Provide text with raised characters duplicated in braille on sign. Locate sign at permanent rooms alongside the door on the latch side.	1	232	\$232
77	Office	G		Signage	Designation

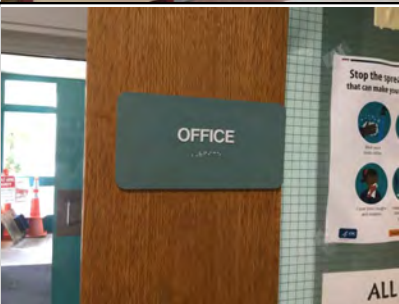
Raised characters < 48" or > 60" above ground Sign not located on the latch side of the door	62" -	Mount signs so that the baseline of the lowest tactile character is 48" min. above finished floor and the baseline of the highest tactile character is 60" max. above the finished floor. Locate sign at permanent rooms alongside the door on the latch side.	1	Labor	\$0
78	Conference	G		Signage	Designation

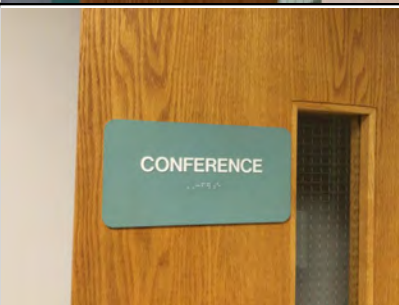
Raised characters < 48" or > 60" above ground Sign not located on the latch side of the door	62" -	Mount signs so that the baseline of the lowest tactile character is 48" min. above finished floor and the baseline of the highest tactile character is 60" max. above the finished floor. Locate sign at permanent rooms alongside the door on the latch side.	1	Labor	\$0

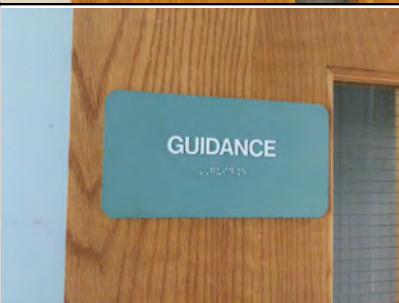
79	Guidance	G		Signage	Designation

Raised characters < 48" or > 60" above ground Sign not located on the latch side of the door	62.5" -	Mount signs so that the baseline of the lowest tactile character is 48" min. above finished floor and the baseline of the highest tactile character is 60" max. above the finished floor. Locate sign at permanent rooms alongside the door on the latch side.	1	Labor	\$0
80	Health	G		Signage	Designation

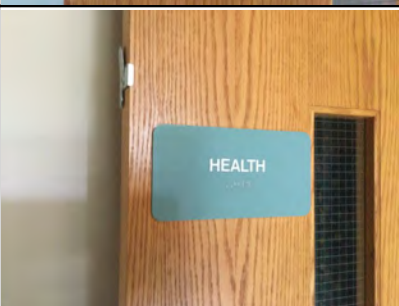
Raised characters < 48" or > 60" above ground Sign not located on the latch side of the door	62" -	Mount signs so that the baseline of the lowest tactile character is 48" min. above finished floor and the baseline of the highest tactile character is 60" max. above the finished floor. Locate sign at permanent rooms alongside the door on the latch side.	1	Labor	\$0

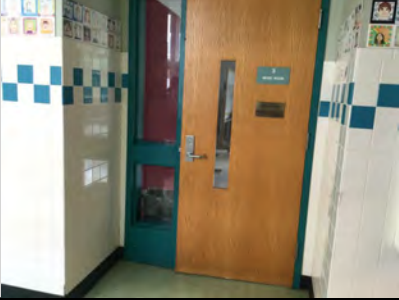
ID	Location	Floor	Room	Element	Type	Photo	Issues	Current Measure	Recommendations	Quantity	Price	Cost Estimation
81	Music Room	G	3	Signage	Designation

Raised characters < 48" or > 60" above ground Sign not located on the latch side of the door	62" -	Mount signs so that the baseline of the lowest tactile character is 48" min. above finished floor and the baseline of the highest tactile character is 60" max. above the finished floor. Locate sign at permanent rooms alongside the door on the latch side.	1	Labor	\$0
82	Grade 3 Sp. Ed	3	11	Signage	Designation

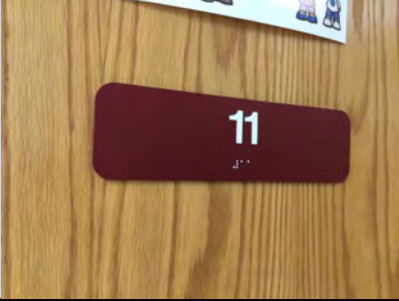
Raised characters < 48" or > 60" above ground Sign not located on the latch side of the door	62" -	Mount signs so that the baseline of the lowest tactile character is 48" min. above finished floor and the baseline of the highest tactile character is 60" max. above the finished floor. Locate sign at permanent rooms alongside the door on the latch side.	1	Labor	\$0

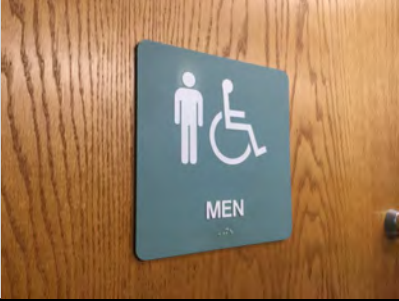
83	Men's Toilet Room Near Exit Door 12 (D3)	G		Signage	Designation

Sign not located on the latch side of the door	-	Locate sign at permanent rooms alongside the door on the latch side.	1	Labor	\$0
84	Women's Toilet Room Near Exit Door 12 (D3)	G		Signage	Designation

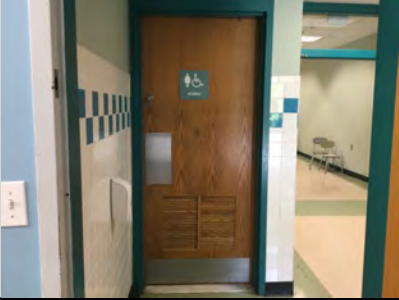
Sign not located on the latch side of the door	-	Locate sign at permanent rooms alongside the door on the latch side.	1	Labor	\$0
85	Gymnasium Near Exit Door 12 (D3)	G		Signage	Designation

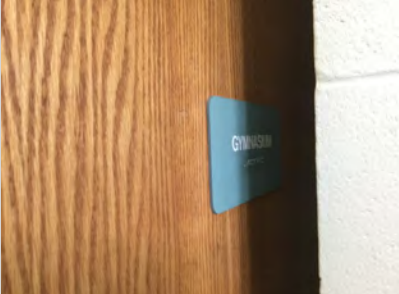
Sign not located on the latch side of the door	-	Locate sign at permanent rooms alongside the door on the latch side.	1	Labor	\$0

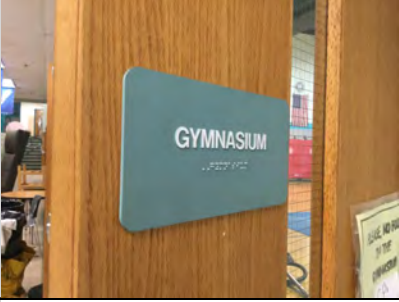
ID	Location	Floor	Room	Element	Type	Photo	Issues	Current Measure	Recommendations	Quantity	Price	Cost Estimation
86	Entrance/Exit to Gymnasium From Hallway Near Elevator	G		Signage	Designation

Sign not located on the latch side of the door	-	Locate sign at permanent rooms alongside the door on the latch side.	1	Labor	\$0
87	Entrance/Exit to Gymnasium From Hallway Near Elevator	G		Signage	Designation

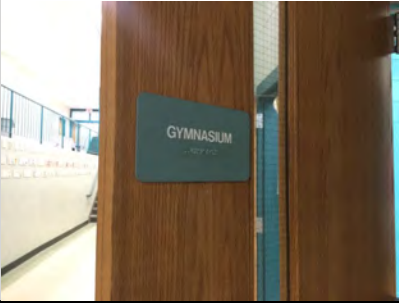
Sign not located on the latch side of the door	-	Locate sign at permanent rooms alongside the door on the latch side.	1	Labor	\$0
88	Activity Room /Guidance Office for All Grades	G	1	Signage	Designation

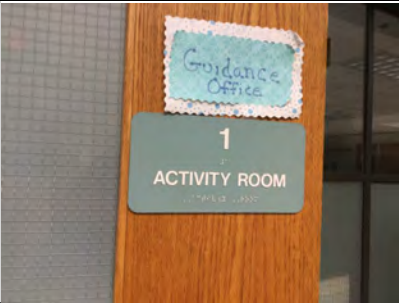
Sign not located on the latch side of the door	-	Locate sign at permanent rooms alongside the door on the latch side.	1	Labor	\$0
89	Art Room for All Grades	G	2	Signage	Designation

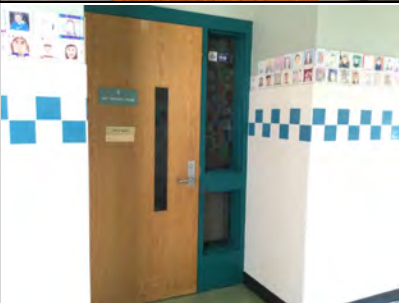
Sign not located on the latch side of the door	-	Locate sign at permanent rooms alongside the door on the latch side.	1	Labor	\$0

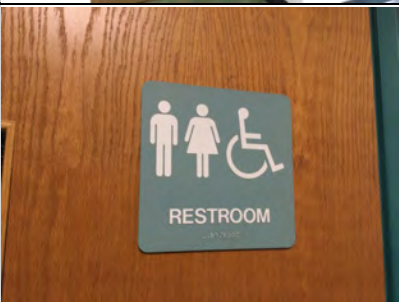
90	Toilets - Art Room for All Grades	G	2	Signage	Designation

Sign not located on the latch side of the door	-	Locate sign at permanent rooms alongside the door on the latch side.	1	Labor	\$0

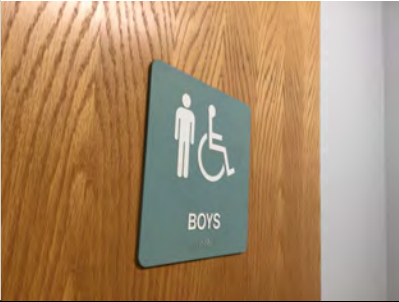
Sign not located on the latch side of the door	-	Locate sign at permanent rooms alongside the door on the latch side.	1	Labor	\$0
93	Stair Near Music Room	G		Signage	Directional

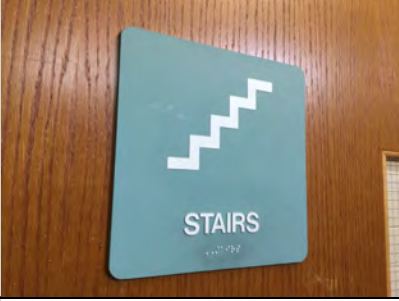
Sign not located on the latch side of the door	-	Locate sign at permanent rooms alongside the door on the latch side.	1	Labor	\$0
94	STEAM Grades 3-6	2	4	Signage	Designation

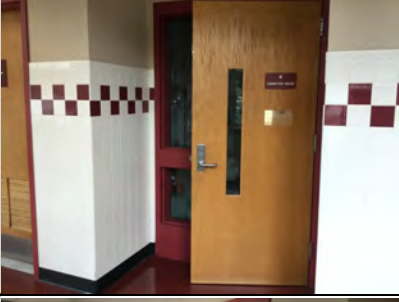
Sign not located on the latch side of the door	-	Locate sign at permanent rooms alongside the door on the latch side. Sign also has the wrong room name. Update sign.	1	232	\$232

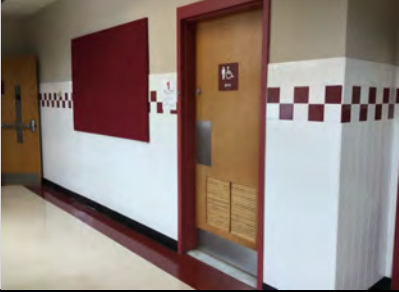
95	Boys' Toilet Room Near Library	2		Signage	Designation

Sign not located on the latch side of the door	-	Locate sign at permanent rooms alongside the door on the latch side.	1	Labor	\$0

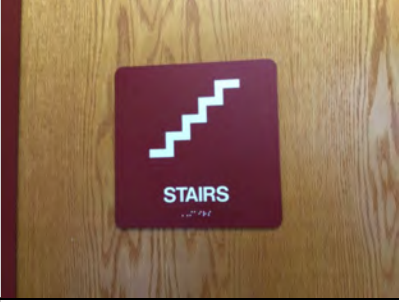
ID	Location	Floor	Room	Element	Type	Photo	Issues	Current Measure	Recommendations	Quantity	Price	Cost Estimation
96	From Girls' Toilet Room to Stair Near Music Room	2		Signage	Directional

Sign not located on the latch side of the door	-	Locate sign at permanent rooms alongside the door on the latch side.	1	Labor	\$0
97	Reading Room - Library	2	6	Signage	Designation

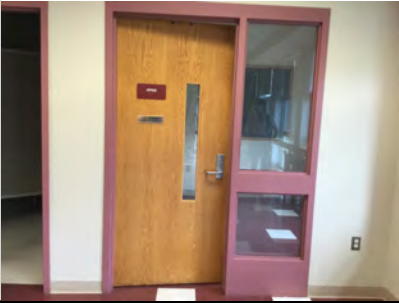
Sign not located on the latch side of the door	-	Locate sign at permanent rooms alongside the door on the latch side.	1	Labor	\$0
98	Reading Room - Library	2	6	Signage	Designation

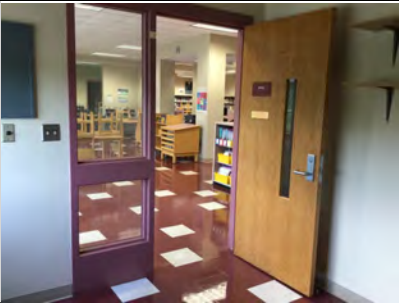
Sign not located on the latch side of the door	-	Locate sign at permanent rooms alongside the door on the latch side.	1	Labor	\$0
99	Work Room - Library	2	6	Signage	Designation

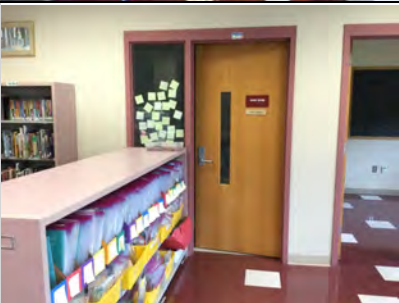
Sign not located on the latch side of the door	- -	Locate sign at permanent rooms alongside the door on the latch side. Ensure there is clear floor space a the sign once it is placed on the latch side of the door.	1	Labor	\$0

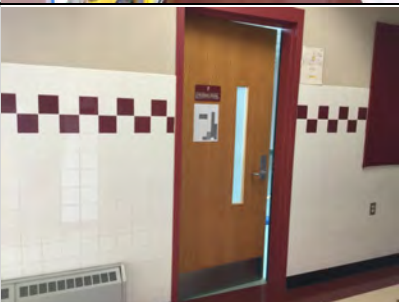
100	Special Needs, OT/PT Grades 3 - 6 Entrance/Exit Near Library	2	7	Signage	Designation

Sign not located on the latch side of the door	-	Locate sign at permanent rooms alongside the door on the latch side.	1	Labor	\$0

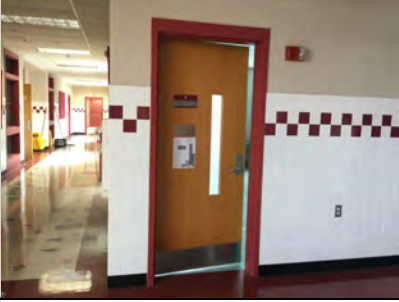
ID	Location	Floor	Room	Element	Type	Photo	Issues	Current Measure	Recommendations	Quantity	Price	Cost Estimation
101	Special Needs, OT/PT Grades 3 - 6 Entrance/Exit Near Elevator	2	7	Signage	Designation

Sign not located on the latch side of the door	-	Locate sign at permanent rooms alongside the door on the latch side.	1	Labor	\$0
102	Sp.Ed Grade 3 - 6	3	12	Signage	Designation

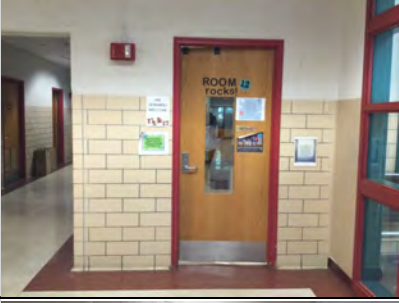
Sign not located on the latch side of the door	-	Locate sign at permanent rooms alongside the door on the latch side.	1	Labor	\$0
103	Sp.Ed Grade 4	3	16	Signage	Designation

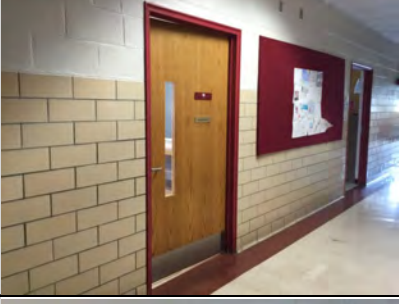
Sign not located on the latch side of the door	-	Locate sign at permanent rooms alongside the door on the latch side.	1	Labor	\$0
104	Grade 4	3	15	Signage	Designation

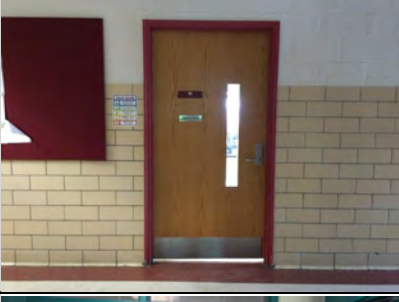
Sign not located on the latch side of the door	-	Locate sign at permanent rooms alongside the door on the latch side.	1	Labor	\$0
105	Sp.Ed Grade 6	1	24	Signage	Designation

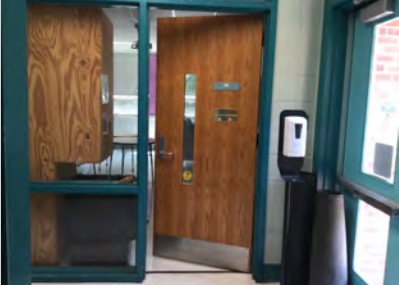
Sign not located on the latch side of the door	-	Locate sign at permanent rooms alongside the door on the latch side.	1	Labor	\$0

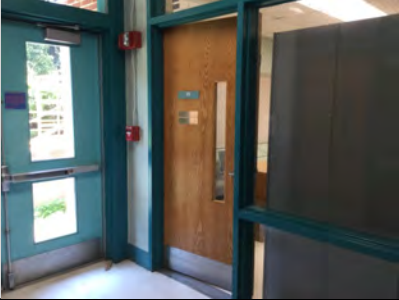
ID	Location	Floor	Room	Element	Type	Photo	Issues	Current Measure	Recommendations	Quantity	Price	Cost Estimation
106	Speech Room for All Grades	1	23	Signage	Designation

Sign not located on the latch side of the door	-	Locate sign at permanent rooms alongside the door on the latch side.	1	Labor	\$0
107	Grade 5	1	18	Signage	Designation

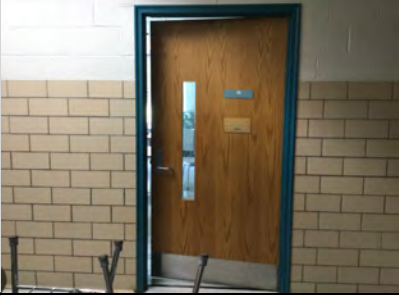
Sign not located on the latch side of the door	-	Locate sign at permanent rooms alongside the door on the latch side.	1	Labor	\$0
108	Boys' Toilet Room Near Room 18	1		Signage	Designation

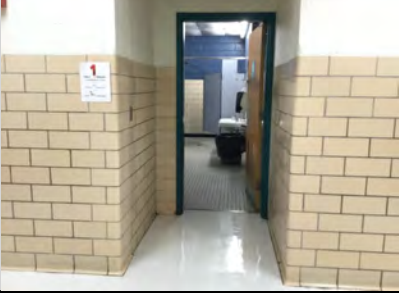
Sign not located on the latch side of the door	-	Locate sign at permanent rooms alongside the door on the latch side.	1	Labor	\$0
109	Girls' Toilet Room Near Room 18	1		Signage	Designation

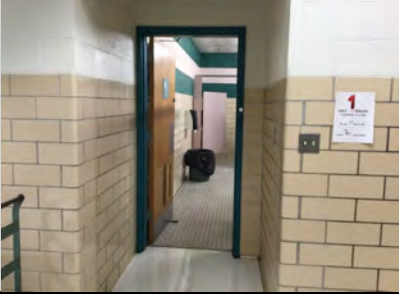
Sign not located on the latch side of the door	-	Locate sign at permanent rooms alongside the door on the latch side.	1	Labor	\$0
Service Counter												
110	Office	G		Service Counter	N/A

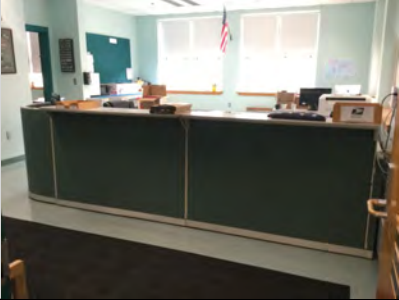
Counter > 36" high	42"	Provide a counter that is 36" max. above the ground or finished floor.	1	880	\$880

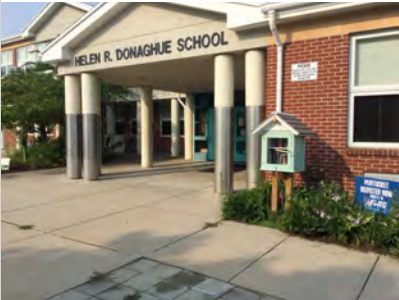
ID	Location	Floor	Room	Element	Type	Photo	Issues	Current Measure	Recommendations	Quantity	Price	Cost Estimation
Operable Parts												
111	Little Library Box/Exit Door 1 (A1)	Ext.		Operable Parts	Other

Element not on an accessible route	-	Clear plants at base of book drop-off.	1	Labor	\$0
112	Bell - Main Entrance/Exit Door 1 (A1)	Ext.		Operable Parts	Other

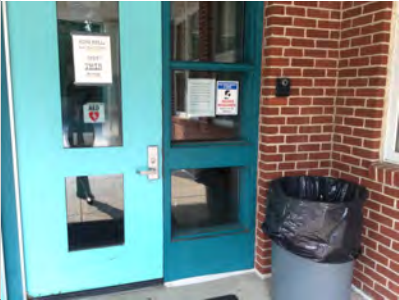
Clear floor space is not provided Reach < 15" or > 48"(forward/side approach)	- 55.5"	Relocate trash container to provide clear floor space at doorbell. Relocate doorbell so that controls are between 15"- 48" above the finished floor.	1	256	\$256
113	Book - Main Entrance/Exit Door 1 (A1)	Ext.		Operable Parts	Other

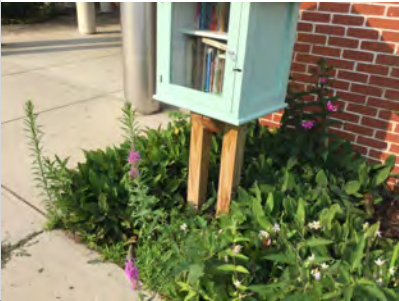
Not operable with a closed fist	-	Provide hardware that can be operable with one hand and not require tight grasping, pinching, or twisting of the wrist.	1	200	\$200
Children's Reach Ranges												
114	Near Exit Door 10 (D2) - Cafeteria	G		Children's Reach Ranges	N/A

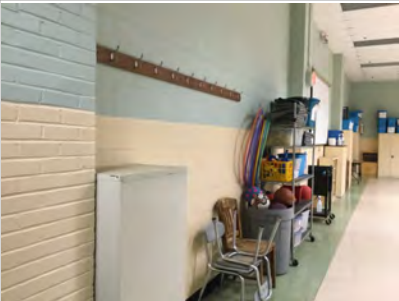
Reach < 16" or > 44" (Ages 9 - 12)	77.75"	Relocate so at least one coat hook is between 16" and 44" above the finished floor.	1	Labor	\$0

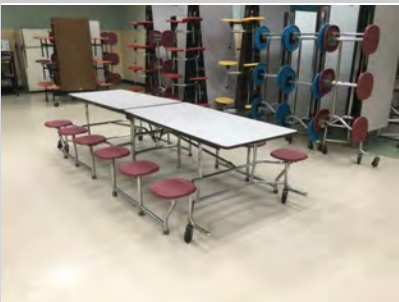
Dining or Work Surfaces												
115	Cafeteria	G		Dining or Work Surfaces	Dining Surface

At least one or 5% accessible tables not provided	-	Ensure that at least 5% of dining surfaces are accessible.	1	1100	\$1100

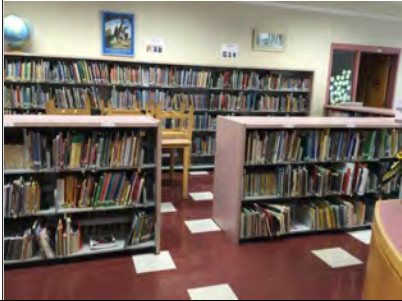
Accessible route not provided at stacks	27"	Ensure a 36" min. accessible route is provided at stacks. (Reposition book shelves.)	1	Labor	\$0
Toilet & Bathing Rooms												
Toilet Compartment												
119	Men's Toilet Room Near Exit Door 12 (D3)	G		Toilet Compartment	Accessible Compartment

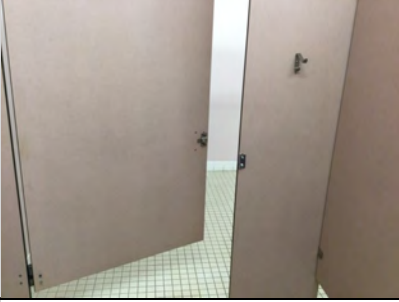
ID	Location	Floor	Room	Element	Type	Photo	Issues	Current Measure	Recommendations	Quantity	Price	Cost Estimation
120	Women's Toilet Room Near Exit Door 12 (D3)	G		Toilet Compartment	Accessible Compartment

Door has non-compliant hardware Door has malfunctioning self-closing hinge	- -	Provide hardware that can be operable with one hand and not require tight grasping, pinching, or twisting of the wrist. (Door pull). Repair hinge.	1	70	\$70
121	Boys' Toilet Room Near Room 18	1		Toilet Compartment	Accessible Compartment

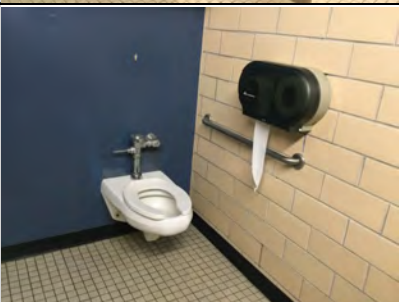
Grab bars not provided Side grab bar < 42" long Non-compliant toilet paper dispenser	- 32" -	Provide one grab bar on the side wall of the water closet and one on the rear wall. Provide a side wall grab bar that is 42" long min. located 12" max. from the rear wall. Relocate toilet paper so that it is 24" min. high, located under the grab bar, and between 7" and 9" from the front of the toilet./Replace dispenser as it does not allow continuous paper flow.	1	2149	\$2149

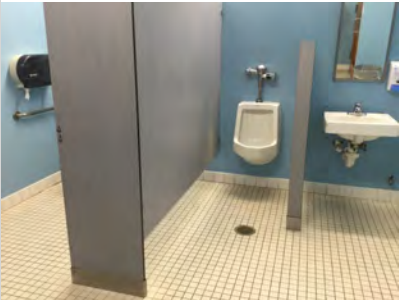
ID	Location	Floor	Room	Element	Type	Photo	Issues	Current Measure	Recommendations	Quantity	Price	Cost Estimation
Urinal												
125	Men's Toilet Room Near Exit Door 12 (D3)	G		Urinal	N/A

Rim > 17" high Urinal recessed > 24" has > 36" clear width	20" 30.5"	Provide at least one urinal with the rim no higher than 17" above the finished floor. If urinal is recessed greater than 24" ensure there is a clear width of 36".	1	3504	\$3504
Dispensers												
126	Women's Toilet Room Near Exit Door 12 (D3)	G		Dispensers	Paper Towel Dispenser

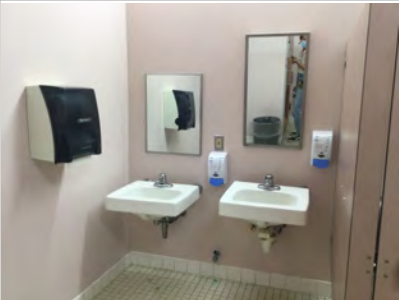
Dispenser acts as a protruding object	-	Relocate dispenser out of the circulation path.	1	256	\$256
Toilet Rooms for Children												
Single-User Toilet (Children)												
127	Girls' & Boys' Toilet Room Near Room 16	3		Single-User Toilet (Children)	N/A

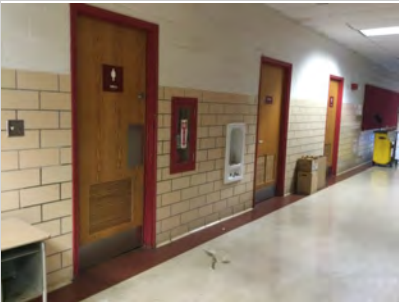
Clearance at toilet < 72" clear deep	-	Provide a directional sign to the nearby accessible toilet rooms.	2	232	\$464

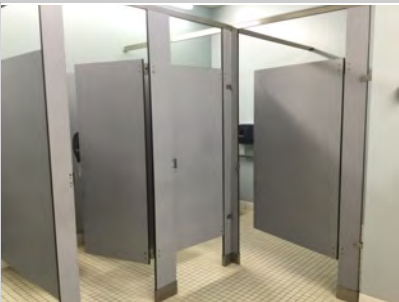
Toilet Compartment (Children)												
128	Boys' Toilet Room Near Library	2		Toilet Compartment (Children)	Accessible Compartment

Door with non-compliant hardware Door with malfunctioning self-closing hinge	- -	Provide hardware that can be operable with one hand and not require tight grasping, pinching, or twisting of the wrist. (Door pull.) Repair self-closing hinge.	1	70	\$70

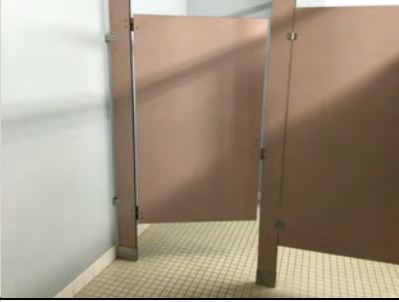
ID	Location	Floor	Room	Element	Type	Photo	Issues	Current Measure	Recommendations	Quantity	Price	Cost Estimation
129	Girls' Toilet Room Near Library	2		Toilet Compartment (Children)	Accessible Compartment

Door with non-compliant hardware Door with malfunctioning self-closing hinge	- -	Provide hardware that can be operable with one hand and not require tight grasping, pinching, or twisting of the wrist. Repair self-closing hinge.	1	70	\$70
130	Boys' Toilet Room Near Library	2		Toilet Compartment (Children)	Accessible Compartment

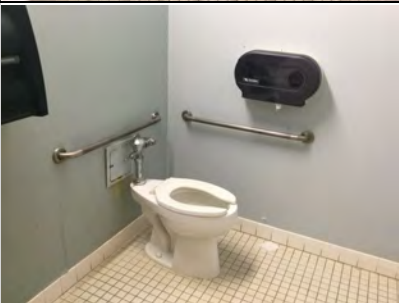
132	Girls' Toilet Room Near Room 2	G		Toilet Compartment (Children)	Accessible Compartment

Toilet seat < 15" or > 17" high (Ages 9 - 12) Side or rear grab bar < 42" long Side or rear grab bar < 25" or > 27" high (Ages 9 - 12) Non-compliant toilet paper dispenser	19" 30" 30.75" -	Install a toilet with a seat between 15"- 17" high above the finished floor. Provide a side/rear wall grab bar that is 42" long located 6" max. from the interior corner. Relocate grab bar to 25"- 27" above the floor. Relocate toilet paper dispenser so that it is between 14"- 19" above the floor and between 7"- 9" in front of the toilet. Ensure dispensers are not mounted above grab bars.	1	3832	\$3832
133	Boys' Toilet Room Near Room 2	G		Toilet Compartment (Children)	Accessible Compartment

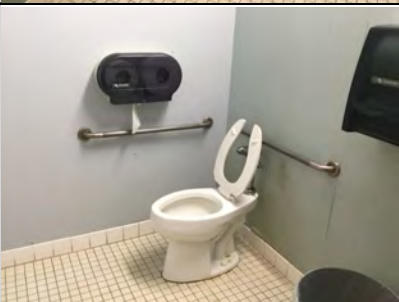
Toilet seat < 15" or > 17" high (Ages 9 - 12) Side or rear grab bar < 42" long Side or rear grab bar < 25" or > 27" high (Ages 9 - 12) Non-compliant toilet paper dispenser	19" 30" 30" -	Install a toilet with a seat between 15"- 17" high above the finished floor. Provide a side/rear wall grab bar that is 42" long located 6" max. from the interior corner. Relocate grab bar to 25"- 27" above the floor. Relocate toilet paper dispenser so that it is between 14"- 19" above the floor and between 7"- 9" in front of the toilet. Ensure dispensers are not mounted above grab bars.	1	3832	\$3832

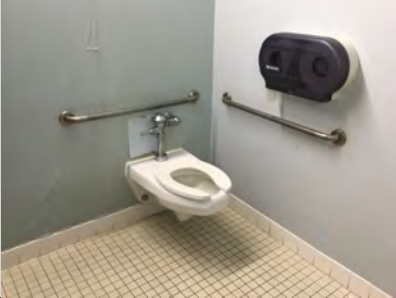
ID	Location	Floor	Room	Element	Type	Photo	Issues	Current Measure	Recommendations	Quantity	Price	Cost Estimation
134	Boys' Toilet Room Near Library	2		Toilet Compartment (Children)	Accessible Compartment

. Toilet seat < 15" or > 17" high (Ages 9 - 12) . Side or rear grab bar < 42" long . Side or rear grab bar < 25" or > 27" high (Ages 9 - 12) . Non-compliant toilet paper dispenser	18.75" 30" 31" -	Install a toilet with a seat between 15"- 17" high above the finished floor. Provide a side/rear wall grab bar that is 42" long located 6" max. from the interior corner. Relocate grab bar to 25"- 27" above the floor. Relocate toilet paper dispenser so that it is between 14"- 19" above the floor and between 7"- 9" in front of the toilet. Ensure dispensers are not mounted above grab bars.	1	3832	\$3832
135	Girls' Toilet Room Near Library	2		Toilet Compartment (Children)	Accessible Compartment

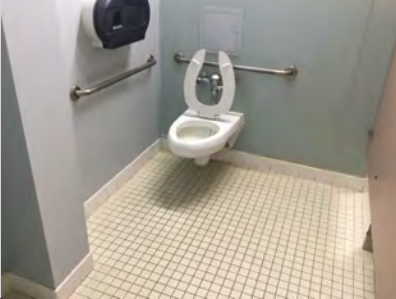
. Toilet seat < 15" or > 17" high (Ages 9 - 12) . Side or rear grab bar < 42" long . Side or rear grab bar < 25" or > 27" high (Ages 9 - 12) . Non-compliant toilet paper dispenser	19" 30" 31" -	Install a toilet with a seat between 15"- 17" high above the finished floor. Provide a side/rear wall grab bar that is 42" long located 6" max. from the interior corner. Relocate grab bar to 25"- 27" above the floor. Relocate toilet paper dispenser so that it is between 14"- 19" above the floor and between 7"- 9" in front of the toilet. Ensure dispensers are not mounted above grab bars.	1	3832	\$3832

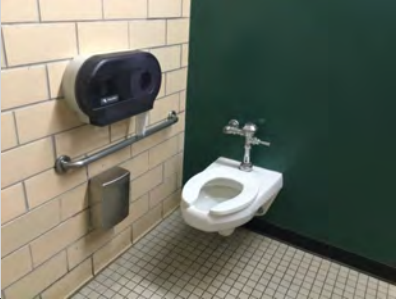
136	Girls' Toilet Room Near Room 18	1		Toilet Compartment (Children)	Accessible Compartment

. Toilet seat < 15" or > 17" high (Ages 9 - 12) . Side or rear grab bar < 42" long . Side or rear grab bar not provided . Non-compliant toilet paper dispenser	19.5" 32" - -	Install a toilet with a seat between 15"- 17" high above the finished floor. Provide a side and rear wall grab bar that is 42" long located 6" max. from the interior corner. Relocate toilet paper dispenser so that it is between 14"- 19" above the floor and between 7"- 9" in front of the toilet. Ensure dispensers are not mounted above grab bars.	1	4218	\$4218
137	Men's Toilet Room Near Exit Door 12 (D3)	G		Toilet Compartment (Children)	Accessible Compartment

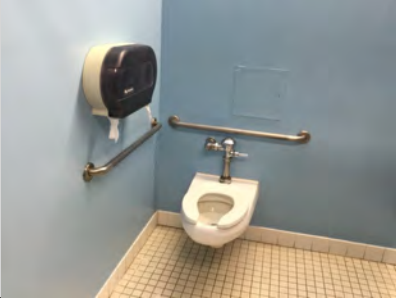
. Side or rear grab bar < 42" long . Side or rear grab bar < 20" or > 25" high (Ages 5 - 8) . Non-compliant toilet paper dispenser	32" 30" - -	Provide a side/rear wall grab bar that is 42" long located 6" max. from the interior corner. Relocate grab bar to 20"- 25" above the floor. Relocate toilet paper dispenser so that it is between 14"- 19" above the floor and between 7"- 9" in front of the toilet. Ensure dispensers and other devices are not mounted above grab bars./Replace dispenser as it does not allow continuous paper flow.	1	1410	\$1410

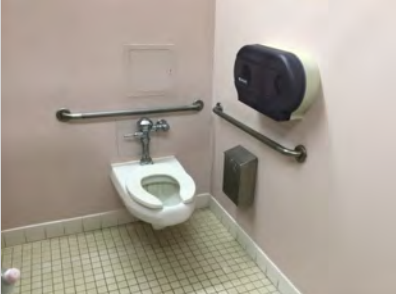
138	Women's Toilet Room Near Exit Door 12 (D3)	G		Toilet Compartment (Children)	Accessible Compartment

. Side or rear grab bar < 42" long . Side or rear grab bar < 20" or > 25" high (Ages 5 - 8) . Non-compliant toilet paper dispenser	30" 31" - 19.75"	Provide a side/rear wall grab bar that is 42" long located 6" max. from the interior corner. Relocate grab bar to 20"- 25" above the floor. Relocate toilet paper dispenser so that it is between 14"- 19" above the floor and between 7"- 9" in front of the toilet. Ensure dispensers and other devices are not mounted above grab bars./Replace dispenser as it does not allow continuous paper flow.	1	1410	\$1410

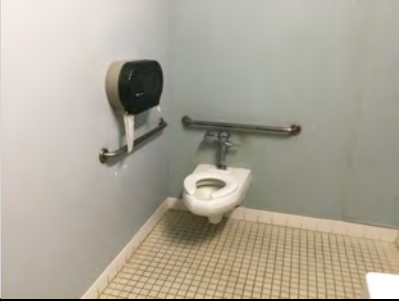
ID	Location	Floor	Room	Element	Type	Photo	Issues	Current Measure	Recommendations	Quantity	Price	Cost Estimation
139	Sp.Ed Toilet Room	3		Toilet Compartment (Children)	Accessible Compartment

Side or rear grab bar < 42" long Side or rear grab bar < 25" or > 27" high (Ages 9 - 12) Non-compliant toilet paper dispenser Toilet seat < 15" or > 17" high (Ages 9 - 12)	18.75" 30" 31" -	Install a toilet with a seat between 15"- 17" high above the finished floor. Provide a side/rear wall grab bar that is 42" long located 6" max. from the interior corner. Relocate grab bar to 25"- 27" above the floor. Relocate toilet paper dispenser so that it is between 14"- 19" above the floor and between 7"- 9" in front of the toilet. Ensure dispensers are not mounted above grab bars.	1	3832	\$3832
140	Sp.Ed Toilet Room for Room 12	3		Toilet Compartment (Children)	Accessible Compartment

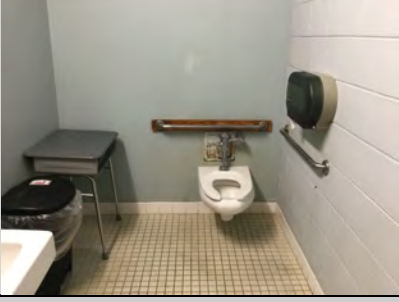
Non-compliant toilet paper dispenser Clearance at toilet < 60" clear width	- -	Relocate toilet paper dispenser so that it is between 14"- 19" above the floor and between 7"- 9" in front of the toilet. Ensure dispensers and other devices are not mounted above grab bars./Replace dispenser as it does not allow continuous paper flow. Provide a wheelchair accessible compartment that is 60" wide min. and 72" deep min. (Remove stored items.)	1	353	\$353

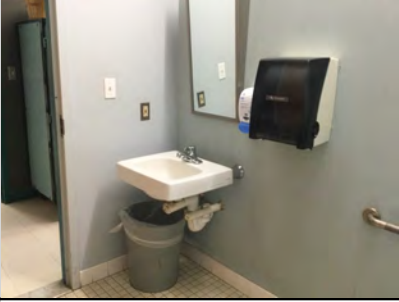
Lavatory (Children)												
141	Girls' Toilet Room Near Room 2	G		Lavatory (Children)	N/A

Toe or knee clearances not provided	23.75"	Provide at least one lavatory with 25" min. knee clearance positioned for a forward approach. Ensure toe clearance is also provided. (Remove trash container.)	1	1686	\$1686
142	Boys' Toilet Room Near Library	2		Lavatory (Children)	N/A

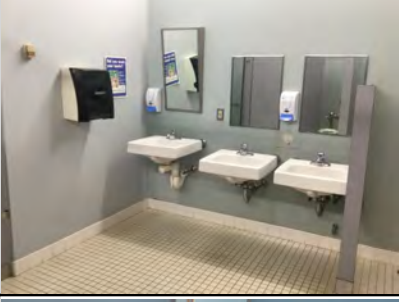
Toe or knee clearances not provided Exposed plumbing underneath	22" -	Provide at least one lavatory with 25" min. knee clearance positioned for a forward approach. Ensure toe clearance is also provided. Insulate or otherwise configure pipes to prevent contact, for at least one lavatory.	1	1778	\$1778
143	Men's Toilet Room Near Exit Door 12 (D3)	G		Lavatory (Children)	N/A

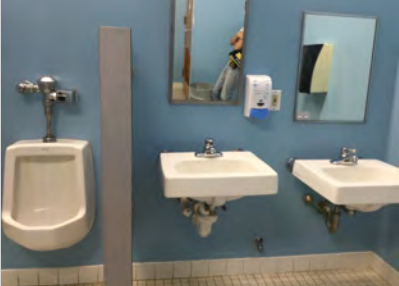
Toe or knee clearances not provided Exposed plumbing underneath Mirror above lavatory w/reflective surface > 31"	22.5" - 39"	Provide at least one lavatory with 25" min. knee clearance positioned for a forward approach. Ensure toe clearance is also provided. Insulate or otherwise configure pipes to prevent contact, for at least one lavatory. Lower mirror so that the bottom surface is at 31" above finished floor.	1	2034	\$2034

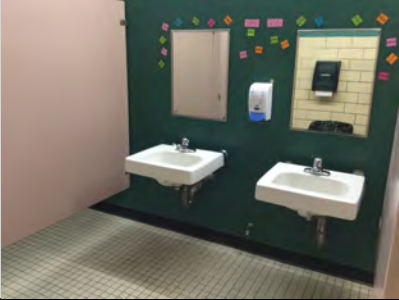
ID	Location	Floor	Room	Element	Type	Photo	Issues	Current Measure	Recommendations	Quantity	Price	Cost Estimation
144	Girls' Toilet Room Near Room 18	1		Lavatory (Children)	N/A

Toe or knee clearances not provided Exposed plumbing underneath Mirror above lavatory w/reflective surface > 31"	22" - 37.75"	Provide at least one lavatory with 25" min. knee clearance positioned for a forward approach. Ensure toe clearance is also provided. Insulate or otherwise configure pipes to prevent contact, for at least one lavatory. Lower mirror so that the bottom surface is at 31" above finished floor.	1	2034	\$2034
145	Boys' Toilet Room Near Room 18	1		Lavatory (Children)	N/A

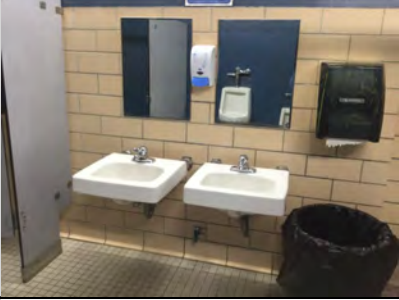
Toe or knee clearances not provided Mirror above lavatory w/reflective surface > 31"	21.5" 38.5"	Provide at least one lavatory with 25" min. knee clearance positioned for a forward approach. Ensure toe clearance is also provided. Lower mirror so that the bottom surface is at 31" above finished floor.	1	1942	\$1942

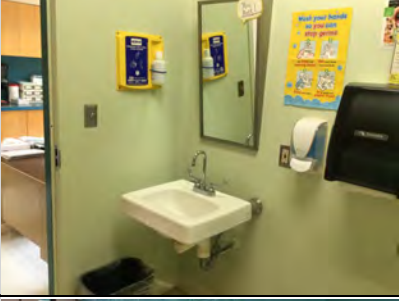
146	Toilet - Health	G		Lavatory (Children)	N/A

Exposed plumbing underneath	-	Insulate or otherwise configure pipes to prevent contact, for at least one lavatory. (Pipes have some exposed area.)	1	92	\$92
147	Girls' Toilet Room Near Room 18	1		Lavatory (Children)	N/A

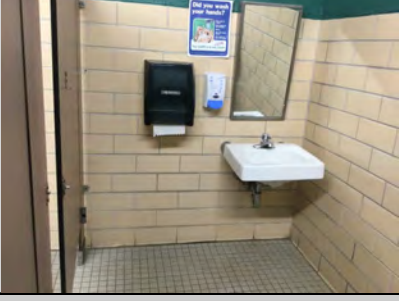
Exposed plumbing underneath Mirror above lavatory w/reflective surface > 31"	- 38"	Insulate or otherwise configure pipes to prevent contact, for at least one lavatory. Lower mirror so that the bottom surface is at 31" above finished floor.	1	348	\$348
Dispensers (Children)												
148	Girls' Toilet Room Near Room 18	1		Dispensers (Children)	Paper Towel Dispenser

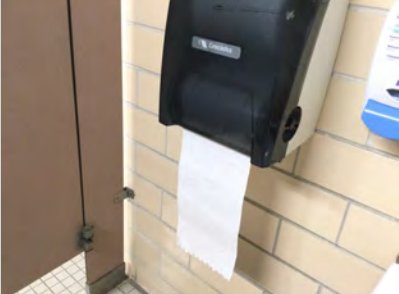
Dispenser not operable with a closed fist	-	Provide a dispenser that can be operable with one hand and not require tight grasping, pinching, or twisting of the wrist. (Issue may be present in all toilet rooms.)	1	200	\$200

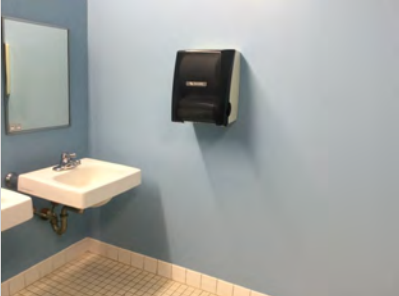
ID	Location	Floor	Room	Element	Type	Photo	Issues	Current Measure	Recommendations	Quantity	Price	Cost Estimation
149	Men's Toilet Room Near Exit Door 12 (D3)	G		Dispensers (Children)	Paper Towel Dispenser

Dispenser is a protruding object	-	Relocate dispenser out of the circulation path.	1	256	\$256
150	Women's Toilet Room Near Exit Door 12 (D3)	G		Dispensers (Children)	Tampon Dispenser

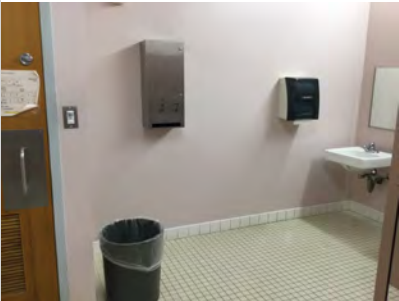
Dispenser is a protruding object	6.75"	Relocate dispenser out of the circulation path.	1	256	\$256
151	Boys' Toilet Room Near Library	2		Dispensers (Children)	Paper Towel Dispenser

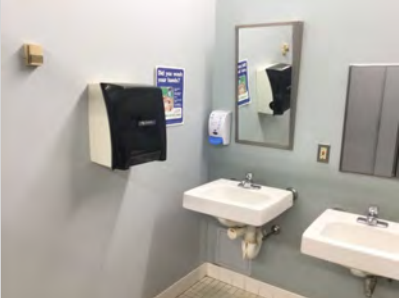
Dispenser is a protruding object		Relocate dispenser out of the circulation path.	1	256	\$256
Additional Access												
Drinking Fountains												
152	Drinking Fountain Near Drop off - Cafeteria	G		Drinking Fountains	N/A

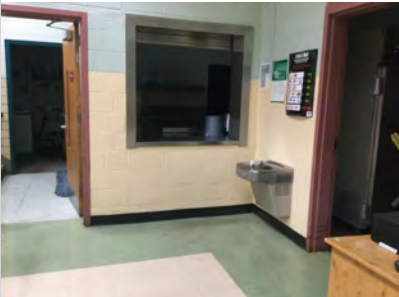
No drinking fountain provided for standing users	-	Provide an additional drinking fountain for standing users or install a Hi-Lo drinking fountain.	1	4028	\$4028

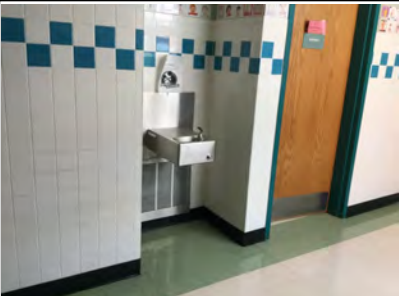
153	Drinking Fountain Near Room 2	G		Drinking Fountains	N/A

No drinking fountain provided for standing users	-	Provide an additional drinking fountain for standing users or install a Hi-Lo drinking fountain.	1	4028	\$4028

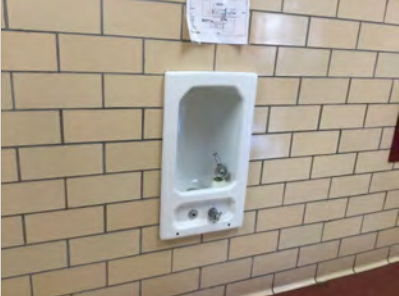
ID	Location	Floor	Room	Element	Type	Photo	Issues	Current Measure	Recommendations	Quantity	Price	Cost Estimation
154	Near Room 10	3		Drinking Fountains	N/A

No drinking fountain provided for standing users	-	Provide an additional drinking fountain for standing users or install a Hi-Lo drinking fountain.	1	4216	\$4216
155	Near Room 18	1		Drinking Fountains	Low

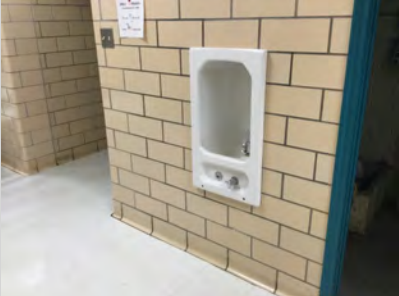
No drinking fountain provided for standing users	-	Provide an additional drinking fountain for standing users or install a Hi-Lo drinking fountain.	1	4216	\$4216
156	Drinking Fountain Near Exit Door 12 (D3)	G		Drinking Fountains	N/A

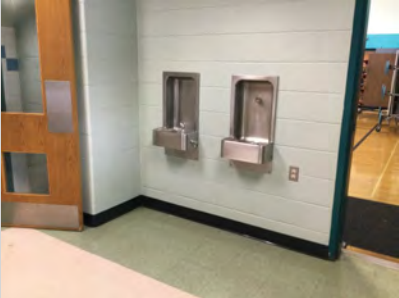
No drinking fountain provided for standing users Standing height fountain does not have cane protection	- 7"	Provide an additional drinking fountain for standing users or install a Hi-Lo drinking fountain. Provide a cane-detectable barrier skirt under the high unit.	1	4918	\$4918
157	Drinking Fountain Near Library	2		Drinking Fountains	Low

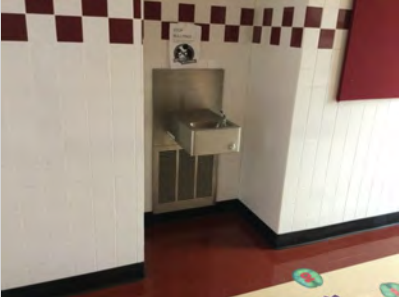
No drinking fountain provided for seated users	-	Provide an additional drinking fountain for seated users or install a Hi-Lo drinking fountain.	1	4028	\$4028

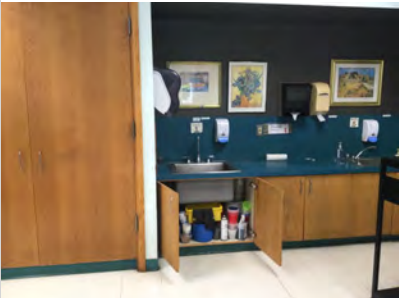
Sinks for Children's Use												
158	Art Room for All Grades	G	2	Sinks for Children's Use	Classroom

Knee or toe clearance not provided	-	Provide at least one sink with 25" high knee and toe clearance positioned for a forward approach.	1	1686	\$1686

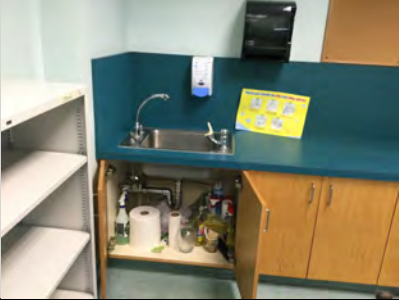
ID	Location	Floor	Room	Element	Type	Photo	Issues	Current Measure	Recommendations	Quantity	Price	Cost Estimation
159	STEAM Grades 3-6	2	4	Sinks for Children's Use	Classroom

Knee or toe clearance not provided	23.5"	Provide at least one sink with 25" high knee and toe clearance positioned for a forward approach.	1	1686	\$1686
160	Grade 3 Sp. Ed	3	11	Sinks for Children's Use	Classroom
