Town of Merrimac, Massachusetts

PART A – Executive Summary

September 2021

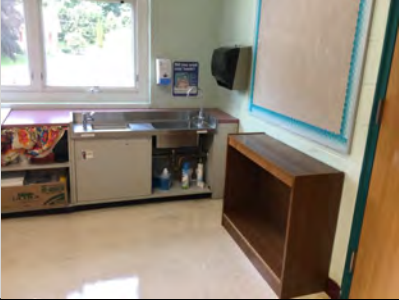
Knee or toe clearance not provided	-	Provide at least one sink with 25" high knee and toe clearance positioned for a forward approach.	1	1686	\$1686
161	Sp.Ed Grade 4	3	16	Sinks for Children's Use	Classroom

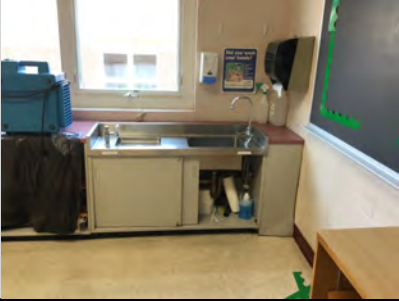
Knee or toe clearance not provided	-	Provide at least one sink with 25" high knee and toe clearance positioned for a forward approach.	1	1686	\$1686
162	Speech Room for All Grades	1	23	Sinks for Children's Use	N/A

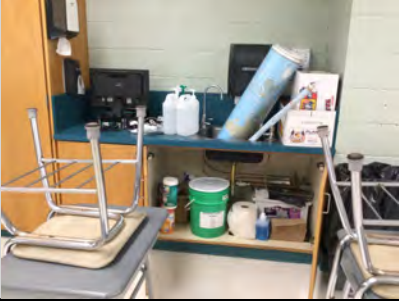
Knee or toe clearance not provided	-	Provide at least one sink with 25" high knee and toe clearance positioned for a forward approach.	1	1686	\$1686

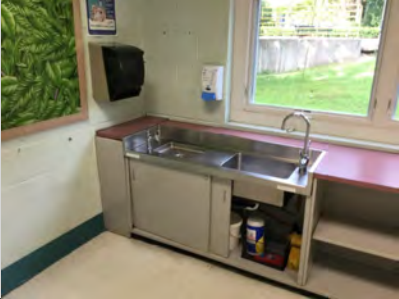
163	Grade 5	1	18	Sinks for Children's Use	Classroom

Knee or toe clearance not provided	-	Provide at least one sink with 25" high knee and toe clearance positioned for a forward approach.	1	1686	\$1686

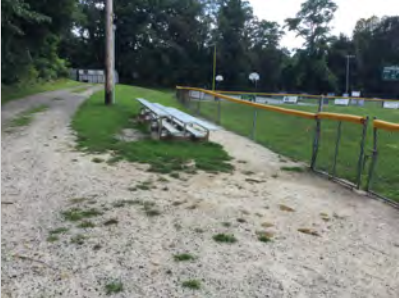
ID	Location	Floor	Room	Element	Type	Photo	Issues	Current Measure	Recommendations	Quantity	Price	Cost Estimation
Field												
164	Sideline Seating - Baseball	Ext.		Field	Baseball

Accessible spaces not provided at sidelines seating No accessible route to all areas of sport activity	- -	Provide a 36" x 48" stable, firm and slip-resistant clear floor space at sidelines seating. Install an accessible route between all areas of sport activity. (Cost estimate for a 4' wide x 240' long stone dust path providing an accessible route connecting all baseball sideline and team seating and the boundary of sport activity at baseball. See illustration in report narrative.)	1	7680	\$7680
165	Route to Softball Field by Parking at Tennis Courts Leading to Exterior Stairs	Ext.		Field	Softball

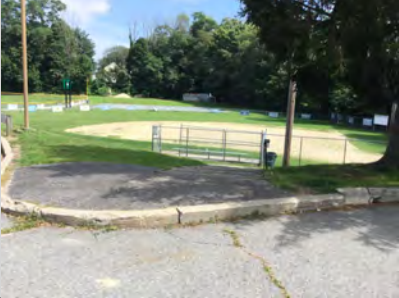
Field not connected to an accessible route	6"	Provide an accessible route to the field. (Cost estimate for a concrete curb ramp. See illustration in report narrative.)	1	2800	\$2800

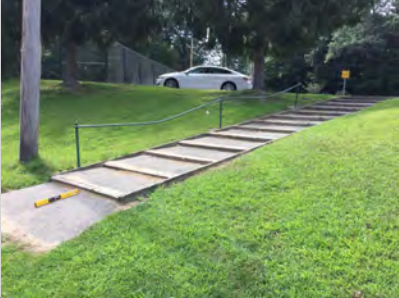
166	Route to Softball Team Seating Third Base Side	Ext.		Field	Softball

Field not connected to an accessible route	-	Provide an accessible route to the field. (Cost estimate for a 4' wide min. x 60' long stone dust path starting at a new curb ramp at the southwest end of the softball field, following the exterior stairs and connecting to the team seating at the third base side of the softball field. Ensure route has a 5% max. run and 2% max. cross slope. See illustration in report narrative.)	1	1920	\$1920
167	Route to Softball Team Seating First Base Side	Ext.		Field	Softball

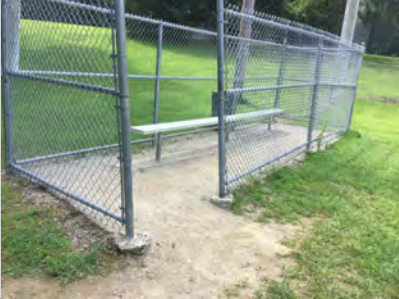
No accessible route to all areas of sport activity	-	Install an accessible route between all areas of sport activity. (Cost estimate for a 4' wide min. x 120' long stone dust path starting at a new curb ramp at the southwest end of the softball field, and connecting to the team seating on the first base side of the softball field. Ensure route has a 5% max. run and 2% max. cross slope. See illustration in report narrative.)	1	3840	\$3840

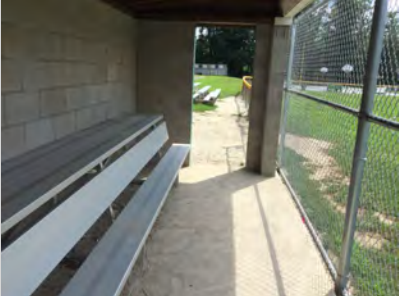
168	Dugouts 1 and 2, Team Seating - Baseball	Ext.		Field	Baseball

No accessible route to all areas of sport activity Accessible spaces not provided at team seating Accessible spaces not provided at sidelines seating	- - -	Provide a 36" x 48" clear floor space at team seating at both baseball dugouts. (Remove a 36" wide section of the seating at the end of the bench in both dugouts.)	2	Labor	\$0

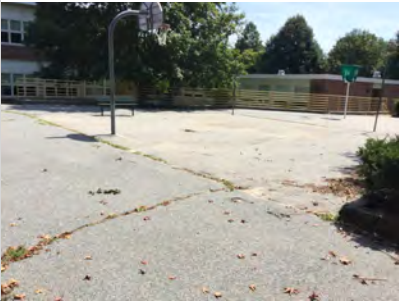
ID	Location	Floor	Room	Element	Type	Photo	Issues	Current Measure	Recommendations	Quantity	Price	Cost Estimation
Court												
169	Upper Paved Play Area	Ext.		Court	Basketball

Court is not connected to an accessible route	- -	Provide an accessible route to the court. (Cost estimate for asphalt to repair cracks in walkway leading to basketball court.)	1	480	\$480
170	Basketball Court Near Baseball Field	Ext.		Court	Basketball

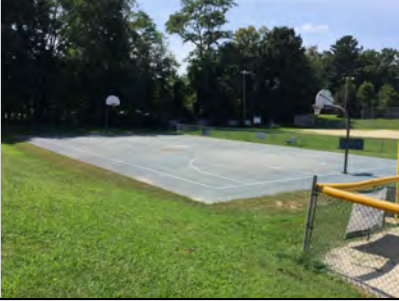
Court is not connected to an accessible route	-	Provide an accessible route to the court. (Cost estimate for a 4' wide min. x 120' long stone dust path from the northwest corner of the basketball court running along the outside of the baseball field's outfield fence and connecting with the existing path at the southeast corner of the school.)	1	3840	\$3840
Best Practice												
171	Main Entrance/Exit Door 1 (A1)	G	Bench		N/A

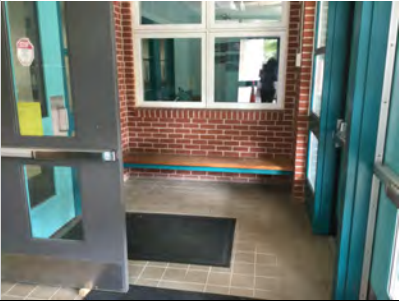
Recommend providing 36"x48" clear space at one end of bench.	1	-	\$0

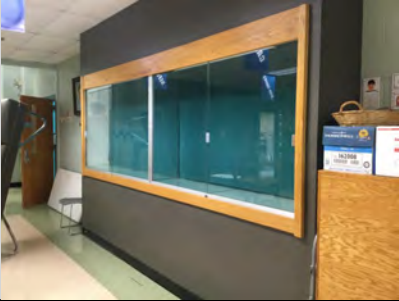
Display Case												
172	Near Elevator	G		Display Case	N/A

Ensure glare does not obstruct view of any items placed in the display case.	1		\$0

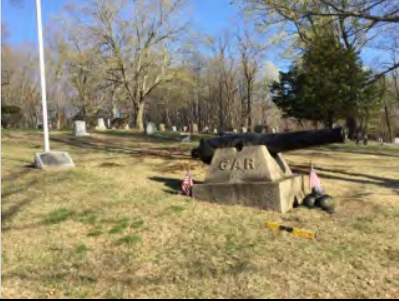
ID	Location	Floor	Room	Element	Type	Photo	Issues	Current Measure	Recommendations	Quantity	Price	Cost Estimation
Approach and Entrance												
Exterior Access Route												
1	Route to Marker at Flag	Ext.		Exterior Access Route	Exterior

Running slope > 1:20 (5%) Accessible route not provided	14.8% -	If access to the marker at the flag or at the cannon is part of Memorial Day remembrances or other public services, provide an accessible route no steeper than 1:20 (5%) and cross slope to be no greater than 1:50 (2.00%). (Cost based on a 4' wide min. x 30' long stone dust path from car path to the cannon and flag.)	1	960	\$960
2	American Flag and Bell	Ext.		Exterior Access Route	Exterior

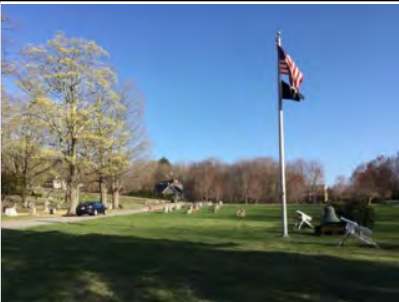
Accessible route not provided		If access to the marker at the flag or at the bell is part of Memorial Day remembrances or other public services, provide an accessible route no steeper than 1:20 (5%) and cross slope to be no greater than 1:50 (2.00%). (Cost based on a 4' wide min. x 30' long stone dust path from car path flag and bell.)	1	960	\$960

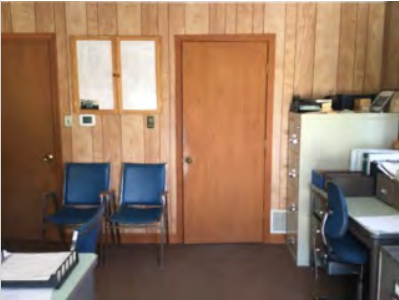
Entrance												
3	Toilet Room Door at Left in Photo	1		Entrance	N/A

Clear width at door < 32" Maneuvering clearance(s) not provided	30" -	Use offset hinges or widen door to provide 32" min. clear width at the door. Relocate the chair to provide 18" min. pull-side maneuvering clearance at the door. (Cost included in ID #8.)	1	-	\$0
4	Main Entry Door	Ext		Entrance	Main Entrance

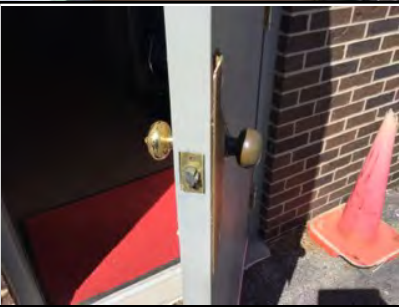
Hardware not operable with a closed fist		Provide hardware that can be operable with one hand and not require tight grasping, pinching, or twisting of the wrist.	1	484	\$484

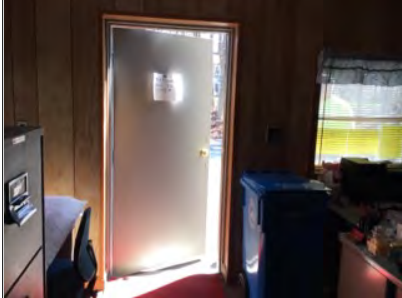
ID	Location	Floor	Room	Element	Type	Photo	Issues	Current Measure	Recommendations	Quantity	Price	Cost Estimation
Emergency Exit												
5	Office Egress Door	1		Emergency Exit	N/A

Tactile sign not provided at emergency exit	-	Provide a sign with raised characters and braille at the emergency exit.	1	232	\$232
Access to Goods and Services												
Doors, Doorways, & Gates												
6	Office Entry Door	Ext		Doors, Doorways, & Gates	N/A

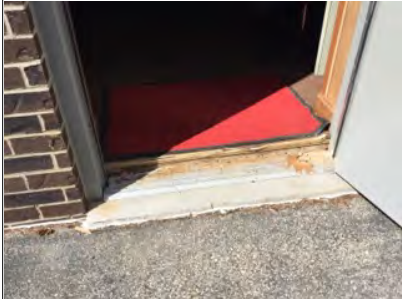
Mat not securely attached Threshold > 3/4" high	- 2"	Secure the mat. Alter the threshold to be 3/4" high max.	1	150	\$150
Operable Parts												
7	Water Spigot With Accessible Hardware	Ext.		Operable Parts	N/A

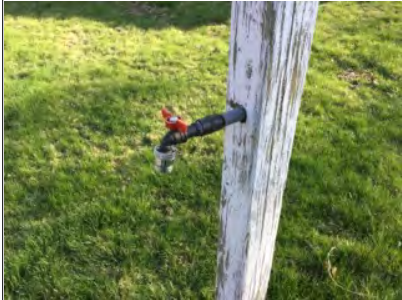
Element not on an accessible route	-	Ensure the water spigot with hardware that can be operated with a closed fist is located on an accessible route. (Cost based on a 4' wide min. x 6' long stone dust path from car path flag and bell.)	1	192	\$192

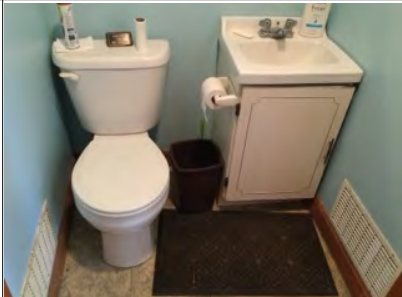
Toilet & Bathing Rooms												
Overall Access												
8	Toilet Room	1		Overall Access	Toilet Room

Turning space not provided Accessible plumbing fixtures or stalls not provided	47" -	Provide an accessible single-user toilet room.	1	24604	\$24604

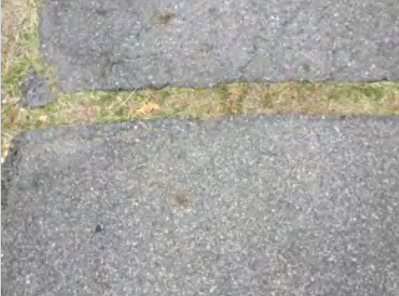
ID	Location	Floor	Room	Element	Type	Photo	Issues	Current Measure	Recommendations	Quantity	Price	Cost Estimation
Approach and Entrance												
Exterior Access Route												
1	Walkway Heading West on East Main Street	Ext		Exterior Access Route	Sidewalk

Surface openings > 1/2" Level changes > 1/4"	5" 1"	Provide an asphalt patch. Alter change in level to be 1/4" high max.	1	-	\$0
2	Walkway Heading West on East Main Street	Ext		Exterior Access Route	Sidewalk

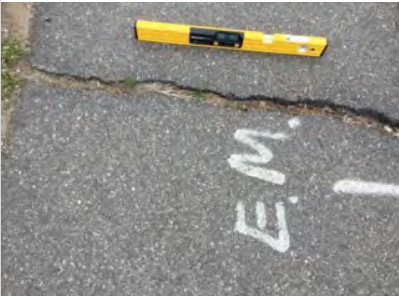
Surface openings > 1/2" Level changes > 1/4"	2" 1.5"	Provide an asphalt patch. Alter change in level to be 1/4" high max.	1	-	\$0
3	Walkway Heading West on East Main Street	Ext		Exterior Access Route	Sidewalk

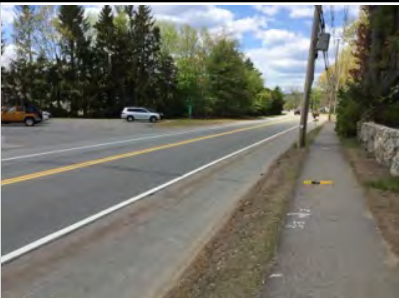
Cross slope > 1:50 (2.00%)	5.2%	Reduce cross slope to be no steeper than 1:50 (2.00%).	1	-	\$0
4	Walkway Heading West on East Main Street	Ext		Exterior Access Route	Sidewalk

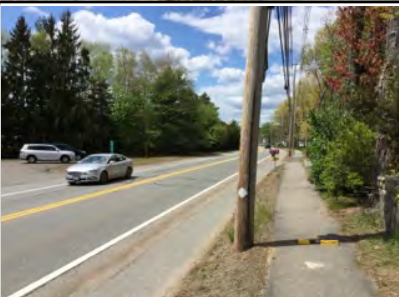
Cross slope > 1:50 (2.00%)	4%	Reduce cross slope to be no steeper than 1:50 (2.00%).	1	-	\$0

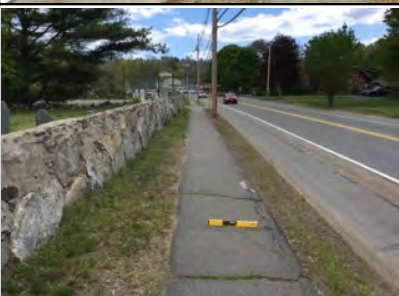
5	Walkway Heading West on East Main Street	Ext		Exterior Access Route	Sidewalk

Cross slope > 1:50 (2.00%)	6.9%	Reduce cross slope to be no steeper than 1:50 (2.00%).	1	-	\$0

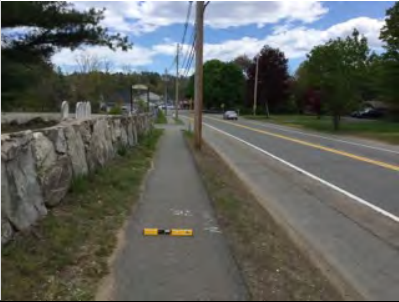
ID	Location	Floor	Room	Element	Type	Photo	Issues	Current Measure	Recommendations	Quantity	Price	Cost Estimation
6	Walkway Heading West on East Main Street	Ext		Exterior Access Route	Sidewalk

Cross slope > 1:50 (2.00%)	4.3%	Reduce cross slope to be no steeper than 1:50 (2.00%).	1	-	\$0
7	Walkway Heading West on East Main Street	Ext		Exterior Access Route	Sidewalk

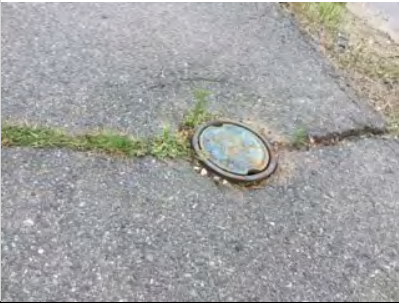
Level changes > 1/4"	0.75"	Alter change in level to be 1/4" high max. Provide as asphalt patch.	1	-	\$0

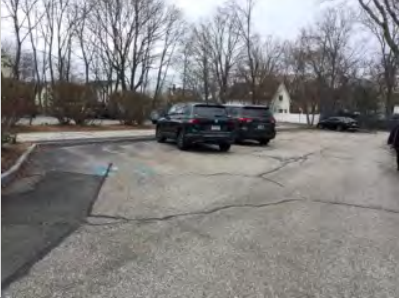
ID	Location	Floor	Room	Element	Type	Photo	Issues	Current Measure	Recommendations	Quantity	Price	Cost Estimation
Approach and Entrance												
Off-Street Parking Lot or Garage												
1	Parking Near Accessible Entrance/Exit	1		Off-Street Parking Lot or Garage	Visitor

Total # of parking Total # of designated accessible parking spaces Total # of designated van accessible spaces Access aisle not provided Sign not provided Sign does not have the designation "Van Accessible"	18 0 1 - - -	Provide a marked access aisle that is at least 96" wide at the van accessible space. Provide a sign with the International Symbol of Accessibility (ISA) with the bottom of the sign 60" min. above the ground and the top 96" max. above the ground. Add the designation "Van Accessible" to the sign located at the van accessible space.	1	800	\$800
Exterior Ramp												
2	Accessible Entrance/Exit	Ext.		Exterior Ramp	N/A

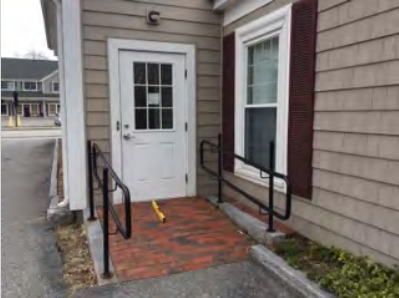
Running slope > 1:12 (8.3%) No top or bottom landing provided	12.1% -	Reduce running slope to be no steeper than 1:12 (8.3%). Provide landing at top of ramp. (Cost based on a 4' wide min. x 15' long concrete ramp with a 5' deep min. level landing at the door with a max. slope of 1:50 (2.00%) in all directions.)	1	17702	\$17702

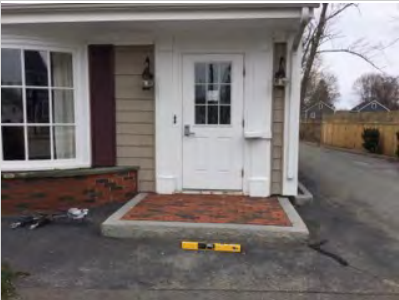
Entrance												
3	Main Entrance/Exit	1		Entrance	Main Entrance

Directional sign to accessible entrance not provided Threshold > 1/2" high	- 2"	Provide a directional sign indicating the location of the nearest accessible entrance. Alter threshold to be 1/2" high max.	1	496	\$496
Emergency Exit												
4	Main Exit/Entrance	1		Emergency Exit	N/A

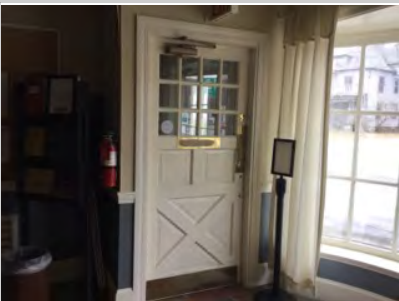
Tactile sign not provided at exit Directional sign to accessible emergency exit not provided	- -	Provide tactile exit signs with raised characters and braille at exit doors. Mount signs between 48"- 60" above the finished floor located on the latch side of the door. Provide a directional sign indicating the location of the nearest accessible emergency exit.	2	232	\$464

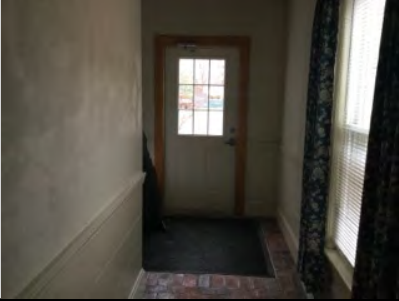
ID	Location	Floor	Room	Element	Type	Photo	Issues	Current Measure	Recommendations	Quantity	Price	Cost Estimation
5	Accessible Exit/Entrance	1		Emergency Exit	N/A

Tactile sign not provided at exit Illuminated Int. Symbol of Acc. not provided (MAAB)	- -	Provide tactile exit signs with raised characters and braille at exit doors. Mount signs between 48"- 60" above the finished floor located on the latch side of the door. If an illuminated exit sign is provided, provide an illuminated International Symbol of Accessibility (ISA).	1	232	\$232
Access to Goods and Services												
Means of Egress												
6	To Accessible Entrance/Exit	1		Means of Egress	N/A

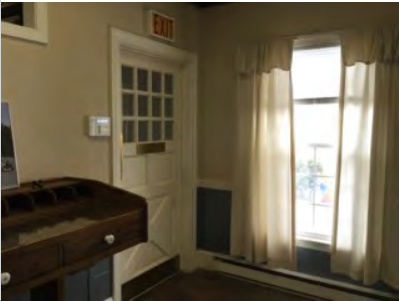
Tactile exit sign not provided Illuminated ISA symbol not provided (MAAB)	- -	Ensure tactile exit signs with raised characters and braille are provided at exit doors. Mount signs between 48"- 60" above the finished floor located on the latch side of the door. If the exit sign is replaced with an illuminated exit sign, provide an illuminated International Symbol of Accessibility (ISA).	1	232	\$232

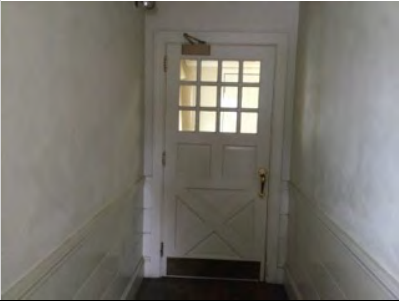
Doors, Doorways, & Gates												
7	From Accessible Entrance/Exit to Lobby	1		Doors, Doorways, & Gates	Vestibule

Maneuvering clearance(s) not provided	-	Provide an automatic door opener. (Door has less than 18" min. pull-side maneuvering clearance.)	1	3060	\$3060
8	Accessible Entrance/Exit	Ext.		Doors, Doorways, & Gates	Other

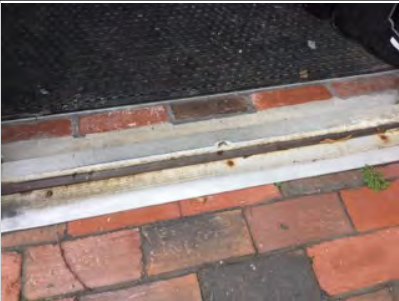
Threshold not beveled Threshold > 1/2" high	- .75"	Bevel the threshold. Alter the threshold to be 1/2" high max.	1	150	\$150

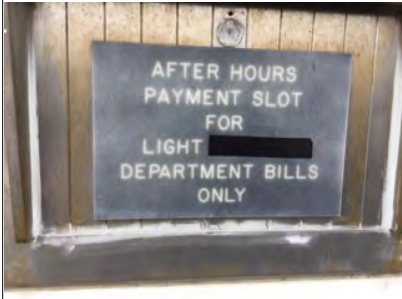
Reach < 15" or > 48"(forward/side approach)	65"	Relocate the height of the after hours electric bill payment slot so that its controls and the slot are between 15"- 48" above the finished floor.	1	256	\$256
Dining or Work Surfaces												
11	Table Near Accessible Entrance/Exit	1		Dining or Work Surfaces	Work Surface

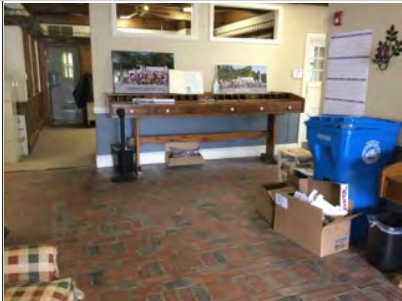
Top of dining/work surface < 28" or > 34"	40.25"	Provide at least one work surface with tops between 28"- 34" above the floor and 27" clear height underneath. (Cost based on a new accessible work surface.)	1	700	\$700

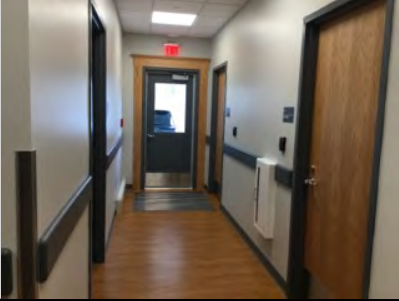
ID	Location	Floor	Room	Element	Type	Photo	Issues	Current Measure	Recommendations	Quantity	Price	Cost Estimation
Approach and Entrance												
Emergency Exit												
1	Exit	1		Emergency Exit	N/A

Tactile sign not provided at exit	-	Provide tactile exit signs with raised characters and braille at exit doors. Mount signs between 48"- 60" above the finished floor located on the latch side of the door.	1	232	\$232
2	Main Entrance/ Exit	1		Emergency Exit	N/A

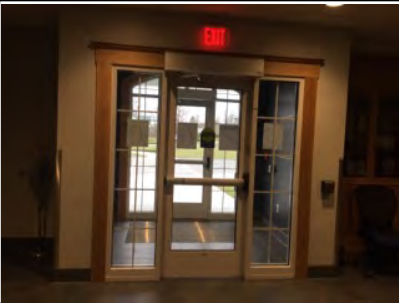
Tactile sign not provided at exit Illuminated Int. Symbol of Acc. not provided (MAAB)	- -	Provide tactile exit signs with raised characters and braille at exit doors. Mount signs between 48"- 60" above the finished floor located on the latch side of the door. Provide an illuminated sign with the International Symbol of Accessibility.	1	432	\$432
3	Training Room Exit	1	152	Emergency Exit	N/A

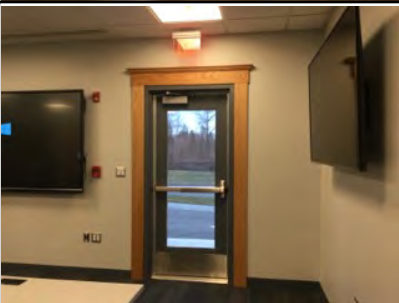
Tactile sign not provided at exit Illuminated Int. Symbol of Acc. not provided (MAAB)	- -	Provide tactile exit signs with raised characters and braille at exit doors. Mount signs between 48"- 60" above the finished floor located on the latch side of the door. Provide an illuminated sign with the International Symbol of Accessibility.	1	432	\$432

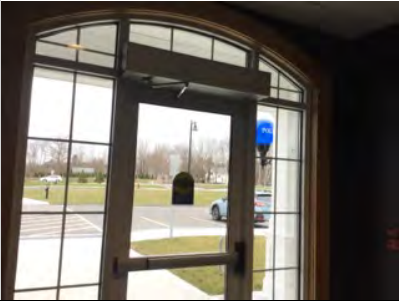
Access to Goods and Services												
Means of Egress												
4	Main Entrance/ Exit	1		Means of Egress	N/A

Tactile exit sign not provided	-	Ensure tactile exit signs with raised characters and braille are provided at exit doors. Mount signs between 48"- 60" above the finished floor located on the latch side of the door.	1	232	\$232

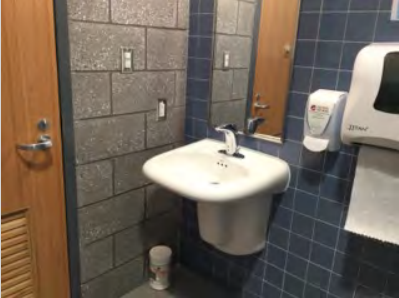
ID	Location	Floor	Room	Element	Type	Photo	Issues	Current Measure	Recommendations	Quantity	Price	Cost Estimation
Doors, Doorways, & Gates												
5	Toilet Room 1	1		Doors, Doorways, & Gates	Toilet Room

Maneuvering clearance(s) not provided	10"	Provide an automatic door opener. (Lack of 18" min. pull-side maneuvering clearance at door.)	1	3060	\$3060
6	Toilet Room 2	1		Doors, Doorways, & Gates	Toilet Room

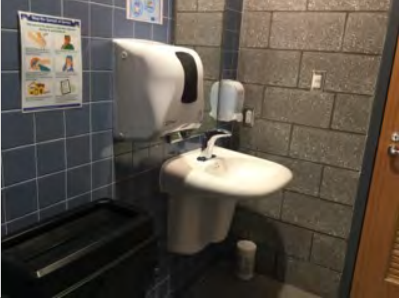
Maneuvering clearance(s) not provided	12"	Provide an automatic door opener. (Lack of 18" min. pull-side maneuvering clearance at door.)	1	3060	\$3060
7	Interview	1	131	Doors, Doorways, & Gates	Other

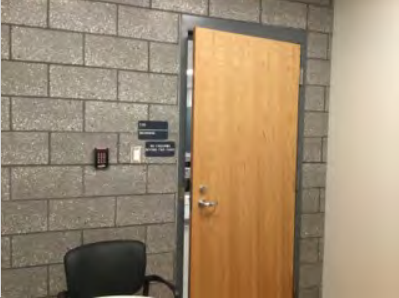
Maneuvering clearance(s) not provided	-	Remove the obstruction/relocate the chair to provide 18" min. maneuvering clearance on the pull-side of the door.	1	Labor	\$0
8	Toilet Room 1	1		Doors, Doorways, & Gates	Toilet Room

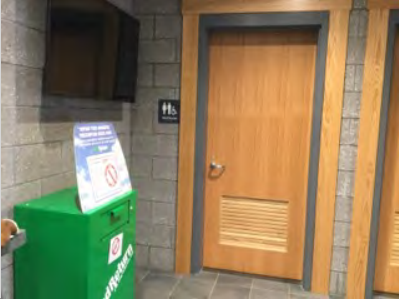
Door requires > 5 lbs. of force to open	13 lbs.	Adjust closers so doors do not require more than 5 pounds of force to open.	1	Labor	\$0

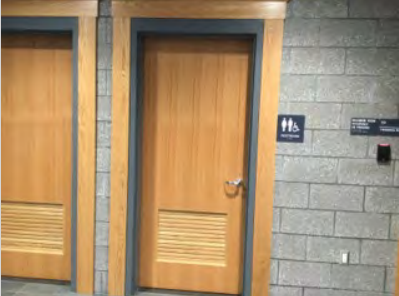
9	Toilet Room 2	1		Doors, Doorways, & Gates	Toilet Room

Door requires > 5 lbs. of force to open	11 lbs.	Adjust closers so doors do not require more than 5 pounds of force to open.	1	Labor	\$0

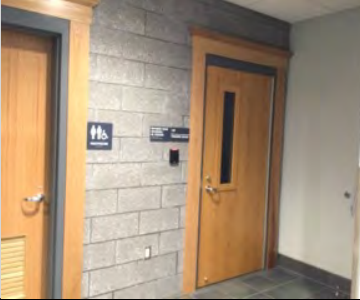
ID	Location	Floor	Room	Element	Type	Photo	Issues	Current Measure	Recommendations	Quantity	Price	Cost Estimation
10	Training Room	1		Doors, Doorways, & Gates	N/A

Door requires > 5 lbs. of force to open	10 lbs.	Adjust closers so doors do not require more than 5 pounds of force to open.	1	Labor	\$0
11	Conference Room	1	102	Doors, Doorways, & Gates	N/A

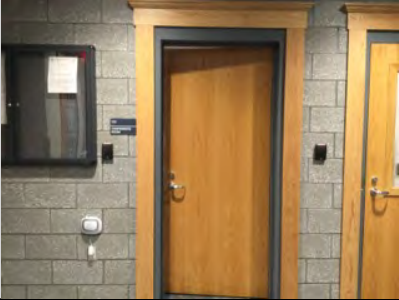
Door requires > 5 lbs. of force to open	15 lbs.	Adjust closers so doors do not require more than 5 pounds of force to open.	1	Labor	\$0
12	To Chief's Office From Lobby	1		Doors, Doorways, & Gates	Circulation

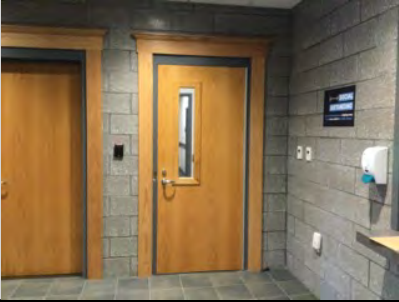
Door requires > 5 lbs. of force to open	15 lbs.	Adjust closers so doors do not require more than 5 pounds of force to open.	1	Labor	\$0
Signage												
13	Training Room	1	152	Signage	Designation

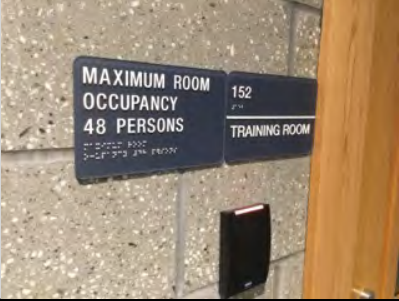
Braille not provided on sign	-	Provide braille on sign below text. (Signs for interior rooms or spaces where the sign is not likely to change over time should have braille provided. In this case, while braille is present for the room number, braille is lacking below the room name designation text.)	1	232	\$232

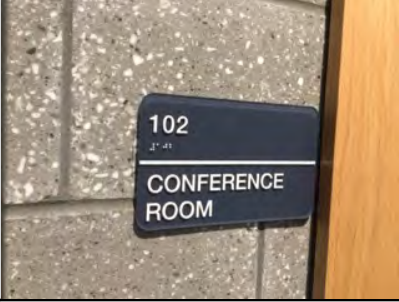
14	Conference Room	1	102	Signage	Designation

Braille not provided on sign	-	Provide braille on sign below text. (Signs for interior rooms or spaces where the sign is not likely to change over time should have braille provided. In this case, while braille is present for the room number, braille is lacking below the room name designation text.)	1	232	\$232

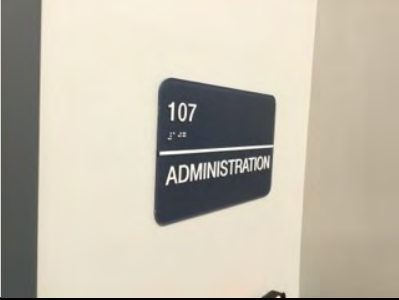
ID	Location	Floor	Room	Element	Type	Photo	Issues	Current Measure	Recommendations	Quantity	Price	Cost Estimation
15	To Chief's Office Through Administration	1	107	Signage	Designation

Braille not provided on sign	-	Provide braille on sign below text. (Signs for interior rooms or spaces where the sign is not likely to change over time should have braille provided. In this case, while braille is present for the room number, braille is lacking below the room name designation text.)	1	232	\$232
16	Chief's Office	1	104	Signage	Designation

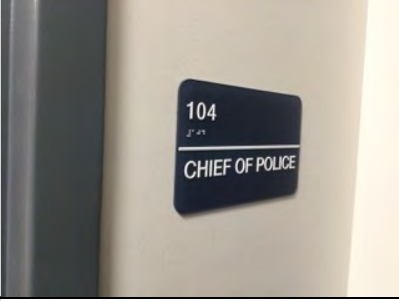
Braille not provided on sign	-	Provide braille on sign below text. (Signs for interior rooms or spaces where the sign is not likely to change over time should have braille provided. In this case, while braille is present for the room number, braille is lacking below the room name designation text.)	1	232	\$232
17	Dispatch Near Squad Room Visited During Tours	1		Signage	Designation

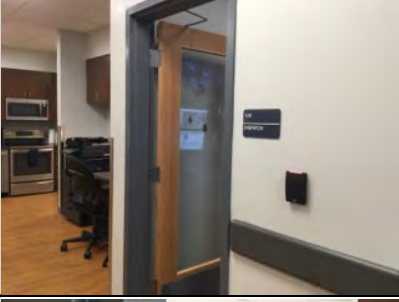
Braille not provided on sign	-	Provide braille on sign below text. (Signs for interior rooms or spaces where the sign is not likely to change over time should have braille provided. In this case, while braille is present for the room number, braille is lacking below the room name designation text.)	1	232	\$232

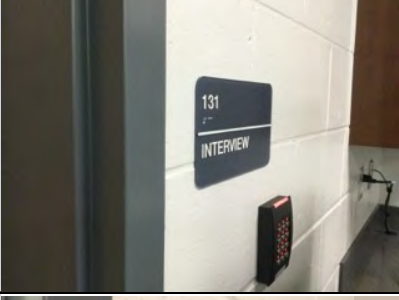
18	Interview	1	131	Signage	Designation

Braille not provided on sign	-	Provide braille on sign below text. (Signs for interior rooms or spaces where the sign is not likely to change over time should have braille provided. In this case, while braille is present for the room number, braille is lacking below the room name designation text.)	1	232	\$232
19	Accessible Cell/Cell 3	1	149	Signage	Designation

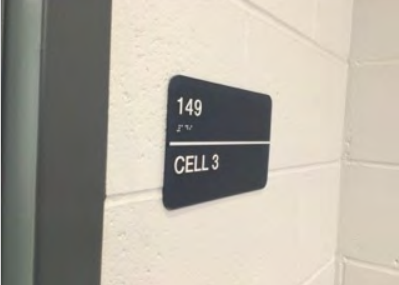
Braille not provided on sign	-	Provide braille on sign below text. (Signs for interior rooms or spaces where the sign is not likely to change over time should have braille provided. In this case, while braille is present for the room number, braille is lacking below the room name designation text.)	1	232	\$232

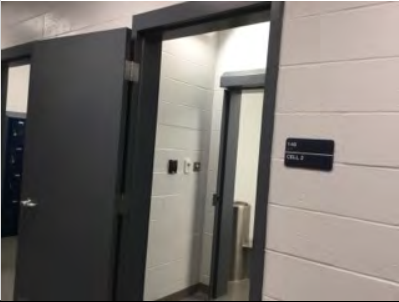
ID	Location	Floor	Room	Element	Type	Photo	Issues	Current Measure	Recommendations	Quantity	Price	Cost Estimation
20	Cell 2	1		Signage	Designation

Braille not provided on sign	-	Provide braille on sign below text. (Signs for interior rooms or spaces where the sign is not likely to change over time should have braille provided. In this case, while braille is present for the room number, braille is lacking below the room name designation text.)	1	232	\$232
21	Cell 1	1		Signage	Designation

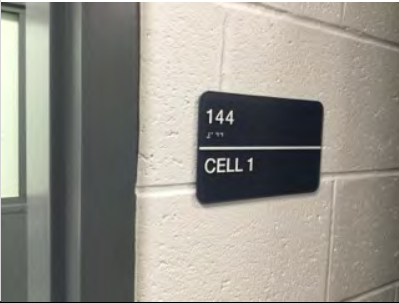
Braille not provided on sign	-	Provide braille on sign below text. (Signs for interior rooms or spaces where the sign is not likely to change over time should have braille provided. In this case, while braille is present for the room number, braille is lacking below the room name designation text.)	1	232	\$232
Service Counter												
22	Booking	1		Service Counter	N/A

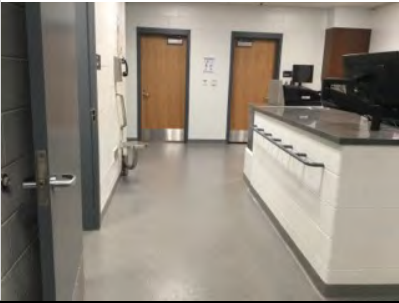
Counter > 36" high	41.5"	If the counter is used by individuals who are being processed in the intake or booking area, provide a counter that is 36" max. above the ground or finished floor.	1	880	\$880

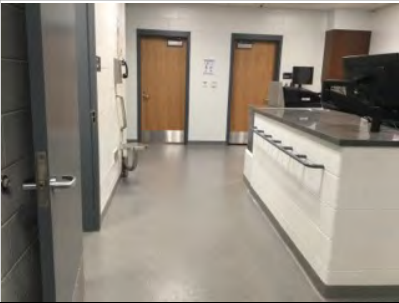
Reach < 15" or > 48"(forward/side approach)	56"	If the phone receiver is removed and returned from its cradle or dialed by individuals who are being processed in the intake or booking area, relocate phone so that controls are between 15" - 48" above the finished floor.	1	Labor	\$0
Assembly Area												
24	Training Room	1	152	Assembly Area	N/A

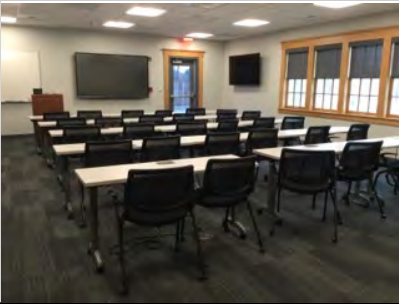
A television and a podium are provided in the training room, however there is no evidence of an assistive listening system. If audible communication is integral to the use of the space, such as with a microphone system connected to speakers, an assistive listening system must be provided. A sign with the International Symbol of Access for Hearing Loss must also be provided. Assistive listening equipment must be kept charged or otherwise maintained in operable working condition so it is available when needed.

Assistive listening devices not provided	-	If audible communication is integral to the use of the space, provide an assistive listening system.	1	1214	\$1214

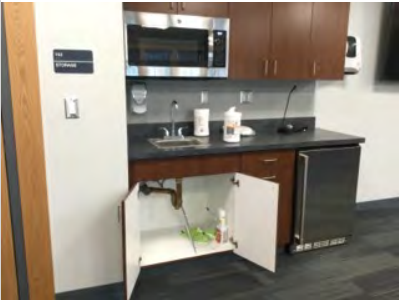
ID	Location	Floor	Room	Element	Type	Photo	Issues	Current Measure	Recommendations	Quantity	Price	Cost Estimation
Kitchens and Kitchenettes												
25	Training Room	1		Kitchens and Kitchenettes	N/A

Microwave controls > 48"	- 62"	Relocate microwave so that controls are between 15"- 48" above the finished floor or provide a second microwave with controls between 15"- 48" above the finished floor.	1	256	\$256
Toilet & Bathing Rooms												
Single-User Toilet												
26	Toilet Room 1	1		Single-User Toilet	N/A

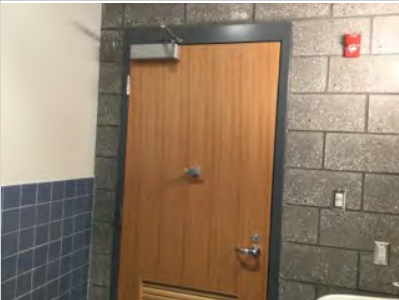
Hook located > 48" high	54.75"	Locate hook no higher than 48" above the finished floor.	1	150	\$150
27	Toilet Room 2	1		Single-User Toilet	N/A

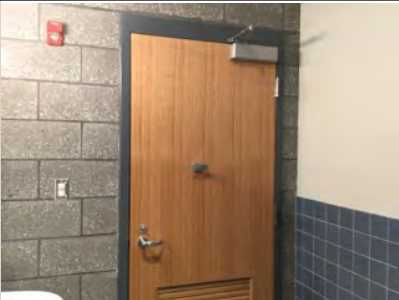
Hook located > 48" high	55"	Locate hook no higher than 48" above the finished floor.	1	150	\$150
Additional Access												
Sink												
28	Training Room	1	152	Sink	N/A

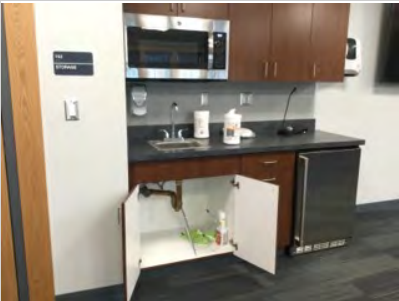
Toe and knee clearances not provided Rim or counter > 34" Exposed plumbing underneath sink	- 36.5 -	Ensure there is a 27" knee clearance positioned for a forward approach (521 CMR sections 12 - Education facilities / training facilities - and section 32). Relocate sink with the front of the rim or counter no higher than 34". Insulate or otherwise configure pipes at sink.	1	4872	\$4872

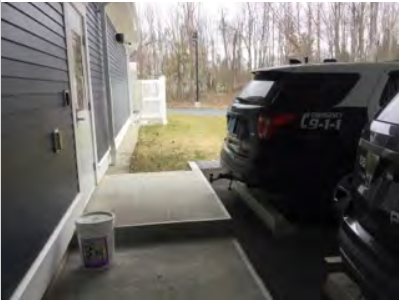
ID	Location	Floor	Room	Element	Type	Photo	Issues	Current Measure	Recommendations	Quantity	Price	Cost Estimation
Door Landing												
29	Squad Room Exit	Ext.		Door Landing	N/A

Recommend providing an accessible route from the egress door landing.	1	-	\$0
Podium												
30	Training Room	1	152	Podium	N/A

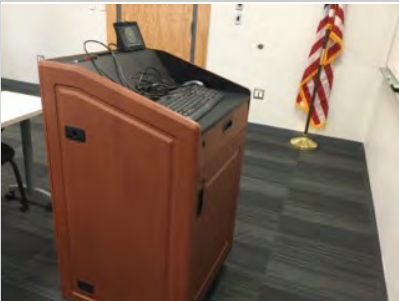
Recommend providing an adjustable height podium with toe and knee clearance in the meeting room.	1	-	\$0
Toilet Lavatory Combo												
31	Accessible Holding Cell	1		Toilet Lavatory Combo	N/A

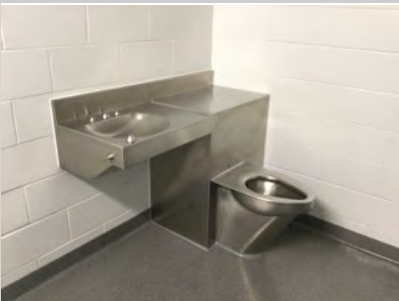
Recommend providing one ligature-resistant grab bar on the side wall of the water closet and one on the rear wall.	1	-	\$0

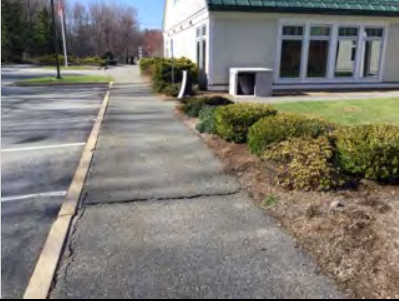
ID	Location	Floor	Room	Element	Type	Photo	Issues	Current Measure	Recommendations	Quantity	Price	Cost Estimation
Approach and Entrance												
Exterior Access Route												
1	Walkway by Library	Ext.		Exterior Access Route	Walkway

Surface openings > 1/2"	2"	Provide asphalt patch at surface opening.	1	160	\$160
2	Walkway by Library	Ext.		Exterior Access Route	Walkway

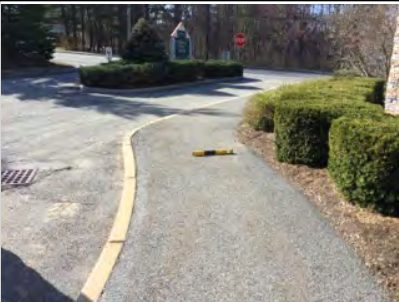
Cross slope > 1:50 (2.00%)	5.1%	Reduce cross slope to be no steeper than 1:50 (2.00%). (Cost based on asphalt to reduce cross slope.)	1	240	\$240
3	Walkway by Meeting Room Entrance	1		Exterior Access Route	Walkway

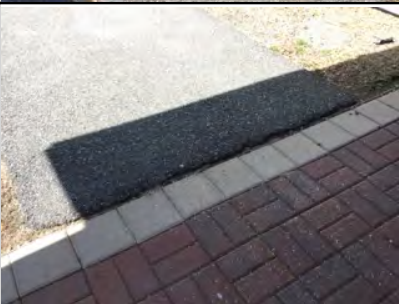
Level changes > 1/4"	1.5"	Alter change in level to be 1/4" high max. (Cost based on an asphalt patch.)	1	160	\$160
Off-Street Parking Lot or Garage												
4	Accessible Parking Near Main Entrance	Ext.		Off-Street Parking Lot or Garage	N/A

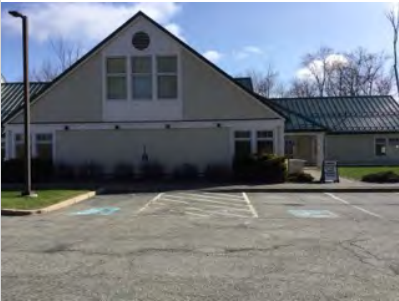
Sign does not have the designation "Van Accessible"	-	Add the designation "Van Accessible" to the sign located at the van accessible space.	1	500	\$500

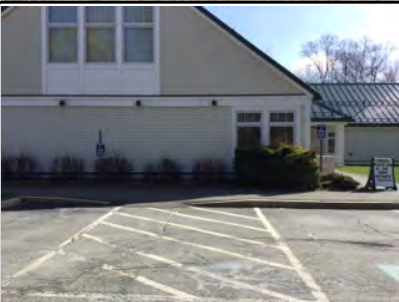
5	Accessible Parking Near Main Entrance	Ext.		Off-Street Parking Lot or Garage	N/A

Sign bottom < 60" above finished grade	31"	Locate sign with the bottom of the sign 60" min. and the tope of the sign 96" max. above the ground.	1	Labor	\$0

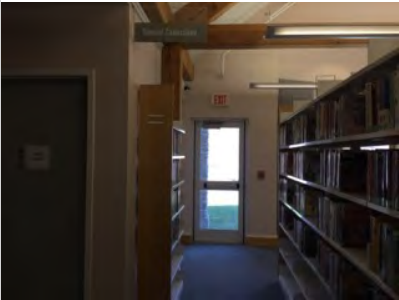
ID	Location	Floor	Room	Element	Type	Photo	Issues	Current Measure	Recommendations	Quantity	Price	Cost Estimation
Emergency Exit												
6	Emergency Exit by Staff Restroom	1		Emergency Exit	N/A

Tactile sign not provided at exit Directional sign to accessible emergency exit not provided	- -	Provide tactile exit signs with raised characters and braille at exit doors. Mount signs between 48"- 60" above the finished floor located on the latch side of the door. Provide a directional sign indicating the location of the nearest accessible emergency exit.	1	232	\$232
7	Emergency Exit	1		Emergency Exit	N/A

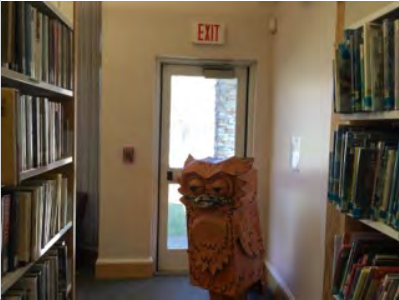
Tactile sign not provided at exit Directional sign to accessible emergency exit not provided	- -	Provide tactile exit signs with raised characters and braille at exit doors. Mount signs between 48"- 60" above the finished floor located on the latch side of the door. Provide a directional sign indicating the location of the nearest accessible emergency exit.	1	232	\$232

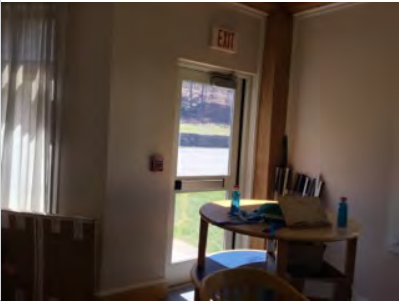
8	Emergency Exit in Reading Room	1		Emergency Exit	N/A

Tactile sign not provided at exit Directional sign to accessible emergency exit not provided	-	Provide tactile exit signs with raised characters and braille at exit doors. Mount signs between 48"- 60" above the finished floor located on the latch side of the door. Provide a directional sign indicating the location of the nearest accessible emergency exit.	1	232	\$232
9	Emergency Exit in Reading Room	1		Emergency Exit	N/A

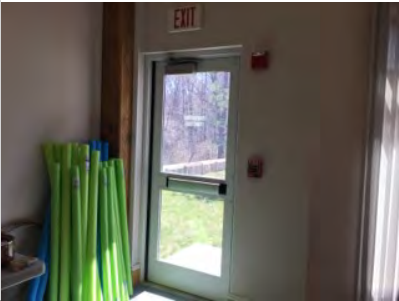
Tactile sign not provided at exit Directional sign to accessible emergency exit not provided	-	Provide tactile exit signs with raised characters and braille at exit doors. Mount signs between 48"- 60" above the finished floor located on the latch side of the door. Provide a directional sign indicating the location of the nearest accessible emergency exit.	1	232	\$232
10	Exit to Parking Lot	1		Emergency Exit	N/A

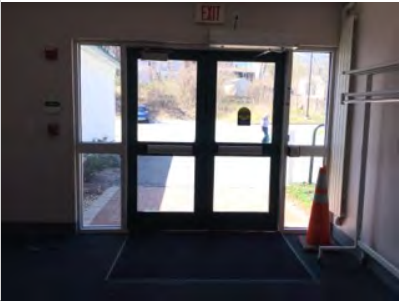
Tactile sign not provided at exit Illuminated Int. Symbol of Acc. not provided (MAAB)	- -	Provide tactile exit signs with raised characters and braille at exit doors. Mount signs between 48"- 60" above the finished floor located on the latch side of the door. If the exit sign is replaced with an illuminated exit sign, provide an illuminated International Symbol of Accessibility (ISA).	1	232	\$232

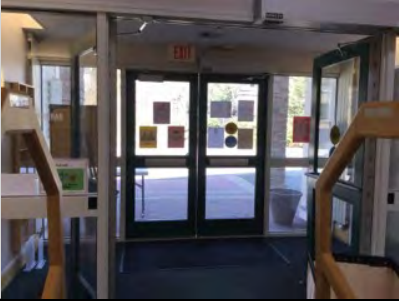
ID	Location	Floor	Room	Element	Type	Photo	Issues	Current Measure	Recommendations	Quantity	Price	Cost Estimation
Means of Egress												
11	Main Exit/Entrance	1		Means of Egress	N/A

Tactile exit sign not provided	-	Ensure tactile exit signs with raised characters and braille are provided at exit doors. Mount signs between 48"- 60" above the finished floor located on the latch side of the door.	1	232	\$232
12	Exit by Children's Area	1		Means of Egress	N/A

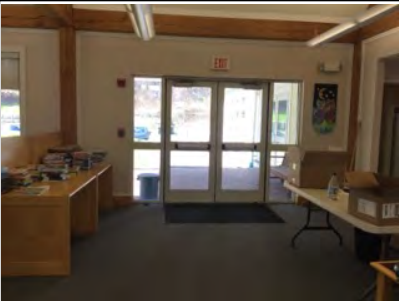
Tactile exit sign not provided Illuminated ISA symbol not provided (MAAB)	- -	Ensure tactile exit signs with raised characters and braille are provided at exit doors. Mount signs between 48"- 60" above the finished floor located on the latch side of the door. If the exit sign is replaced with an illuminated exit sign, provide an illuminated International Symbol of Accessibility (ISA).	1	232	\$232
13	Exit/Entrance	1		Means of Egress	N/A

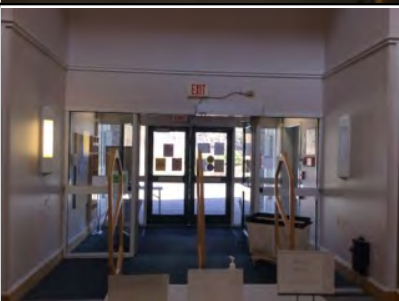
Illuminated ISA symbol not provided (MAAB)	-	If the exit sign is replaced with an illuminated exit sign, provide an illuminated International Symbol of Accessibility (ISA).	1	-	\$0

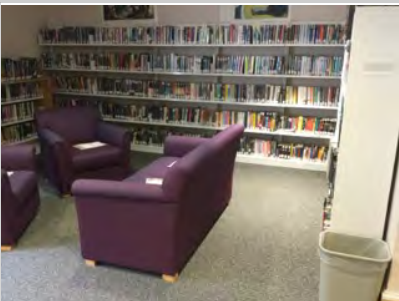
Interior Access Route												
14	Library Interior	1		Interior Access Route	N/A

Route < 36" wide	31"	Ensure that a clear width of 36" min. is maintained at the accessible route.	1	Labor	\$0
Doors, Doorways, & Gates												
15	Study Room	1		Doors, Doorways, & Gates	Other

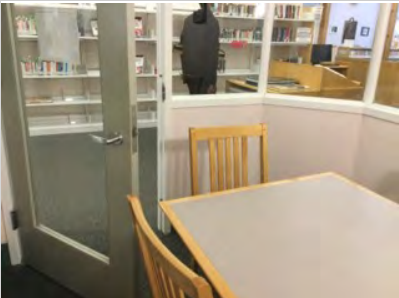
Maneuvering clearance(s) not provided	-	Arrange furniture in at least one study room to provide 18" min. pull-side maneuvering clearance at the exit door from the study room.	1	Labor	\$0

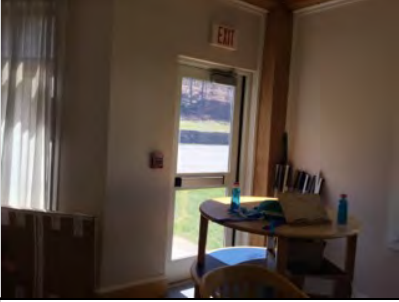
ID	Location	Floor	Room	Element	Type	Photo	Issues	Current Measure	Recommendations	Quantity	Price	Cost Estimation
16	Emergency Exit in Reading Room	1		Doors, Doorways, & Gates	Emergency Egress

Maneuvering clearance(s) not provided	-	Remove the table and stored items to provide maneuvering clearance at the egress door.	1	Labor	\$0
17	Main Exit/Entrance	1		Doors, Doorways, & Gates	Emergency Egress

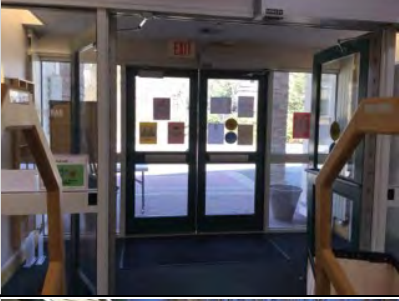
Mat not securely attached	-	Secure the mat.	1	Labor	\$0
18	Emergency Exit by Reading Room	1		Doors, Doorways, & Gates	Emergency Egress

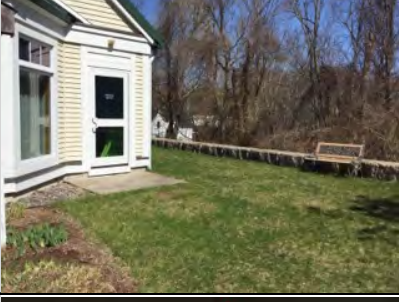
Threshold > 1/2" high	7"	Alter the threshold to be 1/2" high max.	1	150	\$150
19	Toilet Rooms to Meeting Room	1		Doors, Doorways, & Gates	Circulation

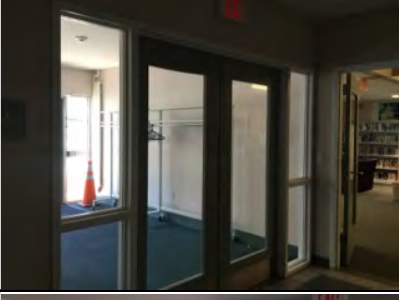
Door requires > 5 lbs. of force to open	12 Lbs.	Adjust closers so doors do not require more than 5 pounds of force to open.	1	Labor	\$0
20	Meeting Room to Kitchen	1		Doors, Doorways, & Gates	Circulation

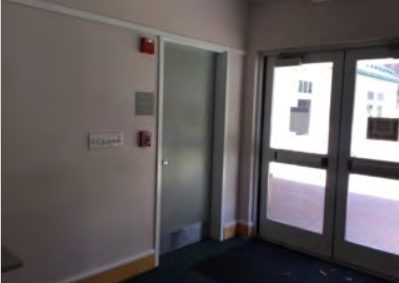
Door requires > 5 lbs. of force to open	17 Lbs.	Adjust closers so doors do not require more than 5 pounds of force to open.	1	Labor	\$0

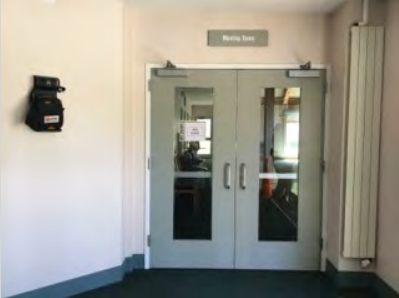
ID	Location	Floor	Room	Element	Type	Photo	Issues	Current Measure	Recommendations	Quantity	Price	Cost Estimation
Signage												
21	Entrance/Exit to Meeting Room	1		Signage	Designation

Raised characters not provided on sign Raised characters < 48" or > 60" above ground Braille not provided on sign Sign not located on the latch side of the door	- - - -	Provide text with raised characters duplicated in braille on sign. Mount signs so that the baseline of the lowest tactile character is 48" min. above finished floor and the baseline of the highest tactile character is 60" max. above the finished floor. Locate sign at permanent rooms alongside the door on the latch side.	1	232	\$232
22	Study Room	1		Signage	Designation

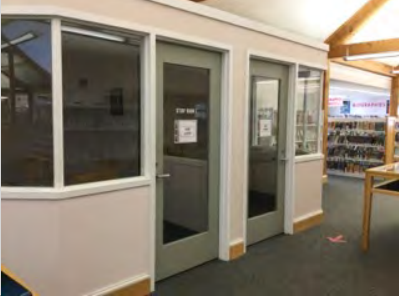
Sign not located on the latch side of the door	-	Locate sign at permanent rooms alongside the door on the latch side.	1	Labor	\$0
Service Counter												
23	Circulation	1		Service Counter	N/A

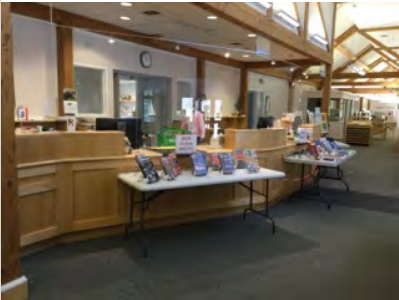
Counter not connected to an accessible route	-	Ensure the accessible counter is connected to an accessible route. (Relocate table.)	1	Labor	\$0

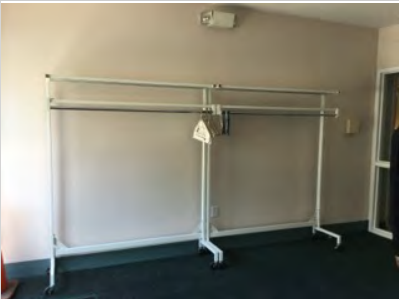
Operable Parts												
24	Clothes Rod Between Meeting Room and Toilet Rooms	1		Operable Parts	Clothes Rod/Hooks

Side reach > 54"	61.75"	Provide a clothes rod between 15" - 48" above the finished floor.	1	256	\$256
25	Book Exchange by Main Entrance	Ext.		Operable Parts	Other

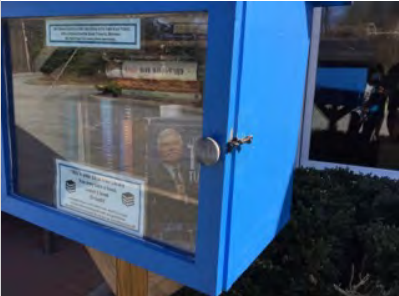
Not operable with a closed fist	-	Provide hardware that can be operable with one hand and not require tight grasping, pinching, or twisting of the wrist.	1	200	\$200

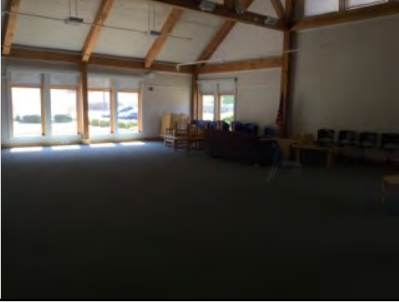
ID	Location	Floor	Room	Element	Type	Photo	Issues	Current Measure	Recommendations	Quantity	Price	Cost Estimation
Assembly Area												
26	Meeting Room	1		Assembly Area	N/A

Assistive listening devices not provided	-	If audible communication is integral to the use of the space, provide an assistive listening system.	1	1214	\$1214
Exterior Benches												
27	Main Entrance	Ext.		Exterior Benches	N/A

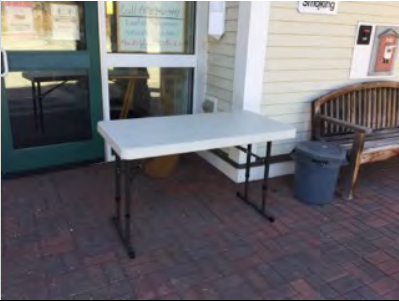
No accessible route to one bench in area		Relocate table and trash container so there is clear floor space alongside the bench.	1	Labor	\$0
28	Exterior Near Children's Area	1		Exterior Benches	N/A

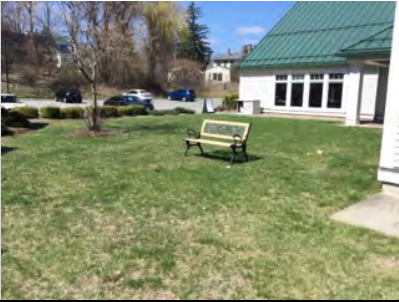
No accessible route to one bench in area	-	Relocate benches on an accessible route or provide an accessible route to 20% of benches (no less than 1) in this area. (Cost based on a 4' wide min. x 15' long stone dust route to bench.)	1	480	\$480
29	Emergency Exit by Reading Room	1		Exterior Benches	N/A

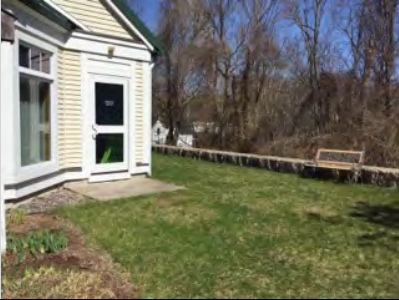
No accessible route to one bench in area	-	Relocate benches on an accessible route or provide an accessible route to 20% of benches (no less than 1) in this area. (Cost based on a 4' wide min. x 15' long stone dust route to bench.)	1	480	\$480

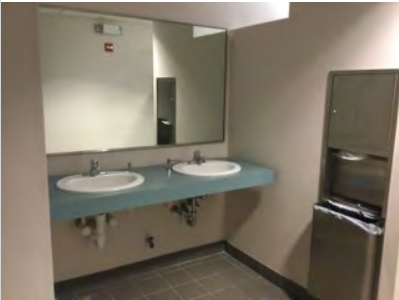
ID	Location	Floor	Room	Element	Type	Photo	Issues	Current Measure	Recommendations	Quantity	Price	Cost Estimation
Lavatory												
30	Men's Toilet Room	1		Lavatory	N/A

Toe or knee clearances not provided	24"	Provide at least one lavatory with knee and toe clearance positioned for a forward approach.	1	1686	\$1686
Toilet Compartment												
31	Women's Toilet Room	1		Toilet Compartment	Accessible Compartment

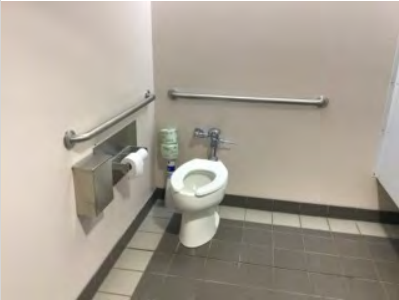
Centerline < or > 18" (MAAB)	20"	Relocate toilet so the centerline is 18" from the side wall.	1	2828	\$2828
Dispensers												
32	Women's Toilet Room	1		Dispensers	Tampon Dispenser

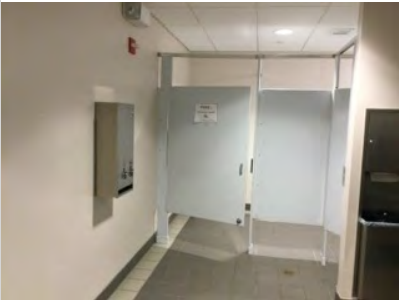
Dispenser acts as a protruding object	7"	Provide a cane-detectible barrier 27" max. above the ground below the dispenser.	1	306	\$306
Additional Access												
Sink												
33	Kitchen	1		Sink	Kitchenette

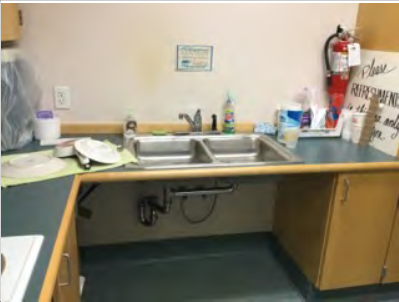
Exposed plumbing underneath sink	-	Insulate or otherwise configure pipes at sink.	1	92	\$92

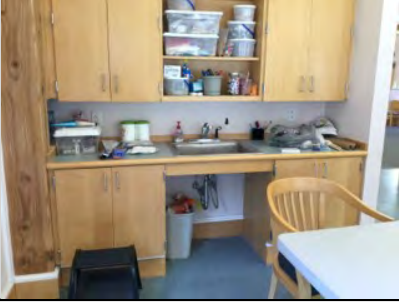
ID	Location	Floor	Room	Element	Type	Photo	Issues	Current Measure	Recommendations	Quantity	Price	Cost Estimation
Sinks for Children's Use												
34	Children's Area	1		Sinks for Children's Use	Other

Exposed plumbing underneath	-	Insulate or otherwise configure pipes to prevent contact, for at least one sink.	1	92	\$92
Best Practice												
Podium												
35	Podium in Meeting Room	1		Podium	N/A

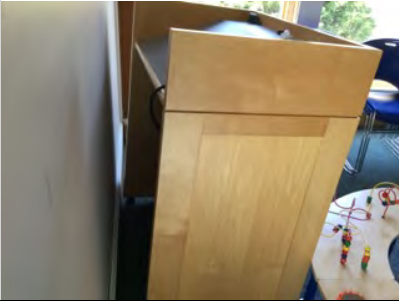
Recommend providing an adjustable height podium with 27" min. knee and toe clearance.	1	-	\$0

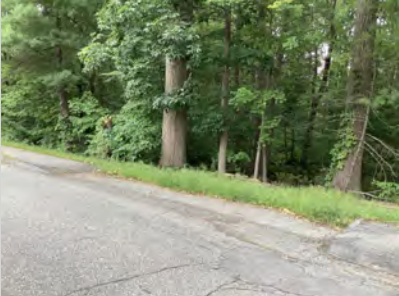
ID	Location	Floor	Room	Element	Type	Photo	Issues	Current Measure	Recommendations	Quantity	Price	Cost Estimation
Pedestrian Access Routes												
Walking Surface												
1	Winter Street Opposite House 30	Ext.		Walking Surface	N/A

Accessible route not provided	-	Recommend an accessible route is provided between sections of terminated walkway.	1	-	\$0
2	Winter Street and Town Forest Road	Ext.		Walking Surface	Sidewalk

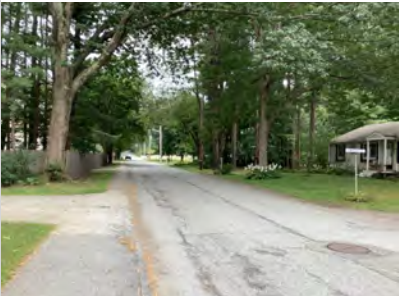
Accessible route not provided	-	Consider an accessible route where sidewalk terminates at street shoulder of 5' min. width is provided along the street.	1	-	\$0
3	Winter Street House 7	Ext.		Walking Surface	Sidewalk

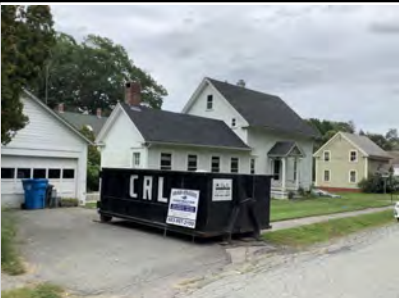
Accessible route not provided	-	Relocate trash container away from the accessible route.	1	-	\$0
4	Winter Street House 22	Ext.		Walking Surface	Underpass
