Town of Merrimac, Massachusetts

PART A – Executive Summary

September 2021

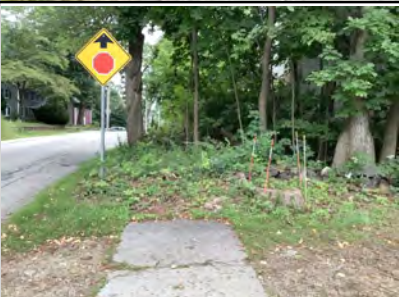
Accessible route not provided	-	Recommend an accessible route to a curb ramp, 60" min. x 60" min. turning space, or signage at accessible route to street indicating the sidewalk terminates.	1	-	\$0

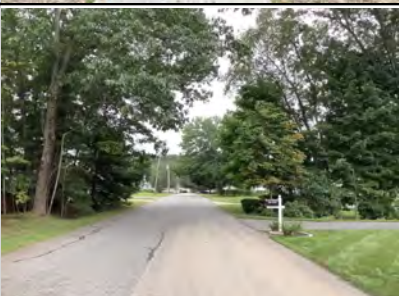
5	Abbott Street	Ext.		Walking Surface	Sidewalk

Accessible route not provided	-	Consider an accessible route of 5' min. width is provided along the street.	1	-	\$0

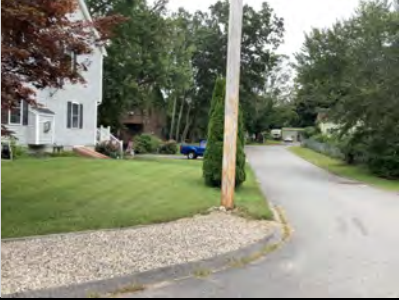
ID	Location	Floor	Room	Element	Type	Photo	Issues	Current Measure	Recommendations	Quantity	Price	Cost Estimation
6	Intersection Sawyer Street and Maple Street	Ext.		Walking Surface	N/A

Accessible route not provided	-	Consider an accessible route of 5' min. width is provided along the street.	1	-	\$0
7	Sawyer Inner Street	Ext.		Walking Surface	N/A

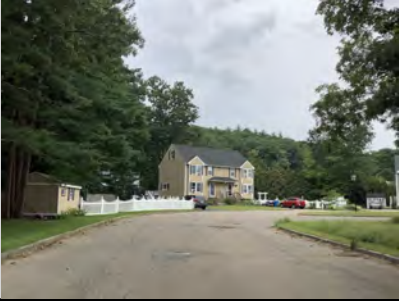
Accessible route not provided	-	Consider an accessible route of 5' min. width is provided along the street.	1	-	\$0
8	Intersection Pine Street and Summer Street	Ext.		Walking Surface	N/A

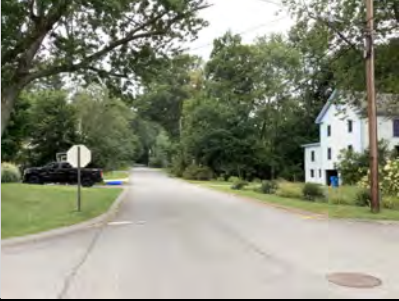
Accessible route not provided	-	Consider an accessible route of 5' min. width is provided along the street.	1	-	\$0
9	Intersection Maple Street and Spring Street	Ext.		Walking Surface	Sidewalk

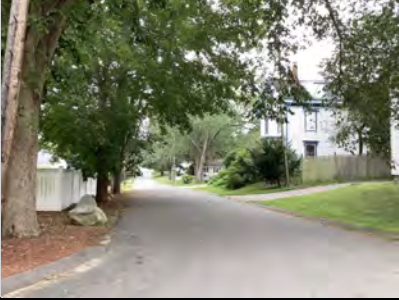
Accessible route not provided	-	Consider an accessible route of 5' min. width is provided along the street.	1	-	\$0
10	Prospect Street House 18	Ext.		Walking Surface	Sidewalk

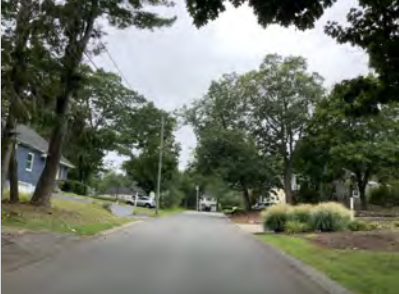
Accessible route not provided	-	Consider an accessible route of 5' min. width is provided along the street.	1	-	\$0

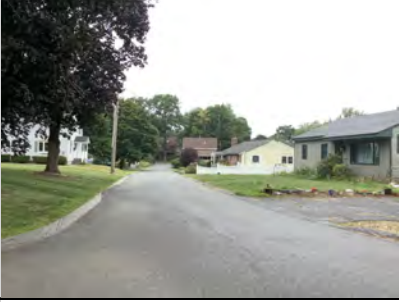
ID	Location	Floor	Room	Element	Type	Photo	Issues	Current Measure	Recommendations	Quantity	Price	Cost Estimation
11	Intersection Prospect Street and Spring Street	Ext.		Walking Surface	Sidewalk

Accessible route not provided	-	Consider an accessible route of 5' min. width is provided along the street.	1	-	\$0
12	Judkins Street	Ext.		Walking Surface	Sidewalk

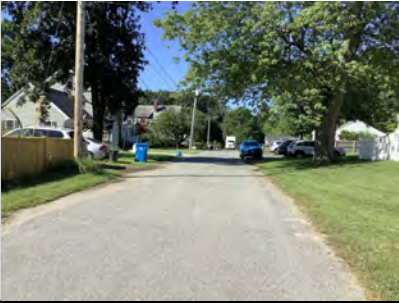
Accessible route not provided	-	Consider an accessible route of 5' min. width is provided along the street.	1	-	\$0
13	Prospect Street House 6	Ext.		Walking Surface	Sidewalk

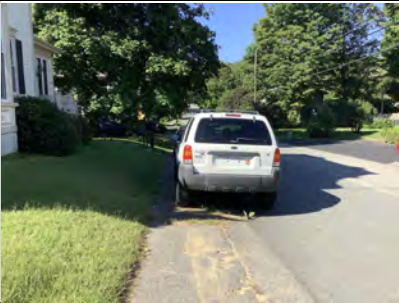
Accessible route not provided	-	Consider an accessible route of 5' min. width is provided along the street.	1	-	\$0
14	Liberty Street House 9	Ext.		Walking Surface	N/A

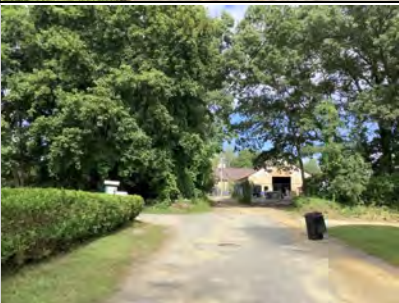
Accessible route not provided	-	Consider an accessible route of 5' min. width is provided along the street.	1	-	\$0
15	Railroad Avenue	Ext.		Walking Surface	N/A

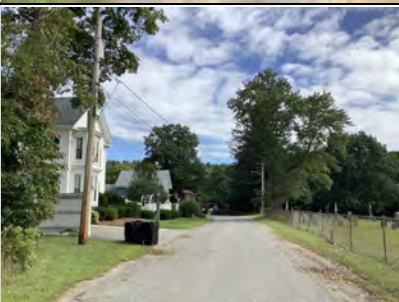
Accessible route not provided	-	Consider an accessible route of 5' min. width is provided along the street.	1	-	\$0

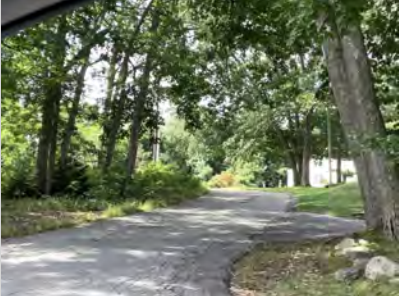
ID	Location	Floor	Room	Element	Type	Photo	Issues	Current Measure	Recommendations	Quantity	Price	Cost Estimation
16	Lincoln Street	Ext.		Walking Surface	N/A

Accessible route not provided	-	Consider an accessible route of 5' min. width is provided along the street.	1	-	\$0
17	Lincoln Street	Ext.		Walking Surface	N/A

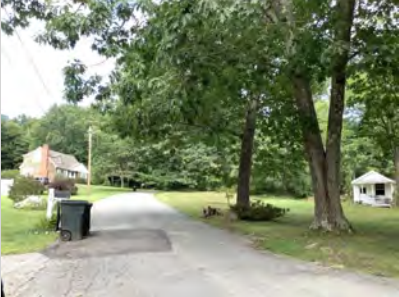
Accessible route not provided	-	Consider an accessible route of 5' min. width is provided along the street.	1	-	\$0
18	Town Forest Road	Ext.		Walking Surface	N/A

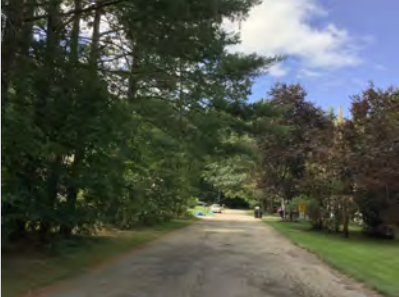
Accessible route not provided	-	Consider an accessible route of 5' min. width is provided along the street.	1	-	\$0
19	Central Street	Ext.		Walking Surface	N/A

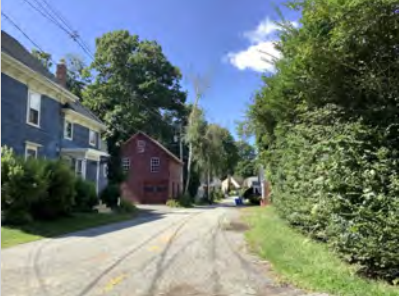
Accessible route not provided	-	Consider an accessible route of 5' min. width is provided along the street.	1	-	\$0
20	Central Street Inner Street	Ext.		Walking Surface	N/A

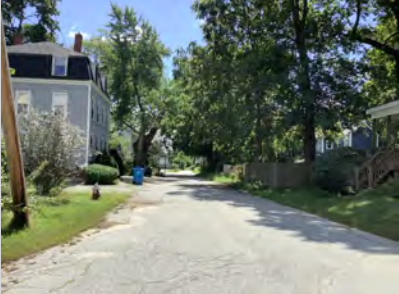
Accessible route not provided	-	Consider an accessible route of 5' min. width is provided along the street.	1	-	\$0

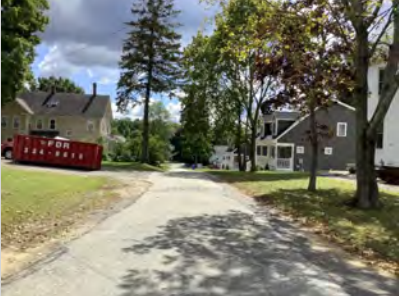
Accessible route not provided	-	Consider an accessible route of 5' min. width is provided along the street.	1	-	\$0
22	Middle Street Residential Inner Road	Ext.		Walking Surface	N/A

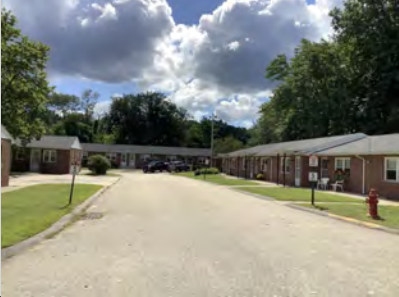
Accessible route not provided	-	Consider an accessible route of 5' min. width is provided along the street.	1	-	\$0
23	Walnut Street	Ext.		Walking Surface	Sidewalk

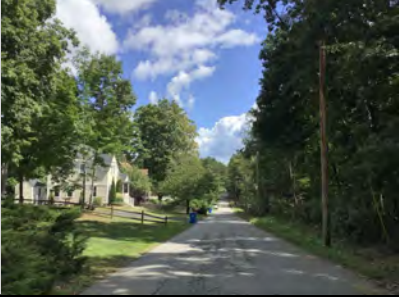
Accessible route not provided	-	Consider an accessible route of 5' min. width is provided along the street.	1	-	\$0
24	School Street Short's Express	Ext.		Walking Surface	N/A

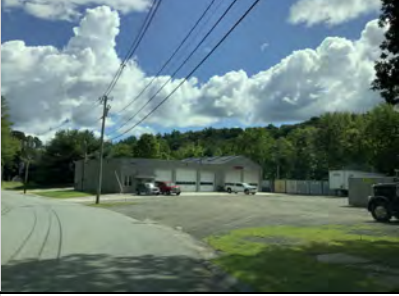
Accessible route not provided	-	Consider an accessible route of 5' min. width is provided along the street.	1	-	\$0
25	Intersection Mill Street and School Street	Ext.		Walking Surface	Sidewalk

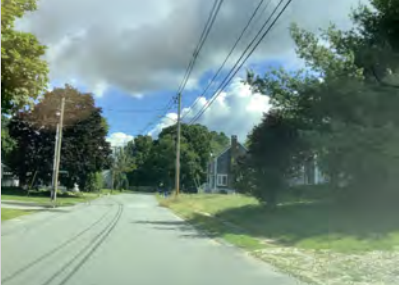
Accessible route not provided	-	Consider an accessible route of 5' min. width is provided along the street.	1	-	\$0

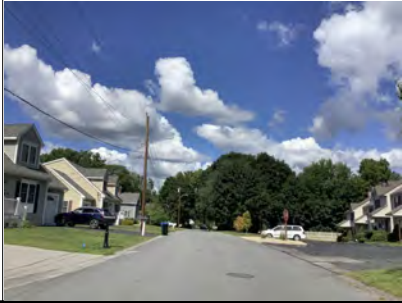
Accessible route not provided	-	Consider an accessible route of 5' min. width is provided along the street.	1	-	\$0
28	Bartlett Street	Ext.		Walking Surface	N/A

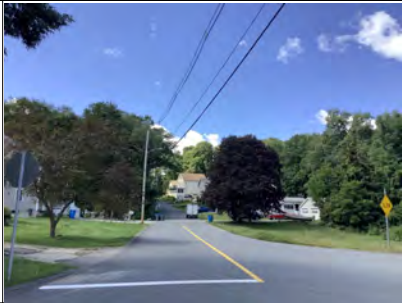
Accessible route not provided	-	Consider an accessible route of 5' min. width is provided along the street.	1	-	\$0
29	Locut Street Field Side	Ext.		Walking Surface	N/A

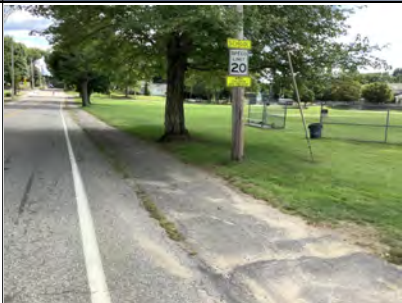
Accessible route not provided	-	Consider an accessible route of 5' min. width is provided along the street.	1	-	\$0
30	Fairfield Ave	Ext.		Walking Surface	N/A

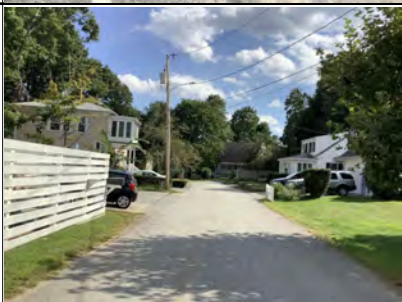
Accessible route not provided	-	Consider an accessible route of 5' min. width is provided along the street.	1	-	\$0

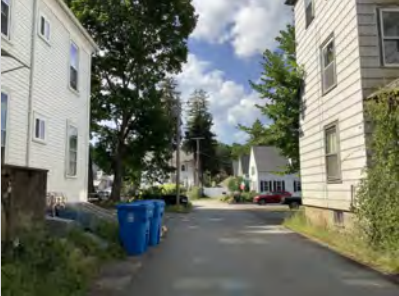
Accessible route not provided	-	Consider an accessible route of 5' min. width is provided along the street.	1	-	\$0
32	Union Street Ext.	Ext.		Walking Surface	Sidewalk

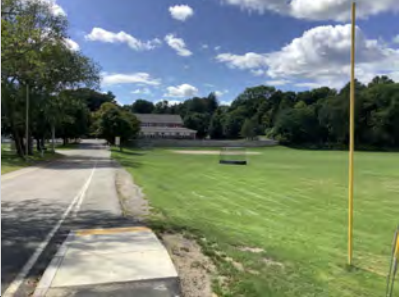
Accessible route not provided Route < 36" wide	- -	Ensure an accessible route is provided. Ensure that a clear width of 36" min. is maintained at the accessible route.	1		\$0
33	School Street Opposite House 45	Ext.		Walking Surface	Sidewalk

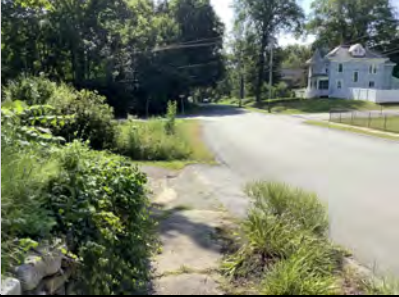
Accessible route not provided Route < 36" wide	- -	Ensure an accessible route is provided. Ensure that a clear width of 36" min. is maintained at the accessible route.	1		\$0
34	Winter Street House 21	Ext.		Walking Surface	Sidewalk

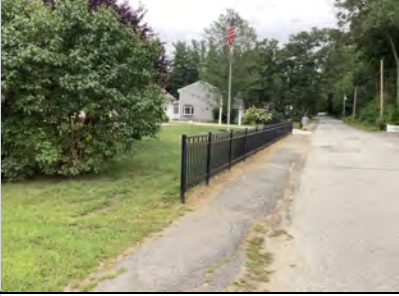
Accessible route not provided Route < 36" wide Route not maintained in operable working condition	- - -	Ensure an accessible route is provided. Ensure that a clear width of 36" min. is maintained at the accessible route. Ensure route is maintained in operable working condition.	1		\$0

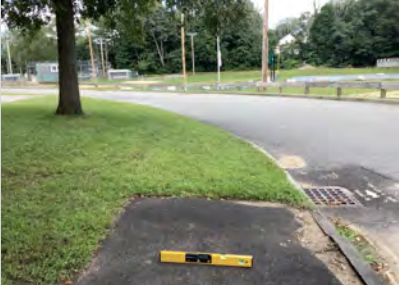
35	Helen R. Donaghue School	Ext.		Walking Surface	Sidewalk

Accessible route not provided Cross slope > 1:50 (2.00%)	- 4.6%	Recommend an accessible route to a curb ramp, 60" min. x 60" min. turning space, or signage at accessible route to street indicating the sidewalk terminates. Reduce cross slope to be no steeper than 1:50 (2.00%).	1	-	\$0

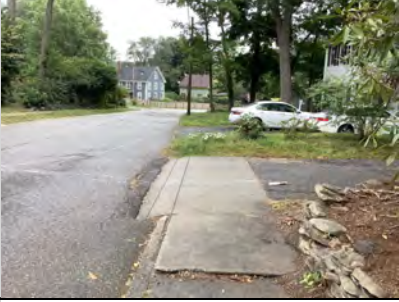
Accessible route not provided Level changes without bevels > 1/4"	- 2"	Ensure an accessible route of 5' min. width is provided along the street. Alter change in level to be 1/4" high max.	1	-	\$0
37	Intersection Woodland Street and Lincoln Street	Ext.		Walking Surface	Sidewalk

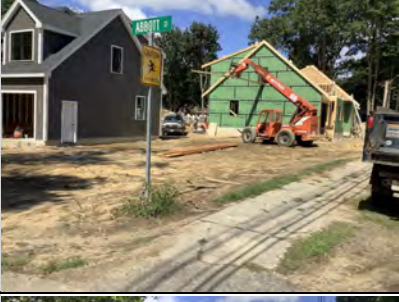
39	Intersection Abbott Street and Church Street	Ext.		Walking Surface	N/A

Accessible route not provided Route not maintained in operable working condition	- -	Ensure an accessible route is provided. Ensure route is maintained in operable working condition.	1		\$0
40	School Street Short's Express	Ext.		Walking Surface	N/A

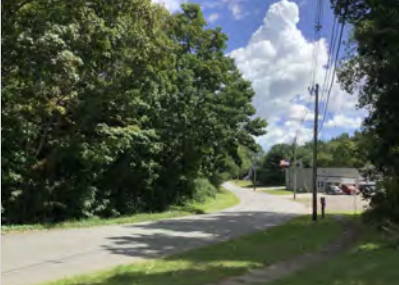
Accessible route not provided Route not maintained in operable working condition	- -	Ensure an accessible route is provided. Ensure route is maintained in operable working condition.	1		\$0

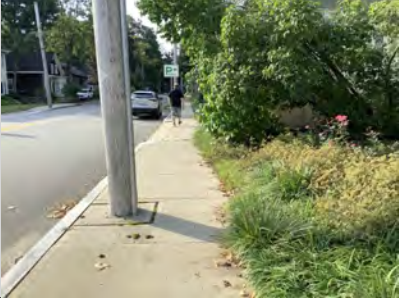
Route < 36" wide	32"	Ensure that a clear width of 36" min. is maintained at the accessible route.	1	-	\$0
42	School Street House 3	Ext.		Walking Surface	Sidewalk

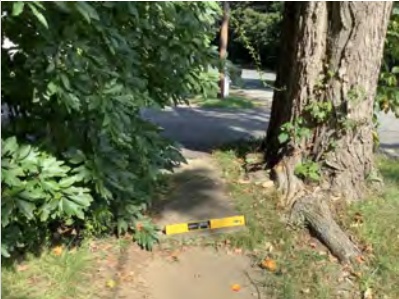
Route < 36" wide Cross slope > 1:50 (2.00%) Level changes without bevels > 1/4" Route not maintained in operable working condition	25" 11.4% 4" -	Ensure that a clear width of 36" min. is maintained at the accessible route. Reduce cross slope to be no steeper than 1:50 (2.00%). Alter change in level to be 1/4" high max. Ensure an accessible route of 4' min. (recommend 5' min.) width is provided. If the accessible route is less than 5' wide, ensure passing spaces of 60" min. by 60" min. at intervals of 200 feet max. are provided.	1	-	\$0
43	School Street House 48	Ext.		Walking Surface	Sidewalk

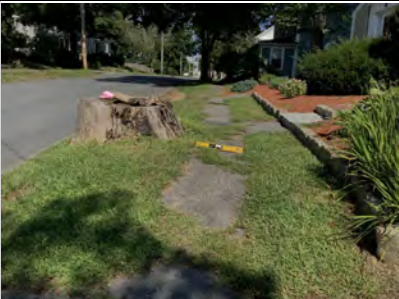
Route < 36" wide Cross slope > 1:50 (2.00%) Surface not stable, firm and slip-resistant Route not maintained in operable working condition	25" 8.1% - -	Reduce cross slope to be no steeper than 1:50 (2.00%). Repair surface. Ensure an accessible route of 4' min. (recommend 5' min.) width is provided. If the accessible route is less than 5' wide, ensure passing spaces of 60" min. by 60" min. at intervals of 200 feet max. are provided.	1	-	\$0

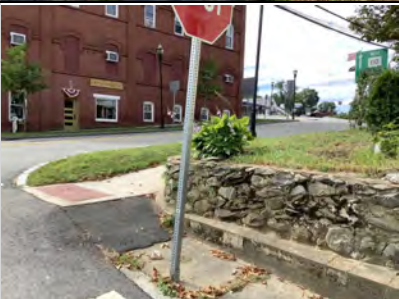
44	Intersection With Liberty Street	Ext.		Walking Surface	Sidewalk

Route < 36" wide Cross slope > 1:50 (2.00%) Route not maintained in operable working condition	30" 3.3% -	Reduce cross slope to be no steeper than 1:50 (2.00%). Ensure an accessible route of 4' min. (recommend 5' min.) width is provided. If the accessible route is less than 5' wide, ensure passing spaces of 60" min. by 60" min. at intervals of 200 feet max. are provided.	1	-	\$0
45	School Street Opposite House 45	Ext.		Walking Surface	Sidewalk

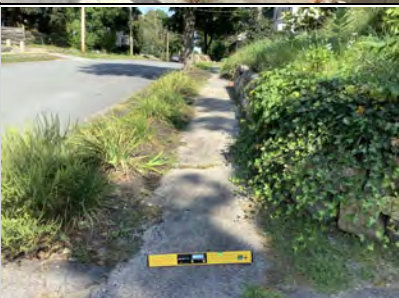
Route < 36" wide Cross slope > 1:50 (2.00%) Route not maintained in operable working condition	29" 9.3% -	Reduce cross slope to be no steeper than 1:50 (2.00%). Ensure an accessible route of 4' min. (recommend 5' min.) width is provided. If the accessible route is less than 5' wide, ensure passing spaces of 60" min. by 60" min. at intervals of 200 feet max. are provided.	1	-	\$0

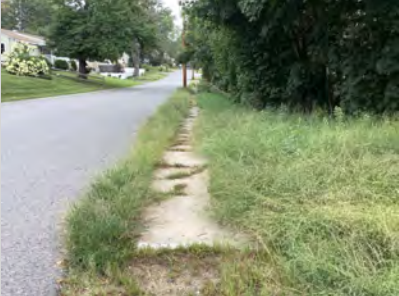
Route < 36" wide Route not maintained in operable working condition	24" -	Ensure an accessible route of 4' min. (recommend 5' min.) width is provided. If the accessible route is less than 5' wide, ensure passing spaces of 60" min. by 60" min. at intervals of 200 feet max. are provided.	1	-	\$0
47	Vendome Street	Ext.		Walking Surface	Sidewalk

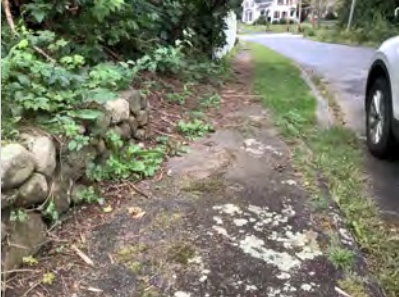
Route < 36" wide Route not maintained in operable working condition	24" -	Ensure an accessible route of 4' min. (recommend 5' min.) width is provided. If the accessible route is less than 5' wide, ensure passing spaces of 60" min. by 60" min. at intervals of 200 feet max. are provided.	1	-	\$0
48	Liberty Street at Enduring Wood Products	Ext.		Walking Surface	Sidewalk

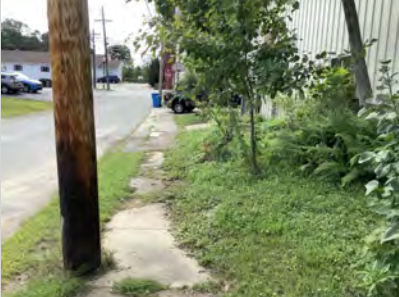
Route < 36" wide Route not maintained in operable working condition	30" -	Ensure an accessible route of 4' min. (recommend 5' min.) width is provided. If the accessible route is less than 5' wide, ensure passing spaces of 60" min. by 60" min. at intervals of 200 feet max. are provided.	1	-	\$0

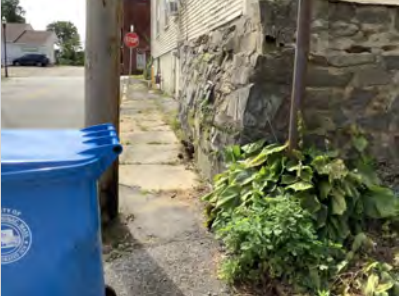
49	Liberty Street at Enduring Wood Products	Ext.		Walking Surface	Sidewalk

Route < 36" wide Route not maintained in operable working condition	30" -	Ensure an accessible route of 4' min. (recommend 5' min.) width is provided. If the accessible route is less than 5' wide, ensure passing spaces of 60" min. by 60" min. at intervals of 200 feet max. are provided.	1	-	\$0
50	Willowdale Drive	Ext.		Walking Surface	Sidewalk

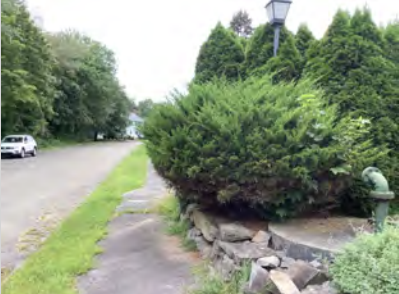
Obstructed by protruding objects Level changes without bevels > 1/4" Does not prevent accumulation of water Route not maintained in operable working condition	- 2" - -	Trim low hanging branches in trees. Alter change in level to be 1/4" high max. Repair surface. Ensure an accessible route of 4' min. (recommend 5' min.) width is provided. If the accessible route is less than 5' wide, ensure passing spaces of 60" min. by 60" min. at intervals of 200 feet max. are provided.	1	-	\$0

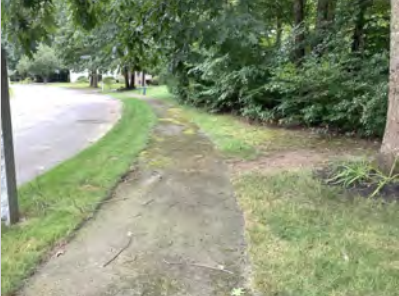
Vertical clearance < 80" above ground Surface not stable, firm and slip-resistant Route not maintained in operable working condition	60" - -	Trim low hanging tree branches. Repair surface. Ensure an accessible route of 4' min. (recommend 5' min.) width is provided. If the accessible route is less than 5' wide, ensure passing spaces of 60" min. by 60" min. at intervals of 200 feet max. are provided.	1	-	\$0
52	Broad Street	Ext.		Walking Surface	Sidewalk

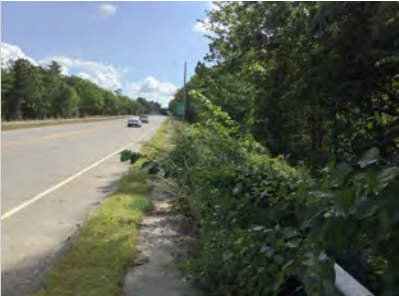
Vertical clearance < 80" above ground Route not maintained in operable working condition	- -	Trim low hanging tree branches. Ensure an accessible route of 4' min. (recommend 5' min.) width is provided. If the accessible route is less than 5' wide, ensure passing spaces of 60" min. by 60" min. at intervals of 200 feet max. are provided.	1	-	\$0

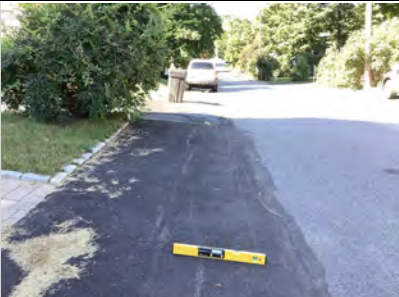
53	Prospect Street House 4	Ext.		Walking Surface	Underpass

Cross slope > 1:50 (2.00%)	7.7%	Reduce cross slope to be no steeper than 1:50 (2.00%).	1	-	\$0
54	Prospect Street House 10	Ext.		Walking Surface	Sidewalk

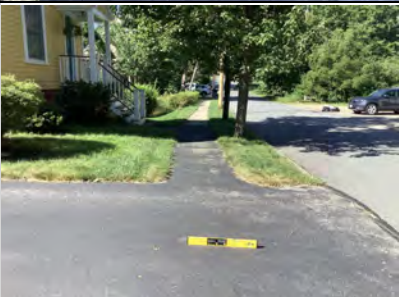
Cross slope > 1:50 (2.00%)	3.7%	Reduce cross slope to be no steeper than 1:50 (2.00%).	1	-	\$0
55	Mechanic Street House 1	Ext.		Walking Surface	Sidewalk

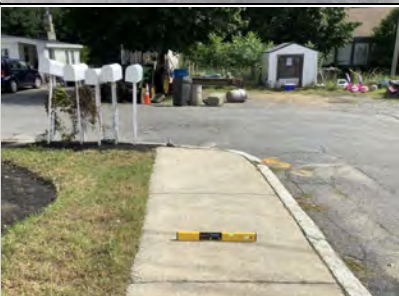
Cross slope > 1:50 (2.00%)	3.9%	Reduce cross slope to be no steeper than 1:50 (2.00%).	1	-	\$0

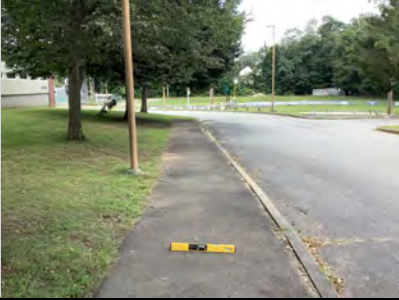
Cross slope > 1:50 (2.00%)	6%	Reduce cross slope to be no steeper than 1:50 (2.00%).	1	-	\$0
57	School Street House 21	Ext.		Walking Surface	Sidewalk

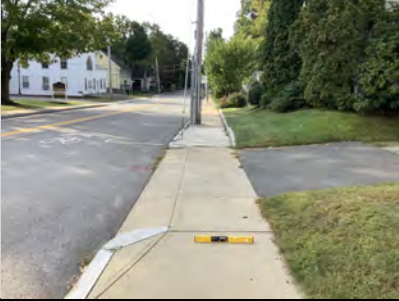
Cross slope > 1:50 (2.00%)	3.2%	Reduce cross slope to be no steeper than 1:50 (2.00%).	1	-	\$0
58	School Street Opposite House 32	Ext.		Walking Surface	Sidewalk

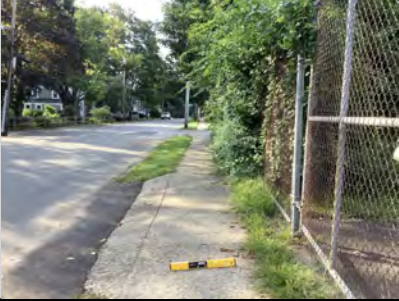
Cross slope > 1:50 (2.00%)	10%	Reduce cross slope to be no steeper than 1:50 (2.00%).	1	-	\$0
59	School Street House 53	Ext.		Walking Surface	Sidewalk

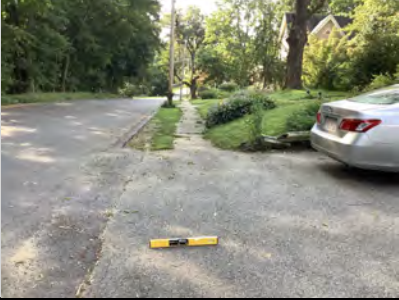
Cross slope > 1:50 (2.00%)	8.7%	Reduce cross slope to be no steeper than 1:50 (2.00%).	1	-	\$0
60	School Street House 3	Ext.		Walking Surface	Sidewalk

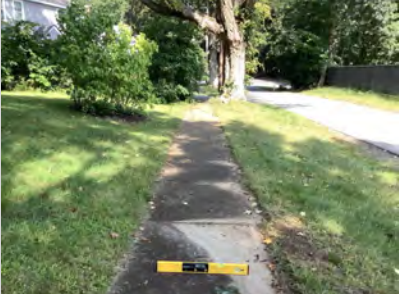
Cross slope > 1:50 (2.00%)	4.8%	Reduce cross slope to be no steeper than 1:50 (2.00%).	1	-	\$0

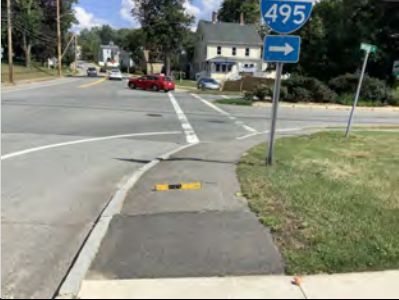
Cross slope > 1:50 (2.00%)	6.8%	Reduce cross slope to be no steeper than 1:50 (2.00%).	1	-	\$0
62	Broad Street at Osaka	Ext.		Walking Surface	Walkway

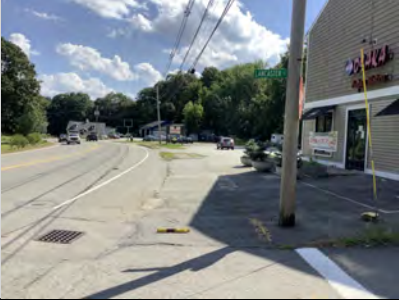
Cross slope > 1:50 (2.00%)	7.4%	Reduce cross slope to be no steeper than 1:50 (2.00%).	1	-	\$0
63	Broad Street at Sloban Auto	Ext.		Walking Surface	Walkway

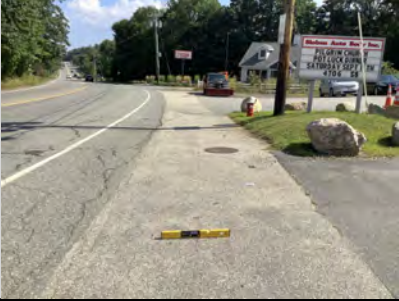
Cross slope > 1:50 (2.00%)	6.3%	Reduce cross slope to be no steeper than 1:50 (2.00%).	1	-	\$0
64	Woodland Street	Ext.		Walking Surface	Sidewalk

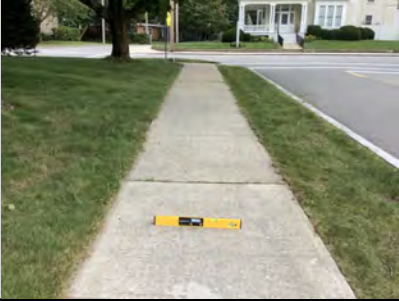
Cross slope > 1:50 (2.00%)	2.9%	Reduce cross slope to be no steeper than 1:50 (2.00%).	1	-	\$0
65	Locust Street House 30	Ext.		Walking Surface	Walkway

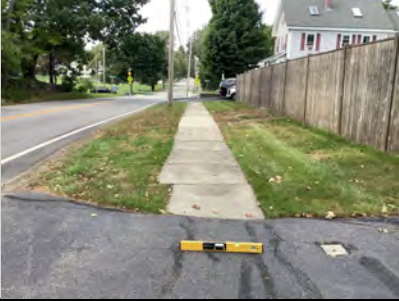
Cross slope > 1:50 (2.00%)	5.2%	Reduce cross slope to be no steeper than 1:50 (2.00%).	1	-	\$0

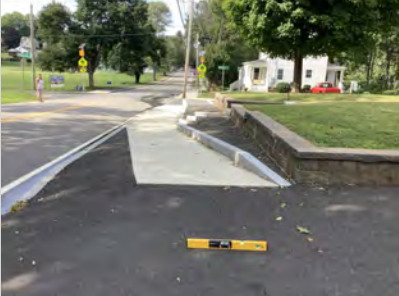
Cross slope > 1:50 (2.00%)	6.8%	Reduce cross slope to be no steeper than 1:50 (2.00%).	1	-	\$0
67	Broad Street Dunkin Donuts	Ext.		Walking Surface	Walkway

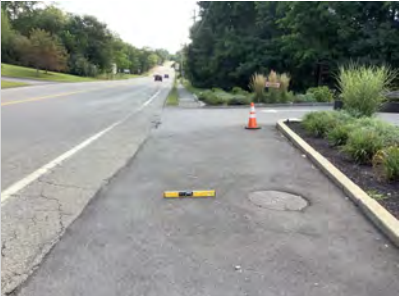
Cross slope > 1:50 (2.00%)	9.1%	Reduce cross slope to be no steeper than 1:50 (2.00%).	1	-	\$0
68	Broad Street Opposite BeWell	Ext.		Walking Surface	Sidewalk

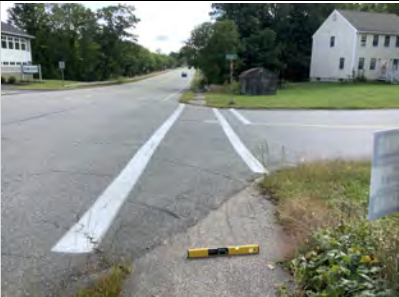
Cross slope > 1:50 (2.00%)	4.9%	Reduce cross slope to be no steeper than 1:50 (2.00%).	1	-	\$0
69	School Street House 33	Ext.		Walking Surface	Sidewalk

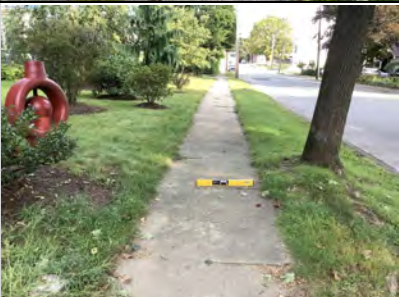
Cross slope > 1:50 (2.00%) Level changes without bevels > 1/4"	4% 1" -	Reduce cross slope to be no steeper than 1:50 (2.00%). Alter change in level to be 1/4" high max.	1	-	\$0
70	Willowdale Drive 1	Ext.		Walking Surface	Overpass

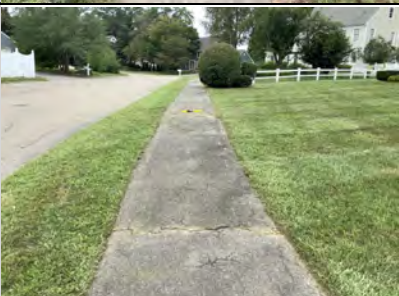
Cross slope > 1:50 (2.00%) Level changes without bevels > 1/4" Does not prevent accumulation of water Route not maintained in operable working condition	4% 0.75" - -	Reduce cross slope to be no steeper than 1:50 (2.00%). Alter change in level to be 1/4" high max. Repair surface. Ensure an accessible route of 4' min. (recommend 5' min.) width is provided. If the accessible route is less than 5' wide, ensure passing spaces of 60" min. by 60" min. at intervals of 200 feet max. are provided.	1	-	\$0

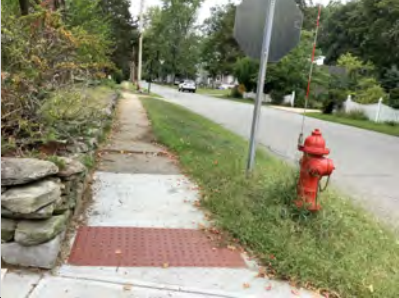
Cross slope > 1:50 (2.00%) Level changes without bevels > 1/4" Does not prevent accumulation of water Route not maintained in operable working condition	3.3% 3" - -	Reduce cross slope to be no steeper than 1:50 (2.00%). Alter change in level to be 1/4" high max. Repair surface. Ensure an accessible route of 4' min. (recommend 5' min.) width is provided. If the accessible route is less than 5' wide, ensure passing spaces of 60" min. by 60" min. at intervals of 200 feet max. are provided.	1	-	\$0
72	Church Street House 81	Ext.		Walking Surface	Sidewalk

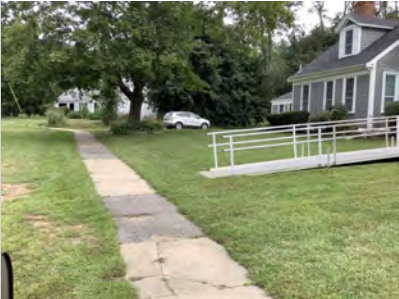
Cross slope > 1:50 (2.00%) Level changes without bevels > 1/4" Route not maintained in operable working condition	2" - -	Reduce cross slope to be no steeper than 1:50 (2.00%). Alter change in level to be 1/4" high max. Ensure an accessible route of 4' min. (recommend 5' min.) width is provided. If the accessible route is less than 5' wide, ensure passing spaces of 60" min. by 60" min. at intervals of 200 feet max. are provided.	1	-	\$0

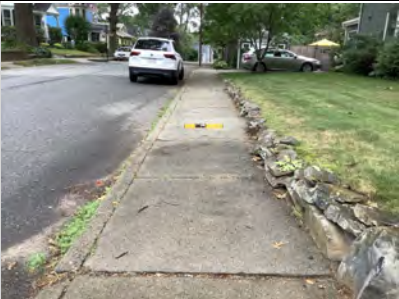
73	Intersection Woodland Street and Grove Street	Ext.		Walking Surface	Sidewalk

Cross slope > 1:50 (2.00%) Level changes without bevels > 1/4" Route not maintained in operable working condition	3.3% 1.25" -	Reduce cross slope to be no steeper than 1:50 (2.00%). Alter change in level to be 1/4" high max. Ensure an accessible route of 4' min. (recommend 5' min.) width is provided. If the accessible route is less than 5' wide, ensure passing spaces of 60" min. by 60" min. at intervals of 200 feet max. are provided.	1	-	\$0
74	Lincoln Street	Ext.		Walking Surface	Sidewalk

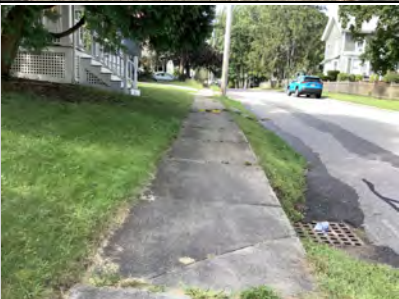
Cross slope > 1:50 (2.00%) Level changes without bevels > 1/4" Route not maintained in operable working condition	6.4% 1.5" -	Reduce cross slope to be no steeper than 1:50 (2.00%). Alter change in level to be 1/4" high max. Ensure an accessible route of 4' min. (recommend 5' min.) width is provided. If the accessible route is less than 5' wide, ensure passing spaces of 60" min. by 60" min. at intervals of 200 feet max. are provided.	1	-	\$0

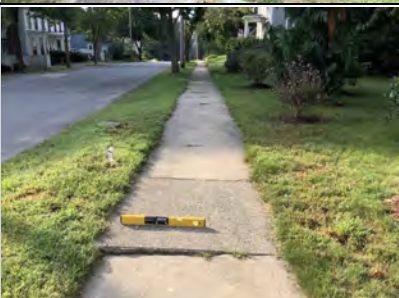
75	School Street House 33	Ext.		Walking Surface	Sidewalk

Cross slope > 1:50 (2.00%) Level changes without bevels > 1/4" Route not maintained in operable working condition	3.7% 3" -	Reduce cross slope to be no steeper than 1:50 (2.00%). Alter change in level to be 1/4" high max. Ensure an accessible route of 4' min. (recommend 5' min.) width is provided. If the accessible route is less than 5' wide, ensure passing spaces of 60" min. by 60" min. at intervals of 200 feet max. are provided.	1	-	\$0

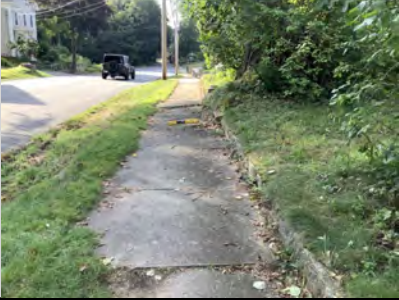
Cross slope > 1:50 (2.00%) Level changes without bevels > 1/4" Route not maintained in operable working condition	4.2% 2.5" -	Reduce cross slope to be no steeper than 1:50 (2.00%). Alter change in level to be 1/4" high max. Ensure an accessible route of 4' min. (recommend 5' min.) width is provided. If the accessible route is less than 5' wide, ensure passing spaces of 60" min. by 60" min. at intervals of 200 feet max. are provided.	1	-	\$0
77	School Street House 41	Ext.		Walking Surface	Sidewalk

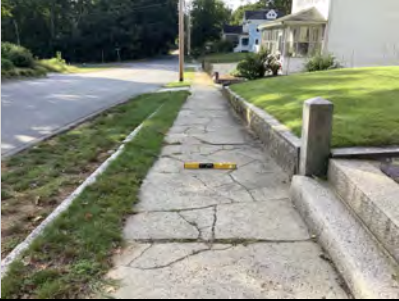
Cross slope > 1:50 (2.00%) Level changes without bevels > 1/4" Route not maintained in operable working condition	2.9% 1" -	Reduce cross slope to be no steeper than 1:50 (2.00%). Alter change in level to be 1/4" high max. Ensure an accessible route of 4' min. (recommend 5' min.) width is provided. If the accessible route is less than 5' wide, ensure passing spaces of 60" min. by 60" min. at intervals of 200 feet max. are provided.	1	-	\$0

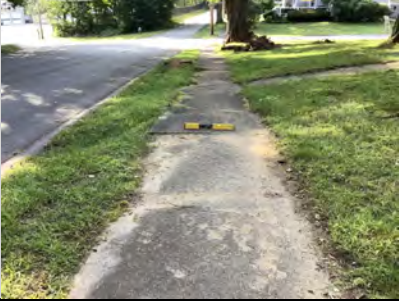
78	School Street House 55	Ext.		Walking Surface	Sidewalk

Cross slope > 1:50 (2.00%) Level changes without bevels > 1/4" Route not maintained in operable working condition	5.3% 1.25" -	Reduce cross slope to be no steeper than 1:50 (2.00%). Alter change in level to be 1/4" high max. Ensure an accessible route of 4' min. (recommend 5' min.) width is provided. If the accessible route is less than 5' wide, ensure passing spaces of 60" min. by 60" min. at intervals of 200 feet max. are provided.	1	-	\$0
79	School Street House 1	Ext.		Walking Surface	Sidewalk

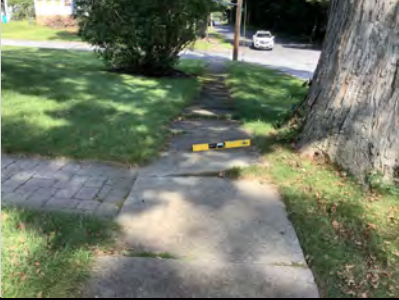
Cross slope > 1:50 (2.00%) Level changes without bevels > 1/4" Route not maintained in operable working condition	10.4% 2.5" -	Reduce cross slope to be no steeper than 1:50 (2.00%). Alter change in level to be 1/4" high max. Ensure an accessible route of 4' min. (recommend 5' min.) width is provided. If the accessible route is less than 5' wide, ensure passing spaces of 60" min. by 60" min. at intervals of 200 feet max. are provided.	1	-	\$0

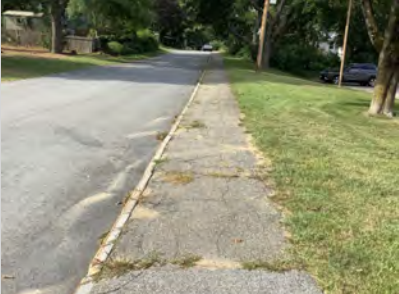
80	Union Street Ext.	Ext.		Walking Surface	Sidewalk

Cross slope > 1:50 (2.00%) Level changes without bevels > 1/4" Route not maintained in operable working condition	4% 0.75" -	Reduce cross slope to be no steeper than 1:50 (2.00%). Alter change in level to be 1/4" high max. Ensure an accessible route of 4' min. (recommend 5' min.) width is provided. If the accessible route is less than 5' wide, ensure passing spaces of 60" min. by 60" min. at intervals of 200 feet max. are provided.	1	-	\$0

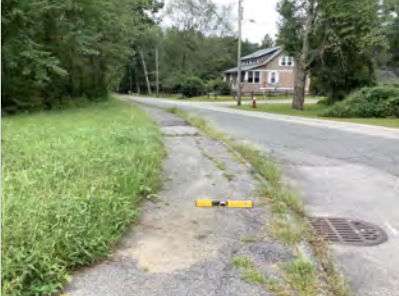
Cross slope > 1:50 (2.00%) Does not prevent accumulation of water Route not maintained in operable working condition	3.1% - -	Reduce cross slope to be no steeper than 1:50 (2.00%). Repair surface. Ensure an accessible route of 4' min. (recommend 5' min.) width is provided. If the accessible route is less than 5' wide, ensure passing spaces of 60" min. by 60" min. at intervals of 200 feet max. are provided.	1	-	\$0
82	Broad Street	Ext.		Walking Surface	Sidewalk

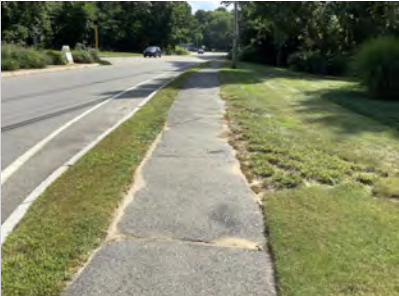
Cross slope > 1:50 (2.00%) Does not prevent accumulation of water Route not maintained in operable working condition	4% 1.5" - -	Reduce cross slope to be no steeper than 1:50 (2.00%). Repair surface. Ensure an accessible route of 4' min. (recommend 5' min.) width is provided. If the accessible route is less than 5' wide, ensure passing spaces of 60" min. by 60" min. at intervals of 200 feet max. are provided.	1	-	\$0

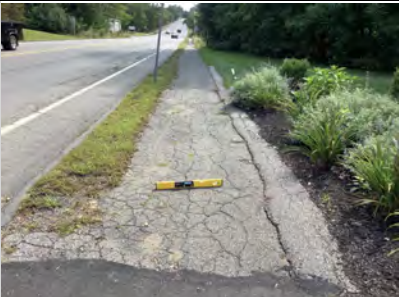
83	Broad Street Dunkin Donuts	Ext.		Walking Surface	Walkway

Cross slope > 1:50 (2.00%) Does not prevent accumulation of water Route not maintained in operable working condition	7.3% - -	Reduce cross slope to be no steeper than 1:50 (2.00%). Repair surface. Ensure an accessible route of 4' min. (recommend 5' min.) width is provided. If the accessible route is less than 5' wide, ensure passing spaces of 60" min. by 60" min. at intervals of 200 feet max. are provided.	1	-	\$0
84	Broad Street Opposite Cobbler's Brook	Ext.		Walking Surface	Sidewalk

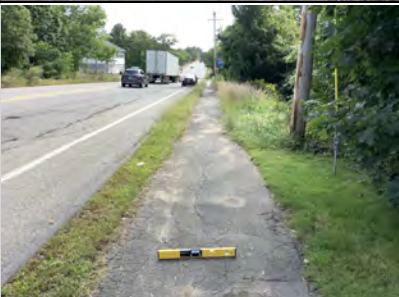
Cross slope > 1:50 (2.00%) Does not prevent accumulation of water Route not maintained in operable working condition	3.7% - -	Reduce cross slope to be no steeper than 1:50 (2.00%). Repair surface. Ensure an accessible route of 4' min. (recommend 5' min.) width is provided. If the accessible route is less than 5' wide, ensure passing spaces of 60" min. by 60" min. at intervals of 200 feet max. are provided.	1	-	\$0

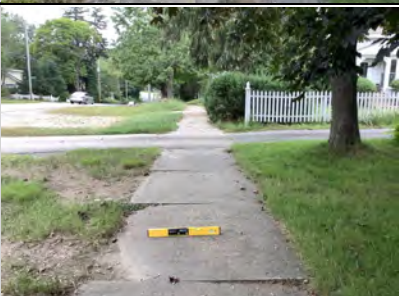
85	Church Street House 63	Ext.		Walking Surface	Sidewalk

Cross slope > 1:50 (2.00%) Route not maintained in operable working condition	4.2% -	Reduce cross slope to be no steeper than 1:50 (2.00%). Ensure an accessible route of 4' min. (recommend 5' min.) width is provided. If the accessible route is less than 5' wide, ensure passing spaces of 60" min. by 60" min. at intervals of 200 feet max. are provided.	1	-	\$0

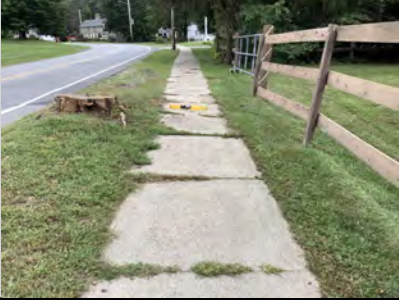
Cross slope > 1:50 (2.00%) Route not maintained in operable working condition	6.2% 1.5" -	Reduce cross slope to be no steeper than 1:50 (2.00%). Ensure an accessible route of 4' min. (recommend 5' min.) width is provided. If the accessible route is less than 5' wide, ensure passing spaces of 60" min. by 60" min. at intervals of 200 feet max. are provided.	1	-	\$0
87	Willowdale Drive House 21	Ext.		Walking Surface	Sidewalk

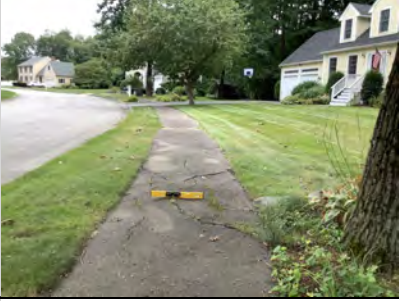
Cross slope > 1:50 (2.00%) Route not maintained in operable working condition	5% -	Reduce cross slope to be no steeper than 1:50 (2.00%). Ensure an accessible route of 4' min. (recommend 5' min.) width is provided. If the accessible route is less than 5' wide, ensure passing spaces of 60" min. by 60" min. at intervals of 200 feet max. are provided.	1	-	\$0

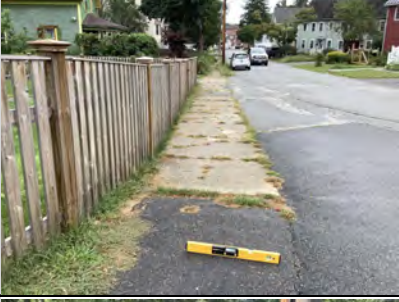
88	Grove Street	Ext.		Walking Surface	Sidewalk

Cross slope > 1:50 (2.00%) Route not maintained in operable working condition	3.9% -	Reduce cross slope to be no steeper than 1:50 (2.00%). Ensure an accessible route of 4' min. (recommend 5' min.) width is provided. If the accessible route is less than 5' wide, ensure passing spaces of 60" min. by 60" min. at intervals of 200 feet max. are provided.	1	-	\$0
89	Prospect Street House 14	Ext.		Walking Surface	Overpass

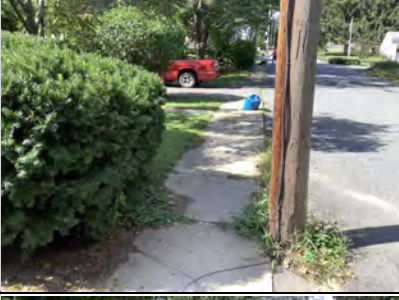
Cross slope > 1:50 (2.00%) Route not maintained in operable working condition	5.2% -	Reduce cross slope to be no steeper than 1:50 (2.00%). Ensure an accessible route of 4' min. (recommend 5' min.) width is provided. If the accessible route is less than 5' wide, ensure passing spaces of 60" min. by 60" min. at intervals of 200 feet max. are provided.	1	-	\$0
90	Helen R. Donaghue School	Ext.		Walking Surface	Sidewalk

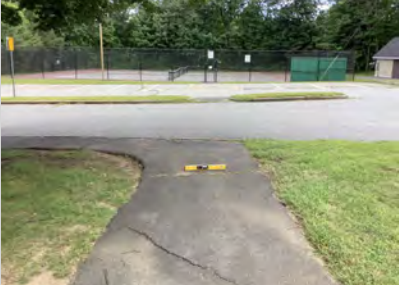
Cross slope > 1:50 (2.00%) Route not maintained in operable working condition	3.2% -	Reduce cross slope to be no steeper than 1:50 (2.00%). Ensure route is maintained in operable working condition.	1	-	\$0

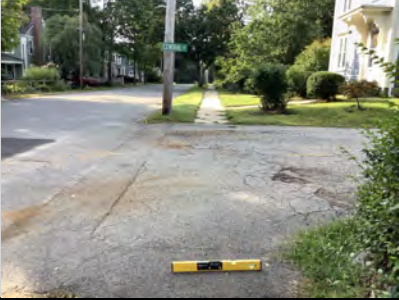
Cross slope > 1:50 (2.00%) Route not maintained in operable working condition	6% -	Reduce cross slope to be no steeper than 1:50 (2.00%). Ensure an accessible route of 4' min. (recommend 5' min.) width is provided. If the accessible route is less than 5' wide, ensure passing spaces of 60" min. by 60" min. at intervals of 200 feet max. are provided.	1	-	\$0
92	School Street House 43	Ext.		Walking Surface	Sidewalk

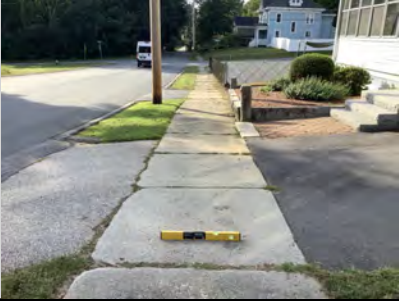
Cross slope > 1:50 (2.00%) Route not maintained in operable working condition	2.8% 1" -	Reduce cross slope to be no steeper than 1:50 (2.00%). Ensure an accessible route of 4' min. (recommend 5' min.) width is provided. If the accessible route is less than 5' wide, ensure passing spaces of 60" min. by 60" min. at intervals of 200 feet max. are provided.	1	-	\$0

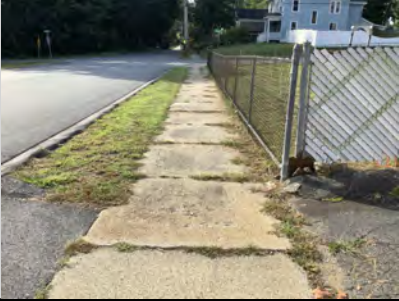
93	School Street Opposite House 52	Ext.		Walking Surface	Sidewalk

Cross slope > 1:50 (2.00%) Route not maintained in operable working condition	3% -	Reduce cross slope to be no steeper than 1:50 (2.00%). Ensure an accessible route of 4' min. (recommend 5' min.) width is provided. If the accessible route is less than 5' wide, ensure passing spaces of 60" min. by 60" min. at intervals of 200 feet max. are provided.	1	-	\$0
94	Intersection School Street and Pleasant Street	Ext.		Walking Surface	Sidewalk

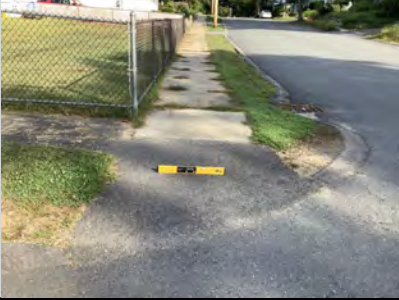
Cross slope > 1:50 (2.00%) Route not maintained in operable working condition	5.6% -	Reduce cross slope to be no steeper than 1:50 (2.00%). Ensure an accessible route of 4' min. (recommend 5' min.) width is provided. If the accessible route is less than 5' wide, ensure passing spaces of 60" min. by 60" min. at intervals of 200 feet max. are provided.	1	-	\$0
95	School Street House 53	Ext.		Walking Surface	Sidewalk

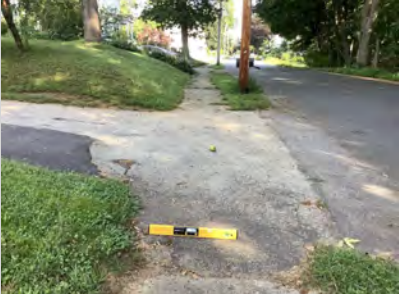
Cross slope > 1:50 (2.00%) Route not maintained in operable working condition	4.9% -	Reduce cross slope to be no steeper than 1:50 (2.00%). Ensure an accessible route of 4' min. (recommend 5' min.) width is provided. If the accessible route is less than 5' wide, ensure passing spaces of 60" min. by 60" min. at intervals of 200 feet max. are provided.	1	-	\$0

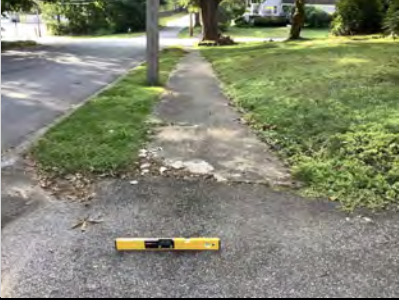
ID	Location	Floor	Room	Element	Type	Photo	Issues	Current Measure	Recommendations	Quantity	Price	Cost Estimation
96	School Street House 55	Ext.		Walking Surface	Sidewalk

Cross slope > 1:50 (2.00%) Route not maintained in operable working condition	5.5% -	Reduce cross slope to be no steeper than 1:50 (2.00%). Ensure an accessible route of 4' min. (recommend 5' min.) width is provided. If the accessible route is less than 5' wide, ensure passing spaces of 60" min. by 60" min. at intervals of 200 feet max. are provided.	1	-	\$0
97	Church Street House 83	Ext.		Walking Surface	Sidewalk

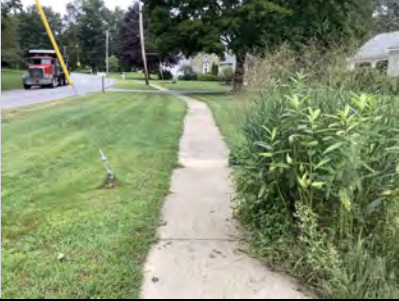
Level changes without bevels > 1/4"	1"	Alter change in level to be 1/4" high max.	1	-	\$0
98	Prospect Street House 40	Ext.		Walking Surface	Sidewalk

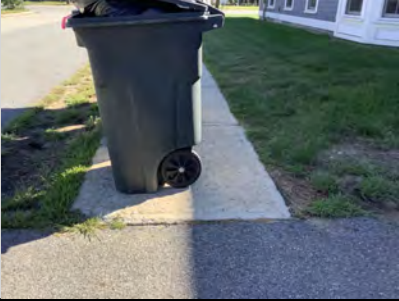
Level changes without bevels > 1/4"	1.25"	Alter change in level to be 1/4" high max.	1	-	\$0
99	Locust Street House 9	Ext.		Walking Surface	Sidewalk

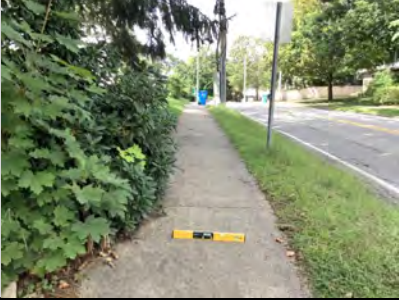
Level changes without bevels > 1/4"	4.4% 1"	Alter change in level to be 1/4" high max.	1	-	\$0

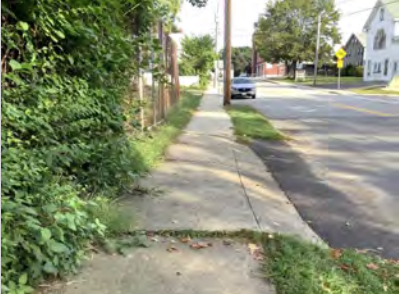
100	School Street Opposite House 32	Ext.		Walking Surface	Sidewalk

Level changes without bevels > 1/4"	2"	Alter change in level to be 1/4" high max.	1	-	\$0

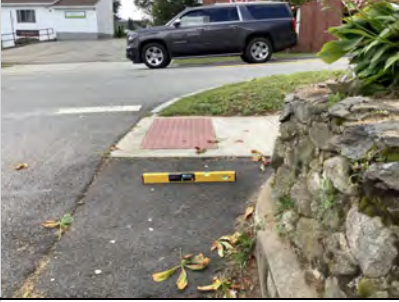
ID	Location	Floor	Room	Element	Type	Photo	Issues	Current Measure	Recommendations	Quantity	Price	Cost Estimation
101	Intersection Liberty Street and East Main Street	Ext.		Walking Surface	Sidewalk

Level changes without bevels > 1/4"	4.2% 1.25"	Alter change in level to be 1/4" high max.	1	-	\$0
102	School Street House 43	Ext.		Walking Surface	Sidewalk

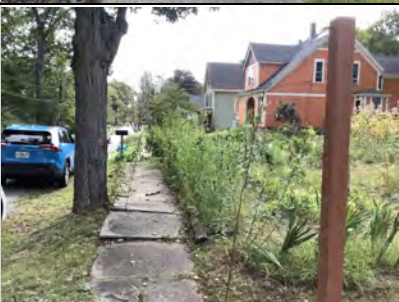
Level changes without bevels > 1/4" Does not prevent accumulation of water Route not maintained in operable working condition	3" - -	Alter change in level to be 1/4" high max. Repair surface. Ensure an accessible route of 4' min. (recommend 5' min.) width is provided. If the accessible route is less than 5' wide, ensure passing spaces of 60" min. by 60" min. at intervals of 200 feet max. are provided.	1	-	\$0

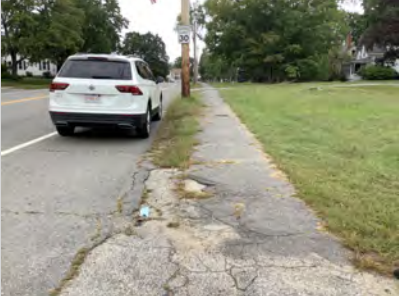
ID	Location	Floor	Room	Element	Type	Photo	Issues	Current Measure	Recommendations	Quantity	Price	Cost Estimation
106	Church Street Across From House 28	Ext.		Walking Surface	Sidewalk

Level changes without bevels > 1/4" Route not maintained in operable working condition	1" -	Alter change in level to be 1/4" high max. Ensure an accessible route of 4' min. (recommend 5' min.) width is provided. If the accessible route is less than 5' wide, ensure passing spaces of 60" min. by 60" min. at intervals of 200 feet max. are provided.	1	-	\$0
107	Church Street Across From House 30	Ext.		Walking Surface	Sidewalk

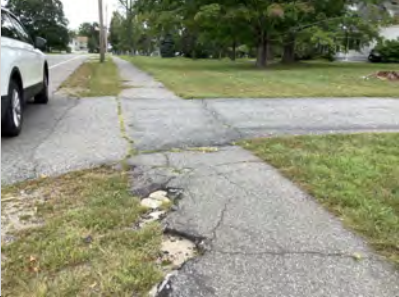
Level changes without bevels > 1/4" Route not maintained in operable working condition	2" -	Alter change in level to be 1/4" high max. Ensure an accessible route of 4' min. (recommend 5' min.) width is provided. If the accessible route is less than 5' wide, ensure passing spaces of 60" min. by 60" min. at intervals of 200 feet max. are provided.	1	-	\$0

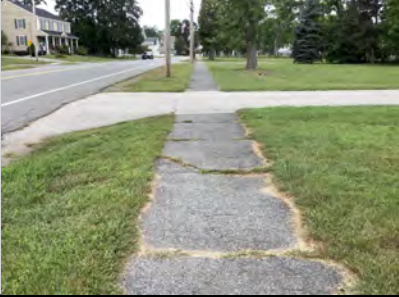
108	Church Street House 31	Ext.		Walking Surface	Sidewalk

Level changes without bevels > 1/4" Route not maintained in operable working condition	2" -	Alter change in level to be 1/4" high max. Ensure an accessible route of 4' min. (recommend 5' min.) width is provided. If the accessible route is less than 5' wide, ensure passing spaces of 60" min. by 60" min. at intervals of 200 feet max. are provided.	1	-	\$0
109	Church Street House 53	Ext.		Walking Surface	Sidewalk

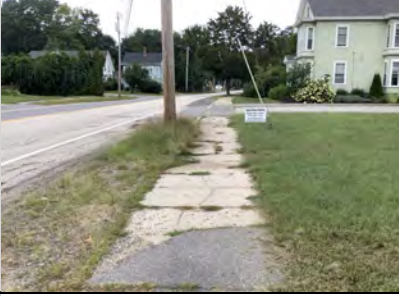
Level changes without bevels > 1/4" Route not maintained in operable working condition	1.5" -	Ensure an accessible route of 4' min. (recommend 5' min.) width is provided. If the accessible route is less than 5' wide, ensure passing spaces of 60" min. by 60" min. at intervals of 200 feet max. are provided.	1	-	\$0
110	Church Street House 55-57	Ext.		Walking Surface	Underpass

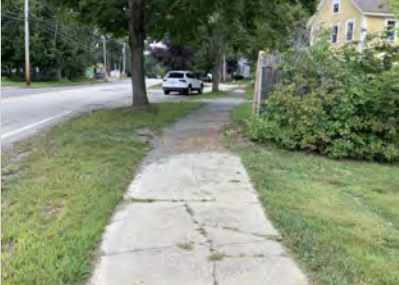
Level changes without bevels > 1/4" Route not maintained in operable working condition	1" -	Alter change in level to be 1/4" high max. Ensure an accessible route of 4' min. (recommend 5' min.) width is provided. If the accessible route is less than 5' wide, ensure passing spaces of 60" min. by 60" min. at intervals of 200 feet max. are provided.	1	-	\$0

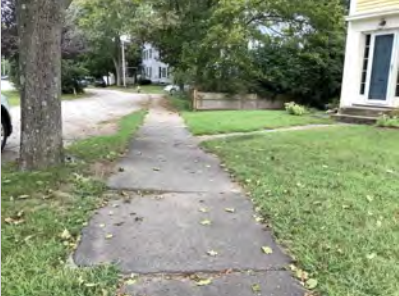
ID	Location	Floor	Room	Element	Type	Photo	Issues	Current Measure	Recommendations	Quantity	Price	Cost Estimation
111	Church Street House 57	Ext.		Walking Surface	Sidewalk

Level changes without bevels > 1/4" Route not maintained in operable working condition	3" -	Alter change in level to be 1/4" high max. Ensure an accessible route of 4' min. (recommend 5' min.) width is provided. If the accessible route is less than 5' wide, ensure passing spaces of 60" min. by 60" min. at intervals of 200 feet max. are provided.	1	-	\$0
112	Nichols Street House 14	Ext.		Walking Surface	Sidewalk

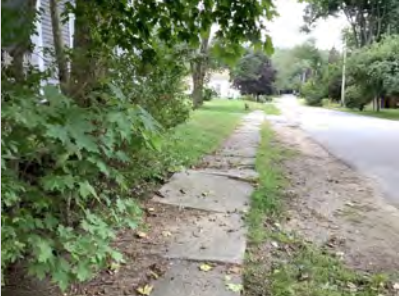
Level changes without bevels > 1/4" Route not maintained in operable working condition	4" -	Alter change in level to be 1/4" high max. Ensure an accessible route of 4' min. (recommend 5' min.) width is provided. If the accessible route is less than 5' wide, ensure passing spaces of 60" min. by 60" min. at intervals of 200 feet max. are provided.	1	-	\$0

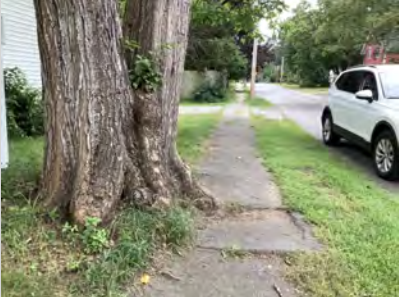
113	Sawyer Street	Ext.		Walking Surface	Sidewalk

Level changes without bevels > 1/4" Route not maintained in operable working condition	2.5" -	Alter change in level to be 1/4" high max. Ensure an accessible route of 4' min. (recommend 5' min.) width is provided. If the accessible route is less than 5' wide, ensure passing spaces of 60" min. by 60" min. at intervals of 200 feet max. are provided.	1	-	\$0
114	Maple Street House 23	Ext.		Walking Surface	Sidewalk

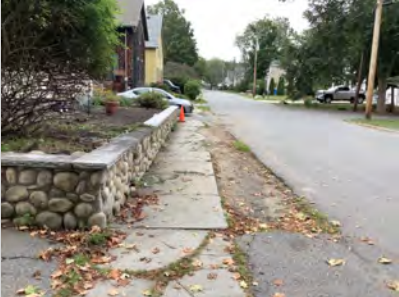
Level changes without bevels > 1/4" Route not maintained in operable working condition	1.5" -	Alter change in level to be 1/4" high max. Ensure an accessible route of 4' min. (recommend 5' min.) width is provided. If the accessible route is less than 5' wide, ensure passing spaces of 60" min. by 60" min. at intervals of 200 feet max. are provided.	1	-	\$0
115	Grove Street House 31	Ext.		Walking Surface	Sidewalk

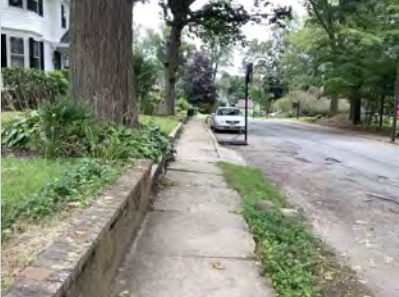
Level changes without bevels > 1/4" Route not maintained in operable working condition	2" -	Alter change in level to be 1/4" high max. Ensure an accessible route of 4' min. (recommend 5' min.) width is provided. If the accessible route is less than 5' wide, ensure passing spaces of 60" min. by 60" min. at intervals of 200 feet max. are provided.	1	-	\$0

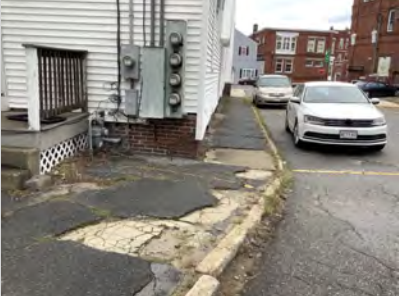
ID	Location	Floor	Room	Element	Type	Photo	Issues	Current Measure	Recommendations	Quantity	Price	Cost Estimation
116	Grove Street	Ext.		Walking Surface	Sidewalk

Level changes without bevels > 1/4" Route not maintained in operable working condition	3" -	Alter change in level to be 1/4" high max. Ensure an accessible route of 4' min. (recommend 5' min.) width is provided. If the accessible route is less than 5' wide, ensure passing spaces of 60" min. by 60" min. at intervals of 200 feet max. are provided.	1	-	\$0
117	Prospect Street House 10	Ext.		Walking Surface	Sidewalk

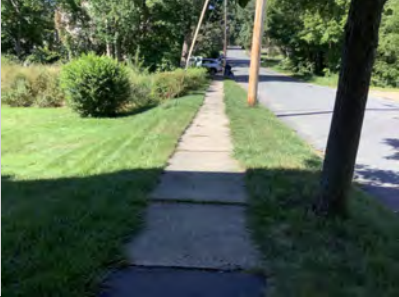
Level changes without bevels > 1/4" Route not maintained in operable working condition	1.5" -	Alter change in level to be 1/4" high max. Ensure an accessible route of 4' min. (recommend 5' min.) width is provided. If the accessible route is less than 5' wide, ensure passing spaces of 60" min. by 60" min. at intervals of 200 feet max. are provided.	1	-	\$0

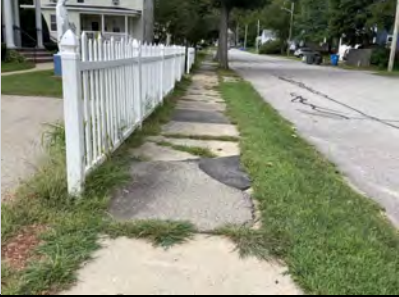
118	Holy Redeemer Parish	Ext.		Walking Surface	Sidewalk

Level changes without bevels > 1/4" Route not maintained in operable working condition	1.5" -	Alter change in level to be 1/4" high max. Ensure route is maintained in operable working condition.	1	-	\$0
119	Holy Redeemer Parish	Ext.		Walking Surface	Sidewalk
