Town of Merrimac, Massachusetts

PART A – Executive Summary

September 2021

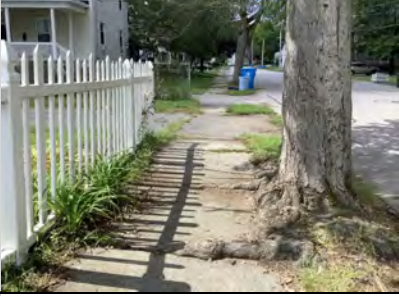
Level changes without bevels > 1/4" Route not maintained in operable working condition	3" -	Alter change in level to be 1/4" high max. Ensure an accessible route of 4' min. (recommend 5' min.) width is provided. If the accessible route is less than 5' wide, ensure passing spaces of 60" min. by 60" min. at intervals of 200 feet max. are provided.	1	-	\$0
120	Pleasant Street	Ext.		Walking Surface	Sidewalk

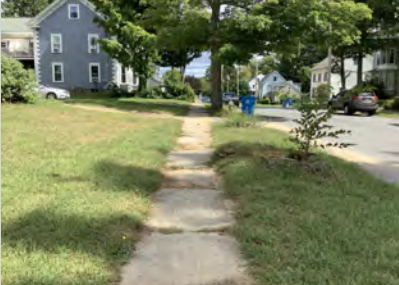
Level changes without bevels > 1/4" Route not maintained in operable working condition	3" -	Alter change in level to be 1/4" high max. Ensure an accessible route of 4' min. (recommend 5' min.) width is provided. If the accessible route is less than 5' wide, ensure passing spaces of 60" min. by 60" min. at intervals of 200 feet max. are provided.	1	-	\$0

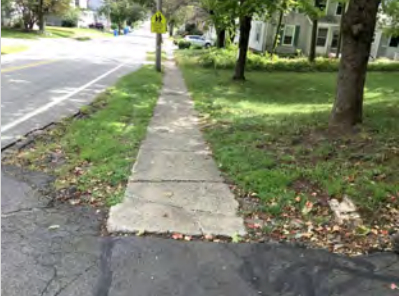
ID	Location	Floor	Room	Element	Type	Photo	Issues	Current Measure	Recommendations	Quantity	Price	Cost Estimation
121	Locust Street House 9	Ext.		Walking Surface	Sidewalk

Level changes without bevels > 1/4" Route not maintained in operable working condition	1" -	Alter change in level to be 1/4" high max. Ensure an accessible route of 4' min. (recommend 5' min.) width is provided. If the accessible route is less than 5' wide, ensure passing spaces of 60" min. by 60" min. at intervals of 200 feet max. are provided.	1	-	\$0
122	Locust Street House 2	Ext.		Walking Surface	Sidewalk

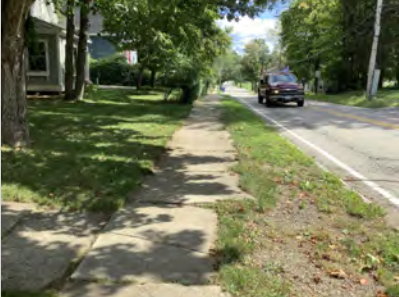
Level changes without bevels > 1/4" Route not maintained in operable working condition	2" -	Alter change in level to be 1/4" high max. Ensure an accessible route of 4' min. (recommend 5' min.) width is provided. If the accessible route is less than 5' wide, ensure passing spaces of 60" min. by 60" min. at intervals of 200 feet max. are provided.	1	-	\$0

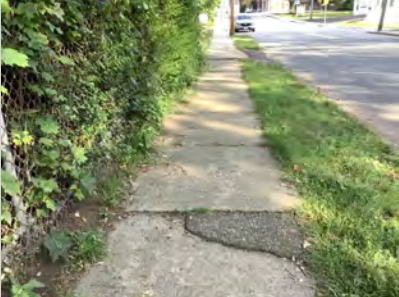
123	School Street Opposite House 34	Ext.		Walking Surface	Sidewalk

Level changes without bevels > 1/4" Route not maintained in operable working condition	0.5" -	Alter change in level to be 1/4" high max. Ensure an accessible route of 4' min. (recommend 5' min.) width is provided. If the accessible route is less than 5' wide, ensure passing spaces of 60" min. by 60" min. at intervals of 200 feet max. are provided.	1	-	\$0
124	School Street Opposite House 48	Ext.		Walking Surface	Sidewalk

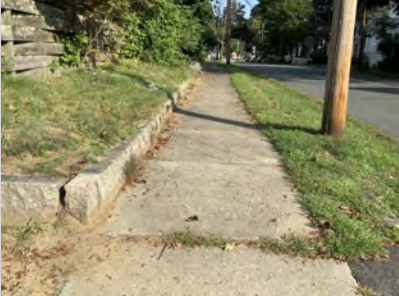
Level changes without bevels > 1/4" Route not maintained in operable working condition	1" -	Alter change in level to be 1/4" high max. Ensure an accessible route of 4' min. (recommend 5' min.) width is provided. If the accessible route is less than 5' wide, ensure passing spaces of 60" min. by 60" min. at intervals of 200 feet max. are provided.	1	-	\$0
125	School Street House 53	Ext.		Walking Surface	Sidewalk

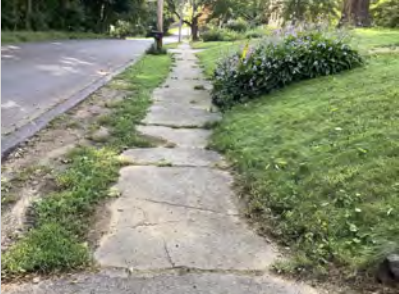
Level changes without bevels > 1/4" Route not maintained in operable working condition	1" -	Alter change in level to be 1/4" high max. Ensure route is maintained in operable working condition.	1	-	\$0

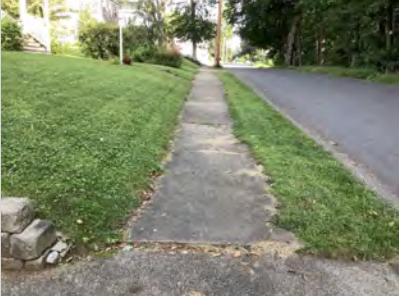
ID	Location	Floor	Room	Element	Type	Photo	Issues	Current Measure	Recommendations	Quantity	Price	Cost Estimation
126	School Street House 55	Ext.		Walking Surface	Sidewalk

Level changes without bevels > 1/4" Route not maintained in operable working condition	1.5" -	Alter change in level to be 1/4" high max. Ensure an accessible route of 4' min. (recommend 5' min.) width is provided. If the accessible route is less than 5' wide, ensure passing spaces of 60" min. by 60" min. at intervals of 200 feet max. are provided.	1	-	\$0
127	School Street House 3	Ext.		Walking Surface	Sidewalk

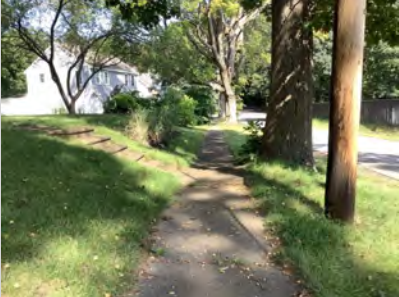
Level changes without bevels > 1/4" Route not maintained in operable working condition	4" -	Alter change in level to be 1/4" high max. Ensure an accessible route of 4' min. (recommend 5' min.) width is provided. If the accessible route is less than 5' wide, ensure passing spaces of 60" min. by 60" min. at intervals of 200 feet max. are provided.	1	-	\$0

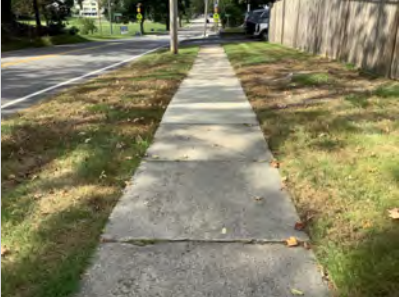
128	Locust Street House 30	Ext.		Walking Surface	Sidewalk

Level changes without bevels > 1/4" Route not maintained in operable working condition	0.5" -	Alter change in level to be 1/4" high max. Ensure an accessible route of 4' min. (recommend 5' min.) width is provided. If the accessible route is less than 5' wide, ensure passing spaces of 60" min. by 60" min. at intervals of 200 feet max. are provided.	1	-	\$0
129	East Main Street at Towne Market	Ext.		Walking Surface	Sidewalk

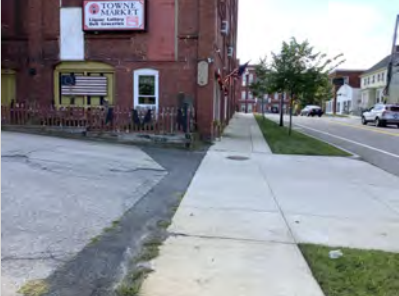
Beveled changes in level > 1/2"	0.5"	Alter surface so that bevel height is 1/4" min.	1	-	\$0
130	Locust Street House 26	Ext.		Walking Surface	Sidewalk

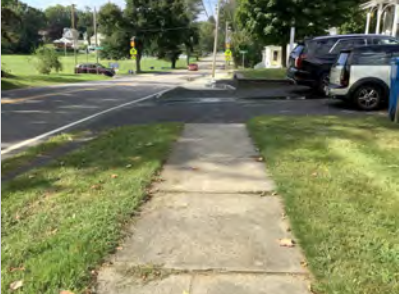
Beveled changes in level > 1/2" Route not maintained in operable working condition	0.5" -	Alter surface so that bevel height is 1/4" min. Ensure an accessible route of 4' min. (recommend 5' min.) width is provided. If the accessible route is less than 5' wide, ensure passing spaces of 60" min. by 60" min. at intervals of 200 feet max. are provided.	1	-	\$0

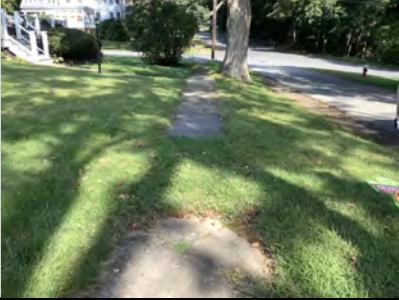
ID	Location	Floor	Room	Element	Type	Photo	Issues	Current Measure	Recommendations	Quantity	Price	Cost Estimation
131	School Street House 1A	Ext.		Walking Surface	Sidewalk

Surface not stable, firm and slip-resistant Route not maintained in operable working condition	- -	Repair surface. Ensure an accessible route of 4' min. (recommend 5' min.) width is provided. If the accessible route is less than 5' wide, ensure passing spaces of 60" min. by 60" min. at intervals of 200 feet max. are provided.	1	-	\$0
132	School Street House 48	Ext.		Walking Surface	Sidewalk

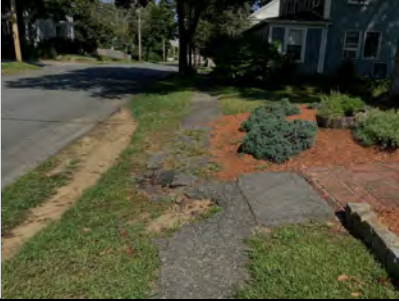
Surface not stable, firm and slip-resistant Route not maintained in operable working condition	- -	Repair surface. Ensure an accessible route of 4' min. (recommend 5' min.) width is provided. If the accessible route is less than 5' wide, ensure passing spaces of 60" min. by 60" min. at intervals of 200 feet max. are provided.	1	-	\$0

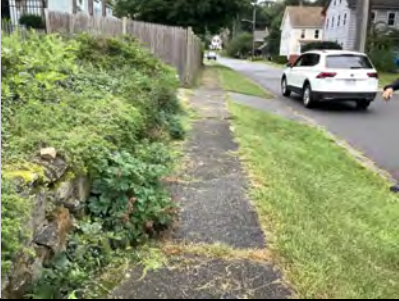
133	Vendome Street	Ext.		Walking Surface	Sidewalk

Does not prevent accumulation of water	-	Repair surface.	1	-	\$0
134	Winter street House 11	Ext.		Walking Surface	Sidewalk

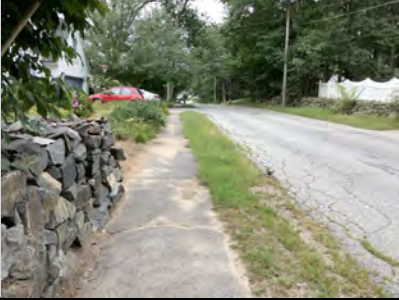
Does not prevent accumulation of water Route not maintained in operable working condition	- -	Repair surface. Ensure an accessible route of 4' min. (recommend 5' min.) width is provided. If the accessible route is less than 5' wide, ensure passing spaces of 60" min. by 60" min. at intervals of 200 feet max. are provided.	1	-	\$0
135	Winter Street House 5	Ext.		Walking Surface	Sidewalk

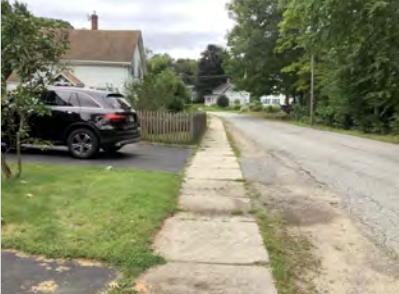
Does not prevent accumulation of water Route not maintained in operable working condition	- -	Repair surface. Ensure an accessible route of 4' min. (recommend 5' min.) width is provided. If the accessible route is less than 5' wide, ensure passing spaces of 60" min. by 60" min. at intervals of 200 feet max. are provided.	1	-	\$0

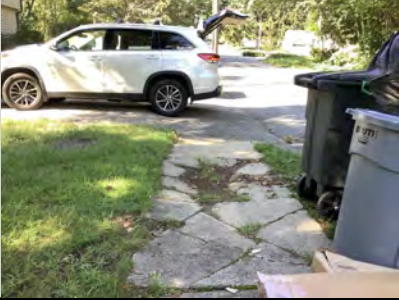
ID	Location	Floor	Room	Element	Type	Photo	Issues	Current Measure	Recommendations	Quantity	Price	Cost Estimation
136	Prospect Street House 12	Ext.		Walking Surface	Sidewalk

Does not prevent accumulation of water Route not maintained in operable working condition	- -	Repair surface. Ensure an accessible route of 4' min. (recommend 5' min.) width is provided. If the accessible route is less than 5' wide, ensure passing spaces of 60" min. by 60" min. at intervals of 200 feet max. are provided.	1	-	\$0
137	Locust Street House 8	Ext.		Walking Surface	Sidewalk

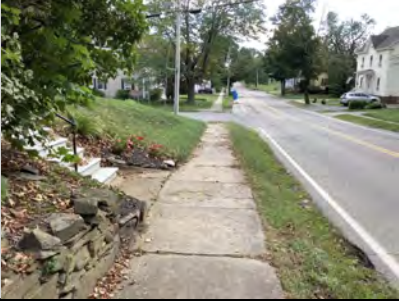
Does not prevent accumulation of water Route not maintained in operable working condition	- -	Repair surface. Ensure an accessible route of 4' min. (recommend 5' min.) width is provided. If the accessible route is less than 5' wide, ensure passing spaces of 60" min. by 60" min. at intervals of 200 feet max. are provided.	1	-	\$0
138	Locust Street House 10	Ext.		Walking Surface	Sidewalk

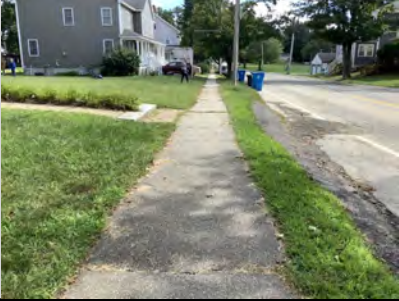
Does not prevent accumulation of water Route not maintained in operable working condition	- -	Repair surface. Ensure an accessible route of 4' min. (recommend 5' min.) width is provided. If the accessible route is less than 5' wide, ensure passing spaces of 60" min. by 60" min. at intervals of 200 feet max. are provided.	1	-	\$0

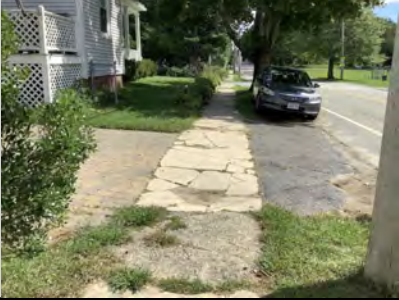
139	Locust Street House 27	Ext.		Walking Surface	Sidewalk

Does not prevent accumulation of water Route not maintained in operable working condition	- -	Repair surface. Ensure an accessible route of 4' min. (recommend 5' min.) width is provided. If the accessible route is less than 5' wide, ensure passing spaces of 60" min. by 60" min. at intervals of 200 feet max. are provided.	1	-	\$0
140	Broad Street at Osaka	Ext.		Walking Surface	Walkway

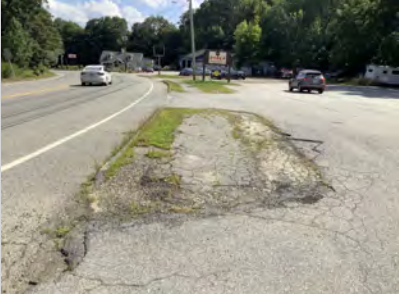
Does not prevent accumulation of water Route not maintained in operable working condition	- -	Repair surface. Ensure an accessible route of 4' min. (recommend 5' min.) width is provided. If the accessible route is less than 5' wide, ensure passing spaces of 60" min. by 60" min. at intervals of 200 feet max. are provided.	1	-	\$0

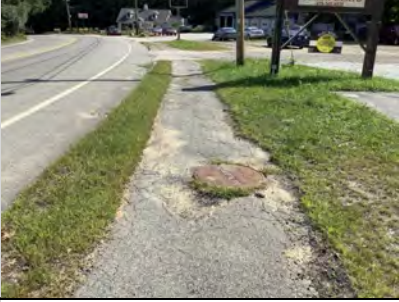
ID	Location	Floor	Room	Element	Type	Photo	Issues	Current Measure	Recommendations	Quantity	Price	Cost Estimation
141	Broad Street at Sloban Auto	Ext.		Walking Surface	Sidewalk

Does not prevent accumulation of water Route not maintained in operable working condition	- -	Repair surface. Ensure an accessible route of 4' min. (recommend 5' min.) width is provided. If the accessible route is less than 5' wide, ensure passing spaces of 60" min. by 60" min. at intervals of 200 feet max. are provided.	1	-	\$0
142	Pilgrim Church	Ext.		Walking Surface	Sidewalk

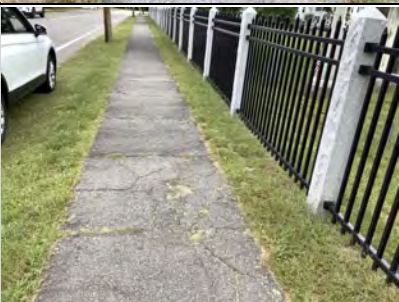
Route not maintained in operable working condition	-	Ensure an accessible route of 4' min. (recommend 5' min.) width is provided. If the accessible route is less than 5' wide, ensure passing spaces of 60" min. by 60" min. at intervals of 200 feet max. are provided.	1	-	\$0

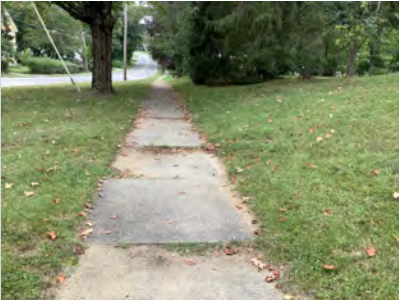
ID	Location	Floor	Room	Element	Type	Photo	Issues	Current Measure	Recommendations	Quantity	Price	Cost Estimation
146	Church Street House 67	Ext.		Walking Surface	Sidewalk

Route not maintained in operable working condition	-	Ensure an accessible route of 4' min. (recommend 5' min.) width is provided. If the accessible route is less than 5' wide, ensure passing spaces of 60" min. by 60" min. at intervals of 200 feet max. are provided.	1	-	\$0
147	Church Street House 71	Ext.		Walking Surface	Sidewalk

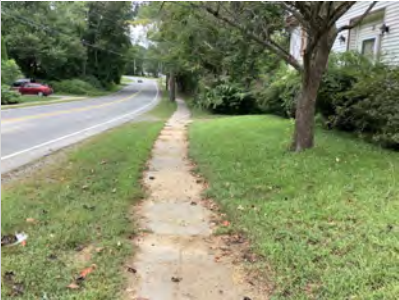
Route not maintained in operable working condition	-	Ensure an accessible route of 4' min. (recommend 5' min.) width is provided. If the accessible route is less than 5' wide, ensure passing spaces of 60" min. by 60" min. at intervals of 200 feet max. are provided.	1	-	\$0
148	Intersection Woodland Street and Vendome Street House 25	Ext.		Walking Surface	Sidewalk

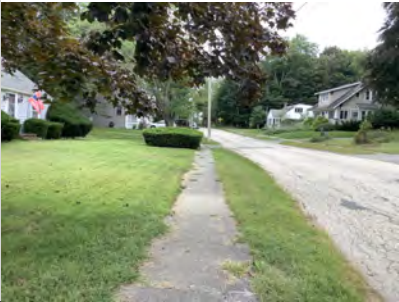
Route not maintained in operable working condition	-	Ensure an accessible route of 4' min. (recommend 5' min.) width is provided. If the accessible route is less than 5' wide, ensure passing spaces of 60" min. by 60" min. at intervals of 200 feet max. are provided.	1	-	\$0

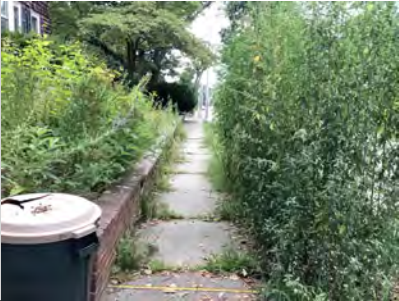
149	Winter Street Across From House 22	Ext.		Walking Surface	Sidewalk

Route not maintained in operable working condition	-	Ensure an accessible route of 4' min. (recommend 5' min.) width is provided. If the accessible route is less than 5' wide, ensure passing spaces of 60" min. by 60" min. at intervals of 200 feet max. are provided.	1	-	\$0
150	Winter Street House 16	Ext.		Walking Surface	Sidewalk

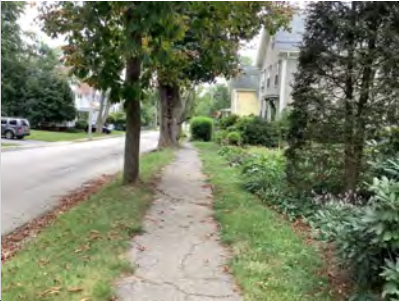
Route not maintained in operable working condition	-	Ensure an accessible route of 4' min. (recommend 5' min.) width is provided. If the accessible route is less than 5' wide, ensure passing spaces of 60" min. by 60" min. at intervals of 200 feet max. are provided.	1	-	\$0

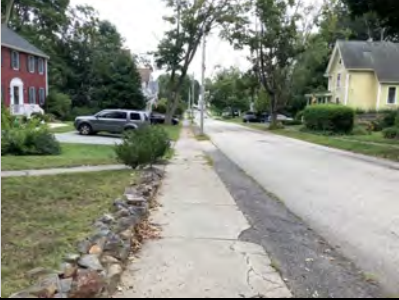
ID	Location	Floor	Room	Element	Type	Photo	Issues	Current Measure	Recommendations	Quantity	Price	Cost Estimation
151	Winter Street House 15	Ext.		Walking Surface	Sidewalk

Route not maintained in operable working condition	-	Ensure an accessible route of 4' min. (recommend 5' min.) width is provided. If the accessible route is less than 5' wide, ensure passing spaces of 60" min. by 60" min. at intervals of 200 feet max. are provided.	1	-	\$0
152	Sawyer Street Opposite House 7	Ext.		Walking Surface	Sidewalk

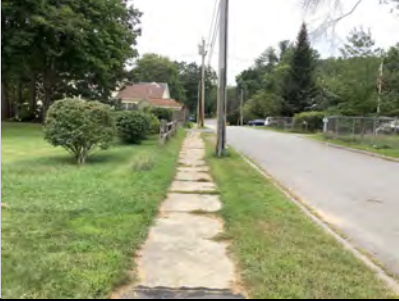
Route not maintained in operable working condition	-	Ensure an accessible route of 4' min. (recommend 5' min.) width is provided. If the accessible route is less than 5' wide, ensure passing spaces of 60" min. by 60" min. at intervals of 200 feet max. are provided.	1	-	\$0
153	Maple Street Beginning of Street	Ext.		Walking Surface	Sidewalk

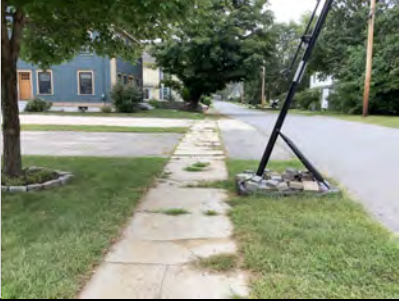
Route not maintained in operable working condition	-	Ensure an accessible route of 4' min. (recommend 5' min.) width is provided. If the accessible route is less than 5' wide, ensure passing spaces of 60" min. by 60" min. at intervals of 200 feet max. are provided.	1	-	\$0

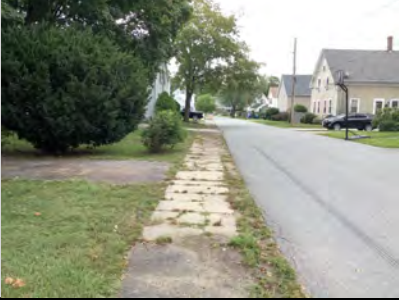
154	Maple Street House 11	Ext.		Walking Surface	Sidewalk

Route not maintained in operable working condition	-	Ensure an accessible route of 4' min. (recommend 5' min.) width is provided. If the accessible route is less than 5' wide, ensure passing spaces of 60" min. by 60" min. at intervals of 200 feet max. are provided.	1	-	\$0
155	Pine Street House 44	Ext.		Walking Surface	Sidewalk

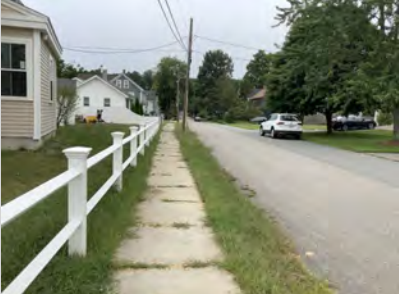
Route not maintained in operable working condition	-	Ensure an accessible route of 4' min. (recommend 5' min.) width is provided. If the accessible route is less than 5' wide, ensure passing spaces of 60" min. by 60" min. at intervals of 200 feet max. are provided.	1	-	\$0

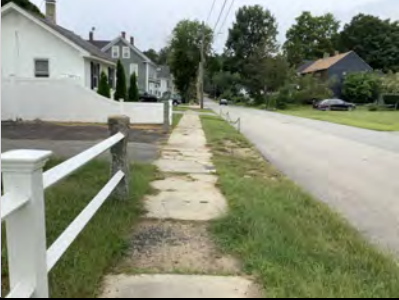
ID	Location	Floor	Room	Element	Type	Photo	Issues	Current Measure	Recommendations	Quantity	Price	Cost Estimation
156	Pine Street House 44	Ext.		Walking Surface	Sidewalk

Route not maintained in operable working condition	-	Ensure an accessible route of 4' min. (recommend 5' min.) width is provided. If the accessible route is less than 5' wide, ensure passing spaces of 60" min. by 60" min. at intervals of 200 feet max. are provided.	1	-	\$0
157	Intersection Pine and Summer Streets	Ext.		Walking Surface	Sidewalk

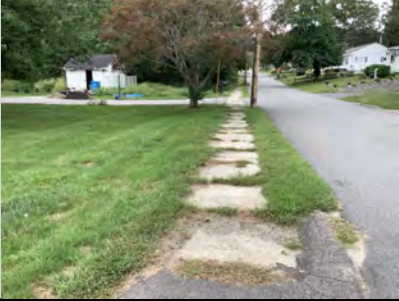
Route not maintained in operable working condition	-	Ensure an accessible route of 4' min. (recommend 5' min.) width is provided. If the accessible route is less than 5' wide, ensure passing spaces of 60" min. by 60" min. at intervals of 200 feet max. are provided.	1	-	\$0
158	Prospect Street House 20	Ext.		Walking Surface	Sidewalk

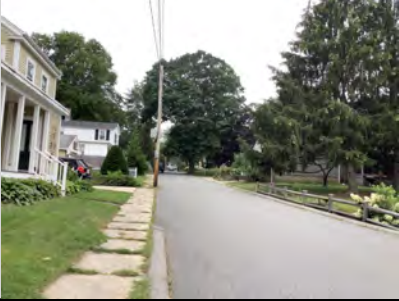
Route not maintained in operable working condition	-	Ensure an accessible route of 4' min. (recommend 5' min.) width is provided. If the accessible route is less than 5' wide, ensure passing spaces of 60" min. by 60" min. at intervals of 200 feet max. are provided.	1	-	\$0

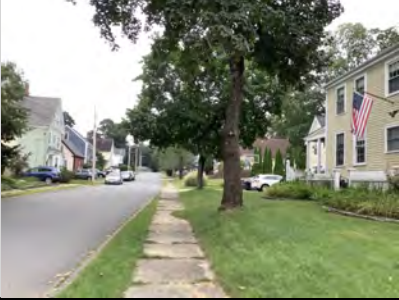
159	Summer Street House 20	Ext.		Walking Surface	Sidewalk

Route not maintained in operable working condition	-	Ensure an accessible route of 4' min. (recommend 5' min.) width is provided. If the accessible route is less than 5' wide, ensure passing spaces of 60" min. by 60" min. at intervals of 200 feet max. are provided.	1	-	\$0
160	Summer Street Opposite House 20	Ext.		Walking Surface	Sidewalk

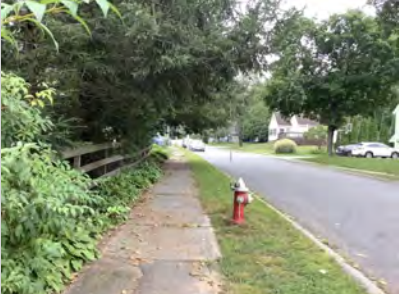
Route not maintained in operable working condition	-	Ensure an accessible route of 4' min. (recommend 5' min.) width is provided. If the accessible route is less than 5' wide, ensure passing spaces of 60" min. by 60" min. at intervals of 200 feet max. are provided.	1	-	\$0

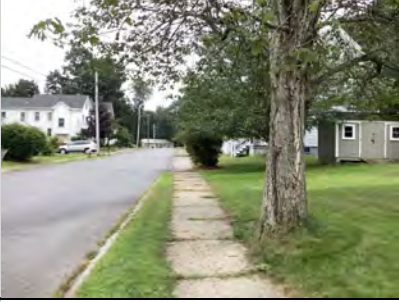
ID	Location	Floor	Room	Element	Type	Photo	Issues	Current Measure	Recommendations	Quantity	Price	Cost Estimation
161	Summer Street Opposite House 13	Ext.		Walking Surface	Sidewalk

Route not maintained in operable working condition	-	Ensure an accessible route of 4' min. (recommend 5' min.) width is provided. If the accessible route is less than 5' wide, ensure passing spaces of 60" min. by 60" min. at intervals of 200 feet max. are provided.	1	-	\$0
162	Summer Street House 13	Ext.		Walking Surface	Sidewalk

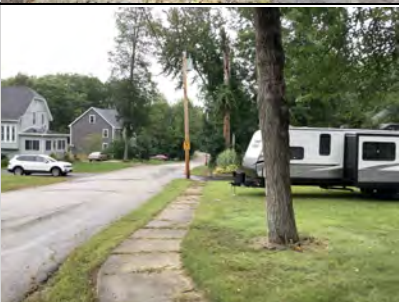
Route not maintained in operable working condition	-	Ensure an accessible route of 4' min. (recommend 5' min.) width is provided. If the accessible route is less than 5' wide, ensure passing spaces of 60" min. by 60" min. at intervals of 200 feet max. are provided.	1	-	\$0

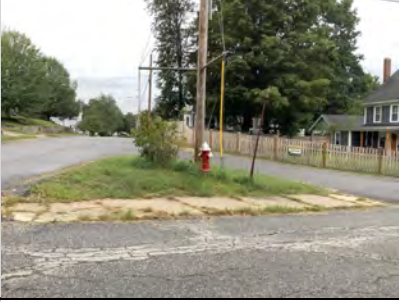
ID	Location	Floor	Room	Element	Type	Photo	Issues	Current Measure	Recommendations	Quantity	Price	Cost Estimation
166	Grove Street	Ext.		Walking Surface	Sidewalk

Route not maintained in operable working condition	-	Ensure an accessible route of 4' min. (recommend 5' min.) width is provided. If the accessible route is less than 5' wide, ensure passing spaces of 60" min. by 60" min. at intervals of 200 feet max. are provided.	1	-	\$0
167	Prospect Street House 4	Ext.		Walking Surface	Sidewalk

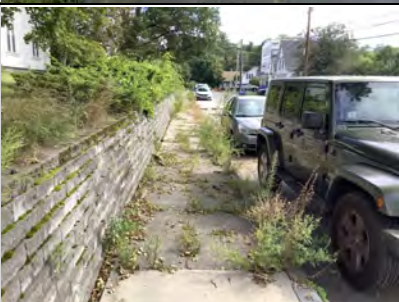
Route not maintained in operable working condition	-	Ensure an accessible route of 4' min. (recommend 5' min.) width is provided. If the accessible route is less than 5' wide, ensure passing spaces of 60" min. by 60" min. at intervals of 200 feet max. are provided.	1	-	\$0

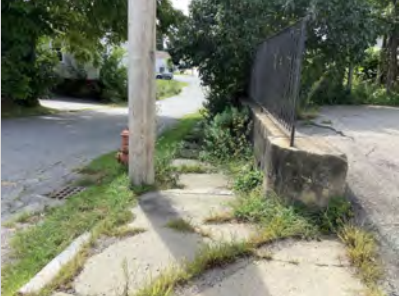
ID	Location	Floor	Room	Element	Type	Photo	Issues	Current Measure	Recommendations	Quantity	Price	Cost Estimation
171	Liberty Street	Ext.		Walking Surface	Sidewalk

Route not maintained in operable working condition	-	Ensure an accessible route of 4' min. (recommend 5' min.) width is provided. If the accessible route is less than 5' wide, ensure passing spaces of 60" min. by 60" min. at intervals of 200 feet max. are provided.	1	-	\$0
172	Green Street House 39	Ext.		Walking Surface	Sidewalk

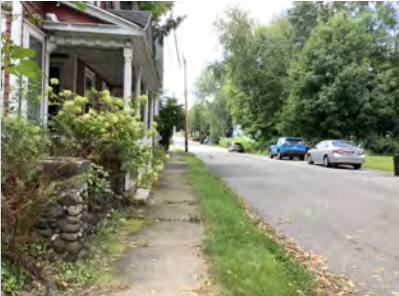
Route not maintained in operable working condition	-	Ensure an accessible route of 4' min. (recommend 5' min.) width is provided. If the accessible route is less than 5' wide, ensure passing spaces of 60" min. by 60" min. at intervals of 200 feet max. are provided.	1	-	\$0
173	Middle Street	Ext.		Walking Surface	Sidewalk

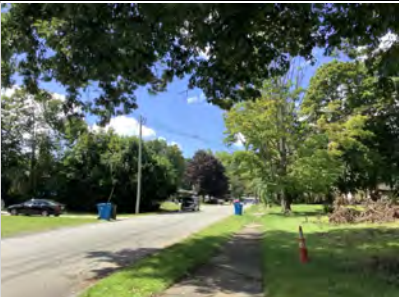
Route not maintained in operable working condition	-	Ensure an accessible route of 4' min. (recommend 5' min.) width is provided. If the accessible route is less than 5' wide, ensure passing spaces of 60" min. by 60" min. at intervals of 200 feet max. are provided.	1	-	\$0

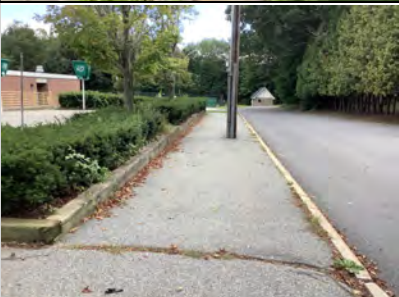
174	Helen R. Donaghue School	Ext.		Walking Surface	Sidewalk

Route not maintained in operable working condition	-	Ensure an accessible route of 4' min. (recommend 5' min.) width is provided. If the accessible route is less than 5' wide, ensure passing spaces of 60" min. by 60" min. at intervals of 200 feet max. are provided.	1	-	\$0
175	Helen R. Donaghue School	Ext.		Walking Surface	Sidewalk

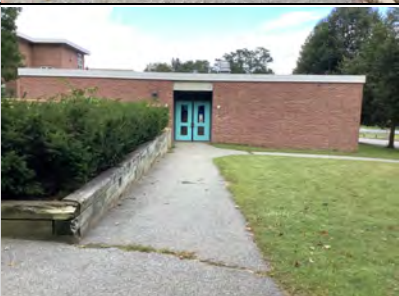
Route not maintained in operable working condition	-	Ensure route is maintained in operable working condition.	1	-	\$0

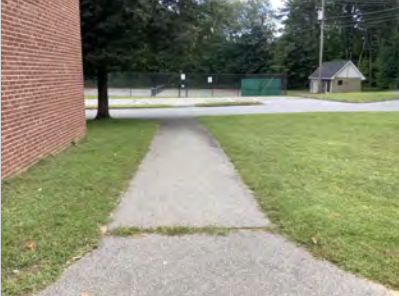
ID	Location	Floor	Room	Element	Type	Photo	Issues	Current Measure	Recommendations	Quantity	Price	Cost Estimation
176	Helen R. Donaghue School	Ext.		Walking Surface	Sidewalk

Route not maintained in operable working condition	-	Ensure route is maintained in operable working condition.	1	-	\$0
177	Adams Street	Ext.		Walking Surface	Sidewalk

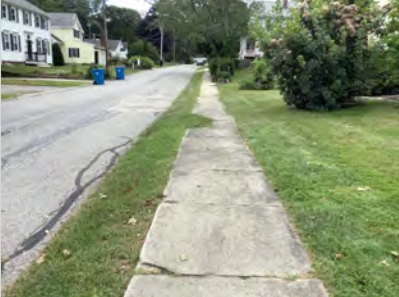
Route not maintained in operable working condition	-	Ensure an accessible route of 4' min. (recommend 5' min.) width is provided. If the accessible route is less than 5' wide, ensure passing spaces of 60" min. by 60" min. at intervals of 200 feet max. are provided.	1	-	\$0
178	Locust Street at Paul C. Rogers Funeral Home	Ext.		Walking Surface	Sidewalk

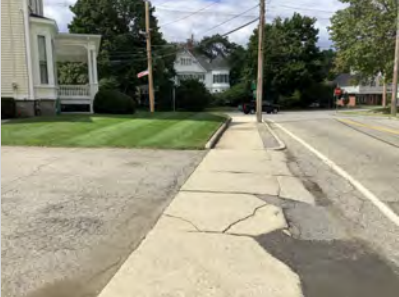
Route not maintained in operable working condition	-	Ensure an accessible route of 4' min. (recommend 5' min.) width is provided. If the accessible route is less than 5' wide, ensure passing spaces of 60"min by 60" min at intervals of 200 feet max. are provided.	1	-	\$0

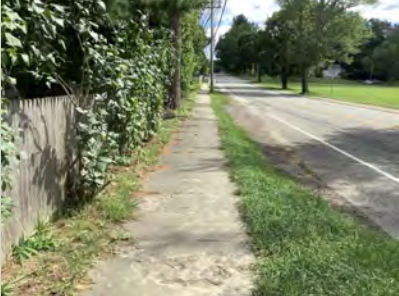
179	Locust Street House 24	Ext.		Walking Surface	Sidewalk

Route not maintained in operable working condition	-	Ensure an accessible route of 4' min. (recommend 5' min.) width is provided. If the accessible route is less than 5' wide, ensure passing spaces of 60" min. by 60" min. at intervals of 200 feet max. are provided.	1	-	\$0
180	School Street Opposite Town Hall	Ext.		Walking Surface	Sidewalk

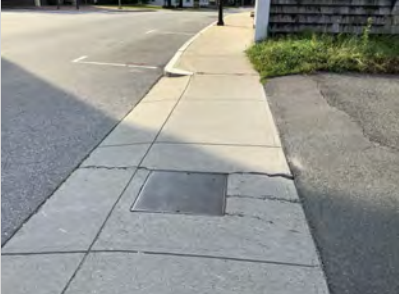
Route not maintained in operable working condition	-	Ensure route is maintained in operable working condition.	1	-	\$0

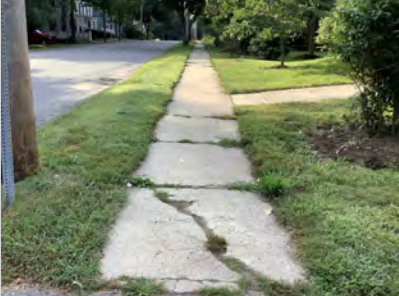
ID	Location	Floor	Room	Element	Type	Photo	Issues	Current Measure	Recommendations	Quantity	Price	Cost Estimation
181	Intersection School Street and Central Street	Ext.		Walking Surface	Sidewalk

Route not maintained in operable working condition	-	Ensure an accessible route of 4' min. (recommend 5' min.) width is provided. If the accessible route is less than 5' wide, ensure passing spaces of 60" min. by 60" min. at intervals of 200 feet max. are provided.	1	-	\$0
182	School Street House 49	Ext.		Walking Surface	Sidewalk

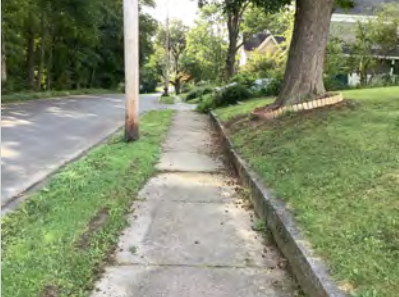
Route not maintained in operable working condition	-	Ensure an accessible route of 4' min. (recommend 5' min.) width is provided. If the accessible route is less than 5' wide, ensure passing spaces of 60" min. by 60" min. at intervals of 200 feet max. are provided.	1	-	\$0
183	School Street House 49	Ext.		Walking Surface	Sidewalk

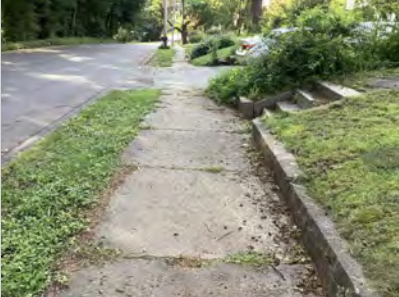
Route not maintained in operable working condition	-	Ensure an accessible route of 4' min. (recommend 5' min.) width is provided. If the accessible route is less than 5' wide, ensure passing spaces of 60" min. by 60" min. at intervals of 200 feet max. are provided.	1	-	\$0

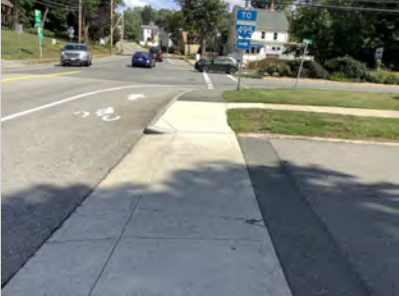
184	East Main Street Bank of America ATM	Ext.		Walking Surface	Sidewalk

Route not maintained in operable working condition	-	Ensure route is maintained in operable working condition.	1	-	\$0
185	East Main Street Bank of America ATM	Ext.		Walking Surface	Sidewalk

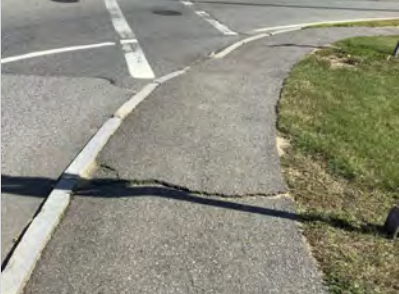
Route not maintained in operable working condition	-	Ensure an accessible route of 4' min. (recommend 5' min.) width is provided. If the accessible route is less than 5' wide, ensure passing spaces of 60" min. by 60" min. at intervals of 200 feet max. are provided.	1	-	\$0

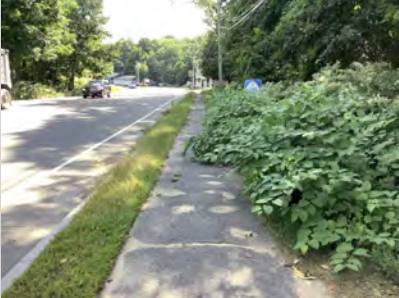
ID	Location	Floor	Room	Element	Type	Photo	Issues	Current Measure	Recommendations	Quantity	Price	Cost Estimation
186	Broad Street	Ext.		Walking Surface	Sidewalk

Route not maintained in operable working condition	-	Ensure an accessible route of 4' min. (recommend 5' min.) width is provided. If the accessible route is less than 5' wide, ensure passing spaces of 60" min. by 60" min. at intervals of 200 feet max. are provided.	1	-	\$0
187	Broad Street	Ext.		Walking Surface	Sidewalk

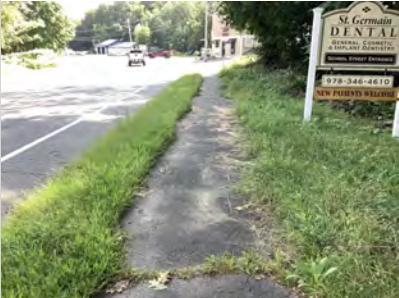
Route not maintained in operable working condition	-	Ensure an accessible route of 4' min. (recommend 5' min.) width is provided. If the accessible route is less than 5' wide, ensure passing spaces of 60" min. by 60" min. at intervals of 200 feet max. are provided.	1	-	\$0
188	Intersection Broad Street and Lancaster Court	Ext.		Walking Surface	Sidewalk

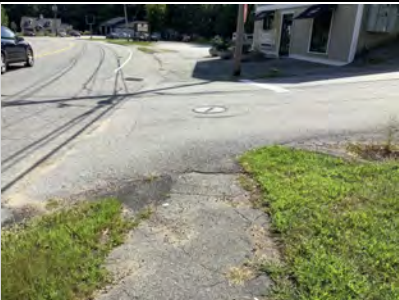
Route not maintained in operable working condition	-	Ensure an accessible route of 4' min. (recommend 5' min.) width is provided. If the accessible route is less than 5' wide, ensure passing spaces of 60" min. by 60" min. at intervals of 200 feet max. are provided.	1	-	\$0

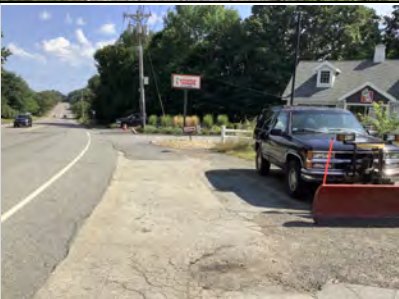
189	Broad Street Sloban Auto	Ext.		Walking Surface	Walkway

Route not maintained in operable working condition	-	Ensure an accessible route of 4' min. (recommend 5' min.) width is provided. If the accessible route is less than 5' wide, ensure passing spaces of 60" min. by 60" min. at intervals of 200 feet max. are provided.	1	-	\$0
190	Forest Street House 3	Ext.		Walking Surface	Sidewalk

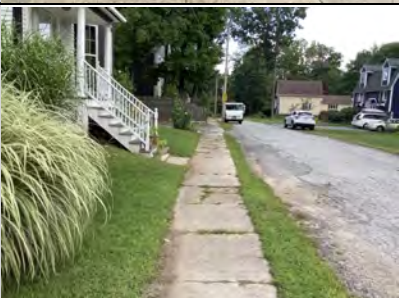
Route not maintained in operable working condition	-	Ensure an accessible route of 4' min. (recommend 5' min.) width is provided. If the accessible route is less than 5' wide, ensure passing spaces of 60" min. by 60" min. at intervals of 200 feet max. are provided.	1	-	\$0

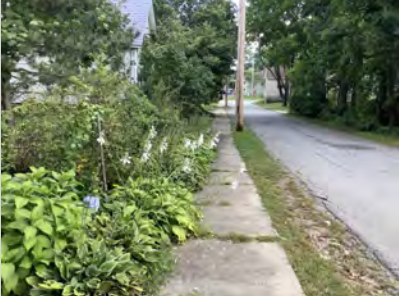
ID	Location	Floor	Room	Element	Type	Photo	Issues	Current Measure	Recommendations	Quantity	Price	Cost Estimation
191	Forest Street	Ext.		Walking Surface	Sidewalk

Route not maintained in operable working condition		Ensure an accessible route of 4' min. (recommend 5' min.) width is provided. If the accessible route is less than 5' wide, ensure passing spaces of 60" min. by 60" min. at intervals of 200 feet max. are provided.	1	-	\$0
192	Locust Street House 30	Ext.		Walking Surface	Sidewalk

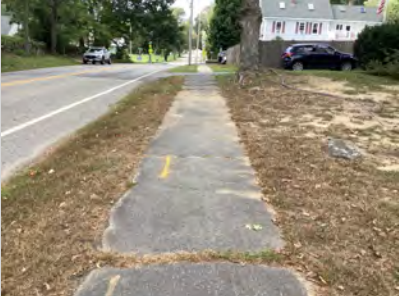
Route not maintained in operable working condition	-	Ensure an accessible route of 4' min. (recommend 5' min.) width is provided. If the accessible route is less than 5' wide, ensure passing spaces of 60" min. by 60" min. at intervals of 200 feet max. are provided.	1	-	\$0
193	Locust Street House 30	Ext.		Walking Surface	Sidewalk

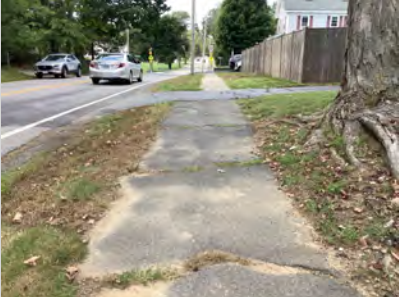
Route not maintained in operable working condition	-	Ensure an accessible route of 4' min. (recommend 5' min.) width is provided. If the accessible route is less than 5' wide, ensure passing spaces of 60" min. by 60" min. at intervals of 200 feet max. are provided.	1	-	\$0

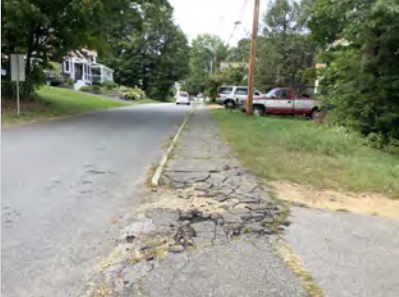
194	Union Street Ext. House 8	Ext.		Walking Surface	Sidewalk

Route not maintained in operable working condition	-	Ensure an accessible route of 4' min. (recommend 5' min.) width is provided. If the accessible route is less than 5' wide, ensure passing spaces of 60" min. by 60" min. at intervals of 200 feet max. are provided.	1	-	\$0
195	Union Street Ext.	Ext.		Walking Surface	Sidewalk

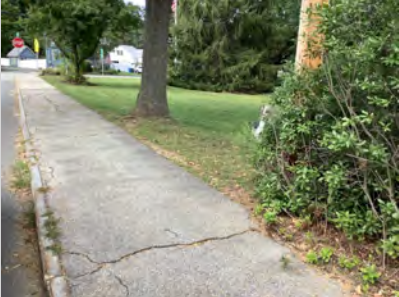
Route not maintained in operable working condition	-	Ensure an accessible route of 4' min. (recommend 5' min.) width is provided. If the accessible route is less than 5' wide, ensure passing spaces of 60" min. by 60" min. at intervals of 200 feet max. are provided.	1	-	\$0

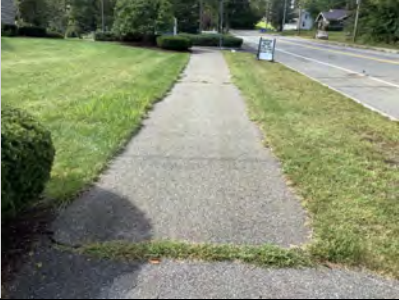
ID	Location	Floor	Room	Element	Type	Photo	Issues	Current Measure	Recommendations	Quantity	Price	Cost Estimation
196	West Main Street Public Library	Ext.		Walking Surface	Sidewalk

Route not maintained in operable working condition	-	Ensure route is maintained in operable working condition.	1	-	\$0
197	Broad Street Opposite BeWell	Ext.		Walking Surface	Sidewalk

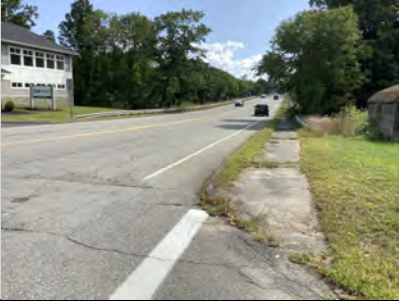
Route not maintained in operable working condition	-	Ensure an accessible route of 4' min. (recommend 5' min.) width is provided. If the accessible route is less than 5' wide, ensure passing spaces of 60" min. by 60" min. at intervals of 200 feet max. are provided.	1	-	\$0
198	Broad Street	Ext.		Walking Surface	Sidewalk

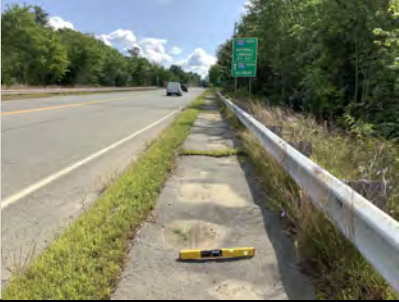
Route not maintained in operable working condition Does not prevent accumulation of water	- -	Repair surface. Ensure an accessible route of 4' min. (recommend 5' min.) width is provided. If the accessible route is less than 5' wide, ensure passing spaces of 60"min by 60" min at intervals of 200 feet max. are provided.	1	-	\$0

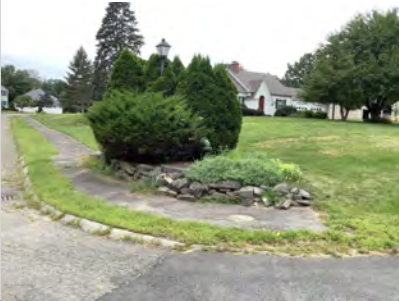
Curb Ramps and Blended Transitions												
Curb Ramp												
199	Willowdale Drive	Ext.		Curb Ramp	N/A

Curb ramp not provided	-	Provide a curb ramp at intersection.	1	-	\$0
200	Willowdale Drive House 27	Ext.		Curb Ramp	N/A

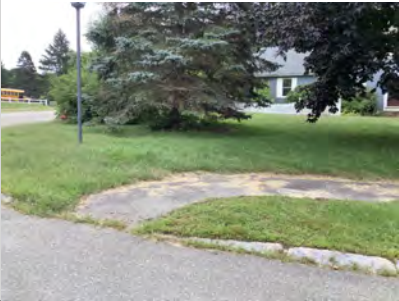
Curb ramp not provided	-	Provide a curb ramp at intersection.	1	-	\$0

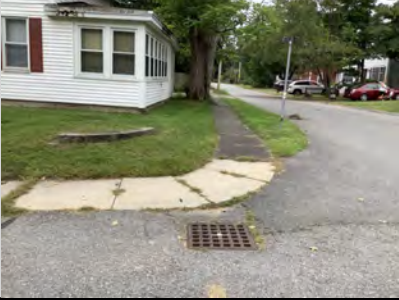
ID	Location	Floor	Room	Element	Type	Photo	Issues	Current Measure	Recommendations	Quantity	Price	Cost Estimation
201	Nichols Street House 24	Ext.		Curb Ramp	N/A

Curb ramp not provided	-	Provide a curb ramp at intersection.	1	-	\$0
202	Intersection Church Street and Winter Street	Ext.		Curb Ramp	N/A

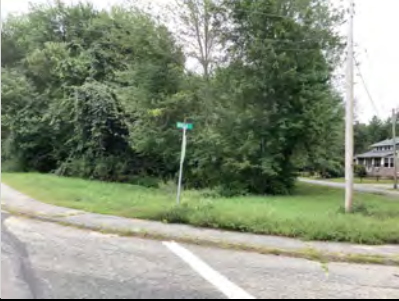
Curb ramp not provided	-	Provide a curb ramp at intersection.	1	-	\$0
203	Winter Street Opposite House 30	Ext.		Curb Ramp	N/A

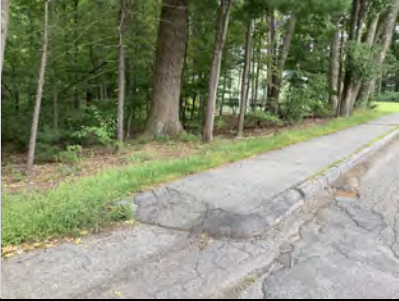
Curb ramp not provided	-	Provide a curb ramp at intersection.	1	-	\$0
204	Winter Street House 25	Ext.		Curb Ramp	N/A

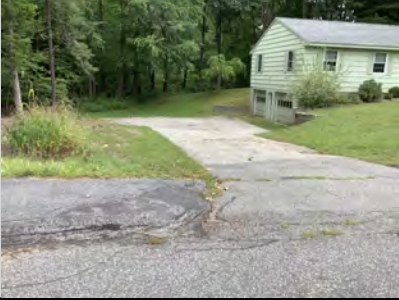
Curb ramp not provided	-	Provide a curb ramp at intersection.	1	-	\$0
205	Winter Street House 25	Ext.		Curb Ramp	N/A

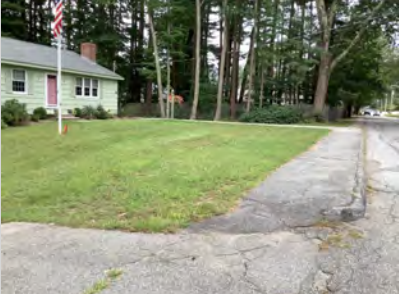
Curb ramp not provided	-	Provide a curb ramp at intersection.	1	-	\$0

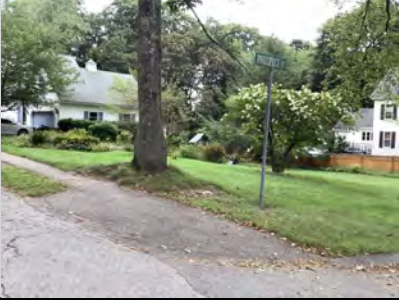
ID	Location	Floor	Room	Element	Type	Photo	Issues	Current Measure	Recommendations	Quantity	Price	Cost Estimation
206	Intersection Winter Street and Prospect Street	Ext.		Curb Ramp	N/A

Curb ramp not provided	-	Provide a curb ramp at intersection.	1	-	\$0
207	Intersection Winter Street and Prospect Street	Ext.		Curb Ramp	N/A

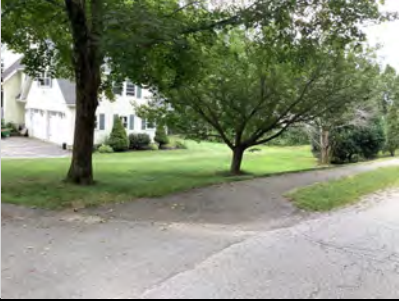
Curb ramp not provided	-	Provide a curb ramp at intersection.	1	-	\$0
208	Intersection Winter Street and Lincoln Street	Ext.		Curb Ramp	N/A

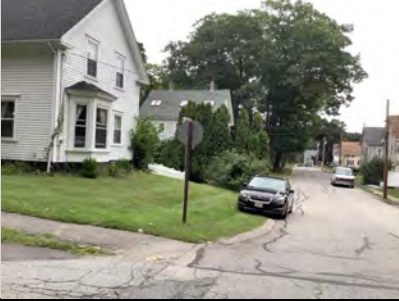
Curb ramp not provided	-	Provide a curb ramp at intersection.	1	-	\$0
209	Intersection Winter Street and Lincoln Street	Ext.		Curb Ramp	N/A

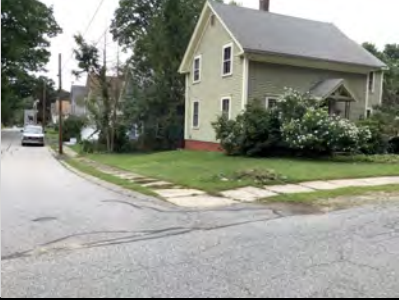
Curb ramp not provided	-	Provide a curb ramp at intersection.	1	-	\$0
210	Intersection Woodland Street and Vendome Street	Ext.		Curb Ramp	N/A

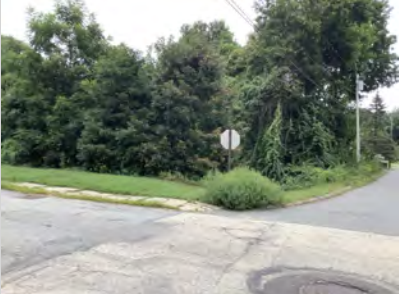
Curb ramp not provided	-	Provide a curb ramp at intersection.	1	-	\$0

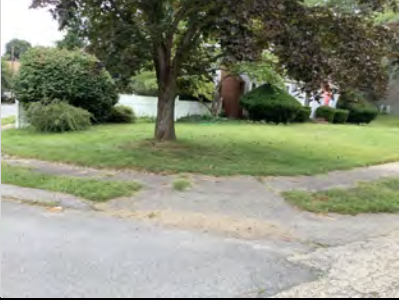
Curb ramp not provided	-	Provide a curb ramp at intersection.	1	-	\$0
212	Intersection Winter Street and Grove Street House 13	Ext.		Curb Ramp	N/A

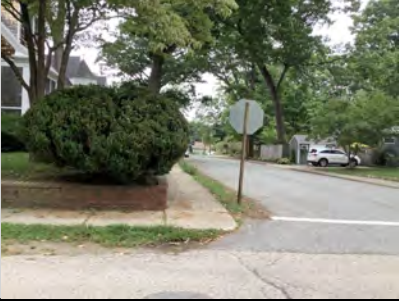
Curb ramp not provided	-	Provide a curb ramp at intersection.	1	-	\$0
213	Intersection Winter Street and Grove Street House 15	Ext.		Curb Ramp	N/A

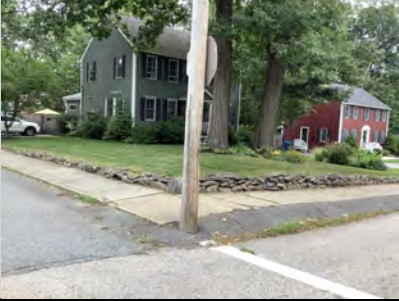
Curb ramp not provided	-	Provide a curb ramp at intersection.	1	-	\$0
214	Intersection Winter Street and Grove Street	Ext.		Curb Ramp	N/A

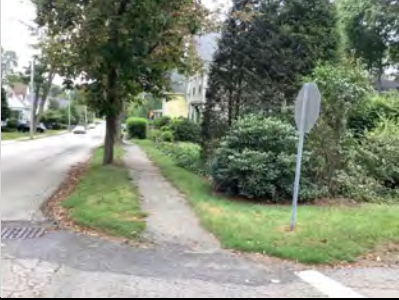
Curb ramp not provided	-	Provide a curb ramp at intersection.	1	-	\$0
215	Intersection Sawyer Street and Abbott Street	Ext.		Curb Ramp	N/A

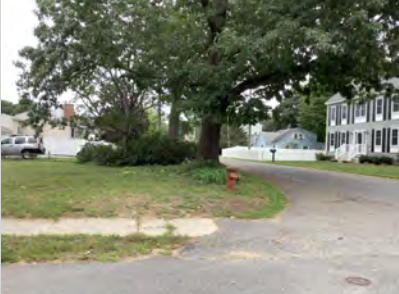
Curb ramp not provided	-	Provide a curb ramp at intersection.	1	-	\$0

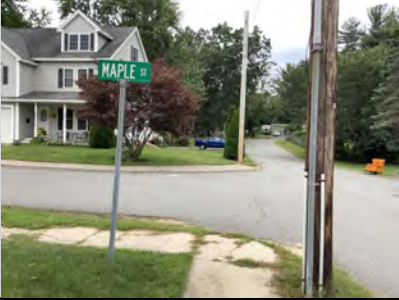
Curb ramp not provided	-	Provide a curb ramp at intersection.	1	-	\$0
217	Intersection Pine Street and Summer Street	Ext.		Curb Ramp	N/A

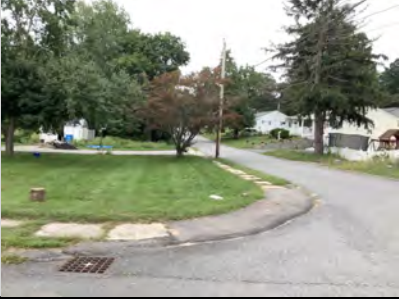
Curb ramp not provided	-	Provide a curb ramp at intersection.	1	-	\$0
218	Intersection Summer Street and Prospect Street	Ext.		Curb Ramp	N/A

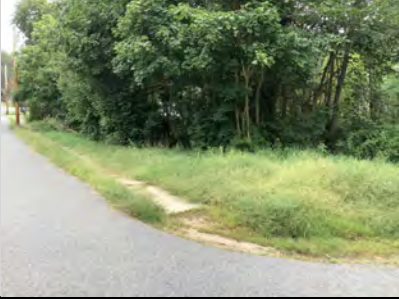
Curb ramp not provided	-	Provide a curb ramp at intersection.	1	-	\$0
219	Intersection Prospect Street and Summer Street Opposite House 20	Ext.		Curb Ramp	N/A

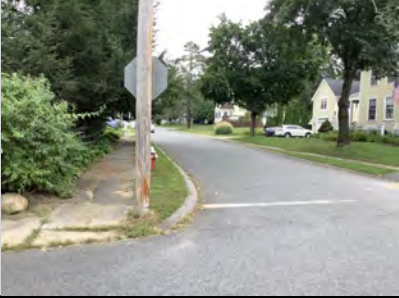
Curb ramp not provided	-	Provide a curb ramp at intersection.	1	-	\$0
220	Summer Street House 20	Ext.		Curb Ramp	N/A

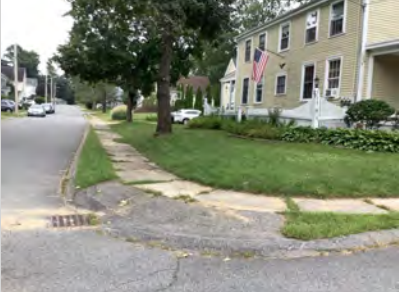
Curb ramp not provided	-	Provide a curb ramp at intersection.	1	-	\$0

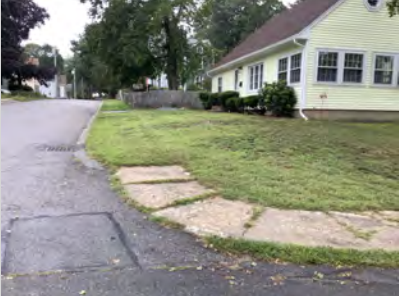
Curb ramp not provided	-	Provide a curb ramp at intersection.	1	-	\$0
222	Intersection Lincoln Street and Summer Street	Ext.		Curb Ramp	N/A

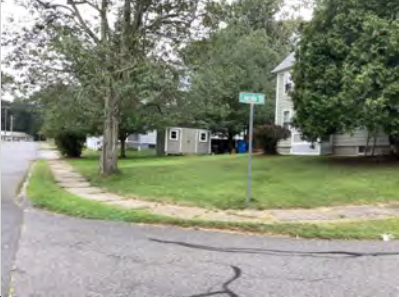
Curb ramp not provided	-	Provide a curb ramp at intersection.	1	-	\$0
223	Intersection Summer Street Vendome Street	Ext.		Curb Ramp	N/A

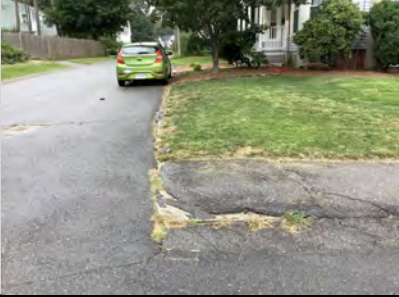
Curb ramp not provided	-	Provide a curb ramp at intersection.	1	-	\$0
224	Intersection Summer Street Vendome Street	Ext.		Curb Ramp	N/A

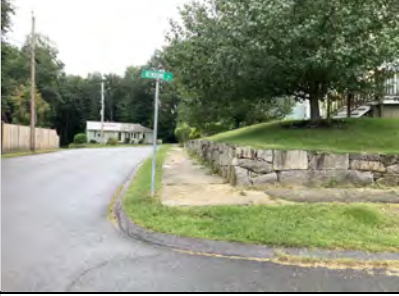
Curb ramp not provided	-	Provide a curb ramp at intersection.	1	-	\$0
225	Intersection Summer Street and Grove Street	Ext.		Curb Ramp	N/A

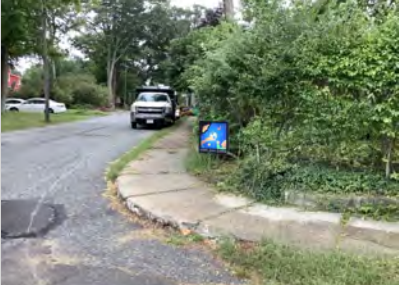
Curb ramp not provided	-	Provide a curb ramp at intersection.	1	-	\$0

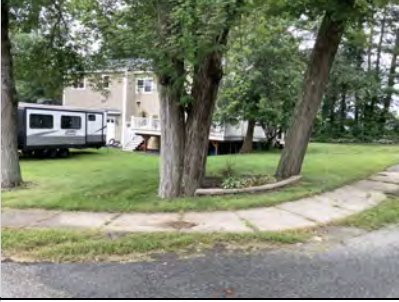
Curb ramp not provided	-	Provide a curb ramp at intersection.	1	-	\$0
227	Intersection Summer Street and Grove Street	Ext.		Curb Ramp	N/A

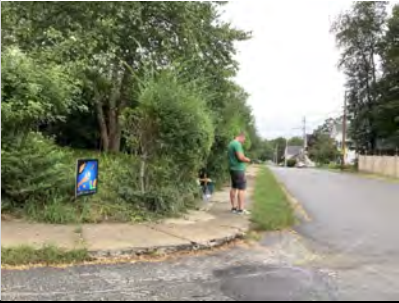
Curb ramp not provided	-	Provide a curb ramp at intersection.	1	-	\$0
228	Intersection Mechanic Street and Liberty Street	Ext.		Curb Ramp	N/A

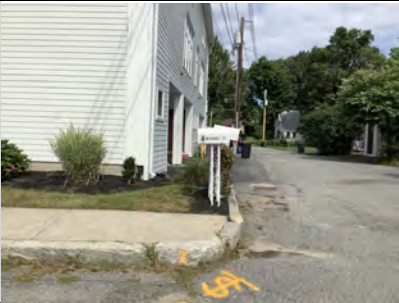
Curb ramp not provided	-	Provide a curb ramp at intersection.	1	-	\$0
229	Intersection Mechanic Street and Liberty Street	Ext.		Curb Ramp	N/A

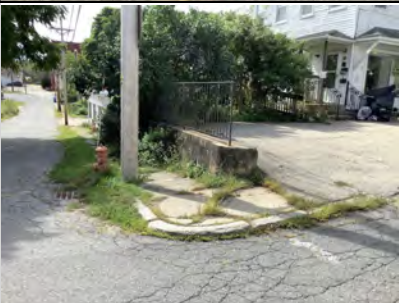
Curb ramp not provided	-	Provide a curb ramp at intersection.	1	-	\$0
230	Helen R. Donaghue School Union Street Ext.	Ext.		Curb Ramp	N/A

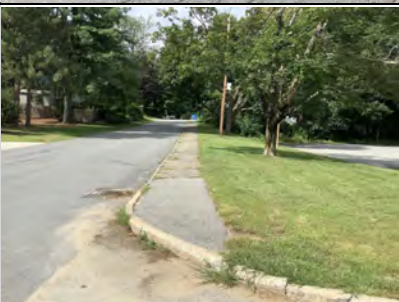
Curb ramp not provided	-	Provide a curb ramp at intersection.	1	-	\$0

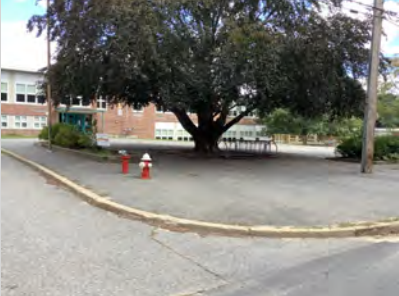
Curb ramp not provided	-	Provide a curb ramp at intersection.	1	-	\$0
232	Intersection Locust Street and Adams Street	Ext.		Curb Ramp	N/A

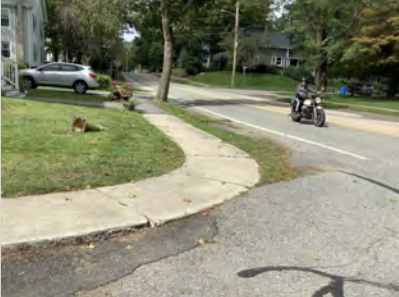
Curb ramp not provided	-	Provide a curb ramp at intersection.	1	-	\$0
233	Intersection Locust Street and Green Street	Ext.		Curb Ramp	N/A

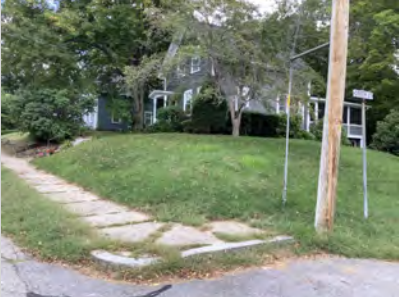
Curb ramp not provided	-	Provide a curb ramp at intersection.	1	-	\$0
234	Intersection Locust Street and Green Street	Ext.		Curb Ramp	N/A

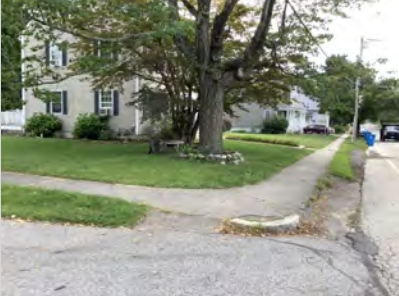
Curb ramp not provided	-	Provide a curb ramp at intersection.	1	-	\$0
235	Intersection Locust Street and Pleasant Street	Ext.		Curb Ramp	N/A

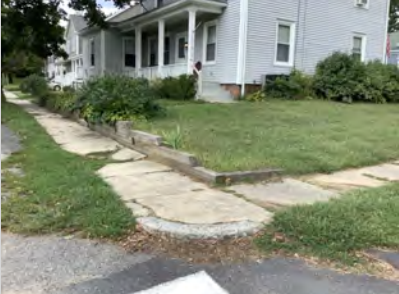
Curb ramp not provided	-	Provide a curb ramp at intersection.	1	-	\$0

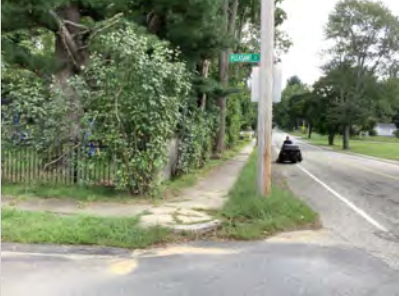
Curb ramp not provided	-	Provide a curb ramp at intersection.	1	-	\$0
237	Intersection School Street and Green Street	Ext.		Curb Ramp	N/A

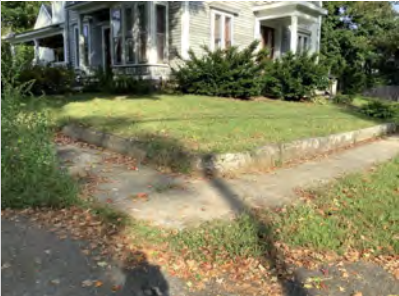
Curb ramp not provided	-	Provide a curb ramp at intersection.	1	-	\$0
238	Intersection School Street and Green Street	Ext.		Curb Ramp	N/A

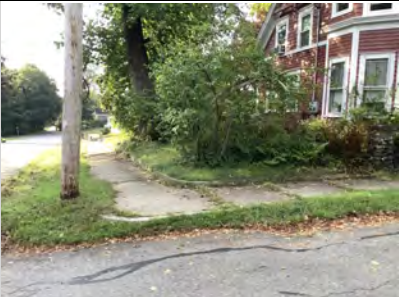
Curb ramp not provided	-	Provide a curb ramp at intersection.	1	-	\$0
239	Intersection School Street and Pleasant Street	Ext.		Curb Ramp	N/A

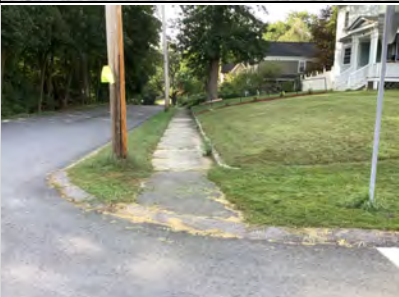
Curb ramp not provided	-	Provide a curb ramp at intersection.	1	-	\$0
240	Intersection School Street and Middle Street	Ext.		Curb Ramp	N/A

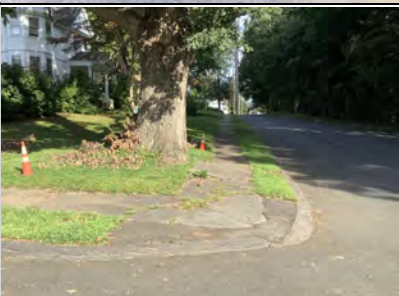
Curb ramp not provided	-	Provide a curb ramp at intersection.	1	-	\$0

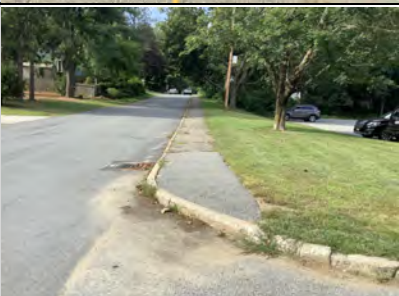
Curb ramp not provided	-	Provide a curb ramp at intersection.	1	-	\$0
