Town of Merrimac, Massachusetts

PART A – Executive Summary

September 2021

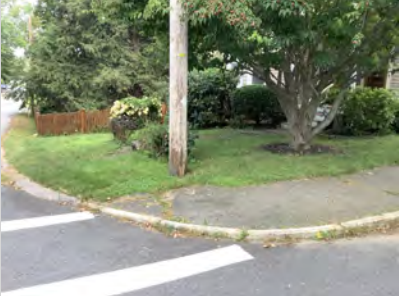
Curb ramp not provided	-	Provide a curb ramp at intersection.	1	-	\$0
247	Intersection Union Street Ext. and Adams Street	Ext.		Curb Ramp	N/A

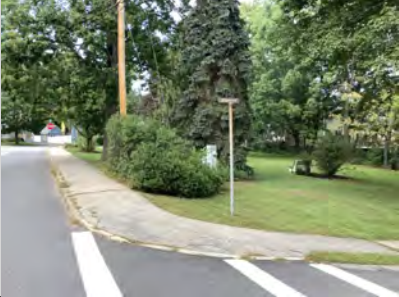
Curb ramp not provided	-	Provide a curb ramp at intersection.	1	-	\$0
248	Broad Street	Ext.		Curb Ramp	N/A

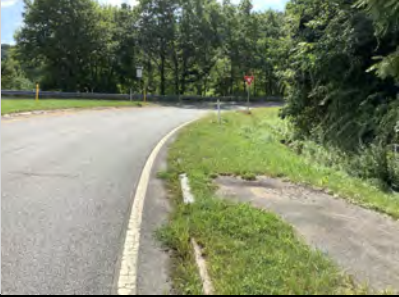
Curb ramp not provided	-	Provide a curb ramp at intersection.	1	-	\$0
249	Broad Street	Ext.		Curb Ramp	N/A

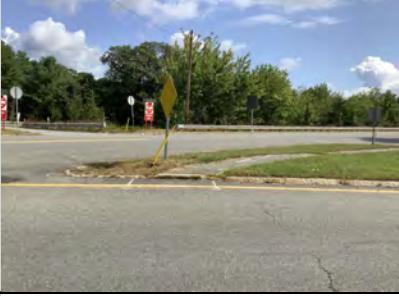
Curb ramp not provided	-	Provide a curb ramp at intersection.	1	-	\$0
250	Broad Street	Ext.		Curb Ramp	N/A

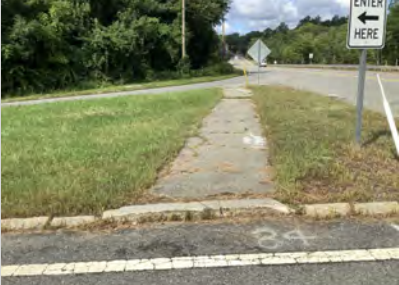
Curb ramp not provided	-	Provide a curb ramp at intersection.	1	-	\$0

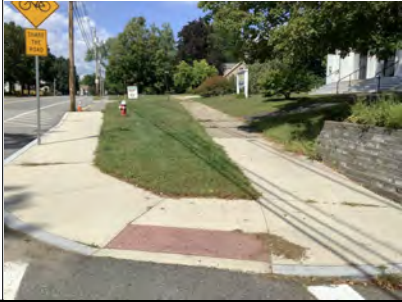
Width of curb ramp < 36" Transition from curb ramp to street not flush	-	Ensure that a clear width of 36" min. is maintained at the curb ramp. Ensure transition from curb ramp to street is flush or free of changes in level.	1	-	\$0
253	Intersection School Street and Lancaster Court	Ext.		Diagonal Curb Ramp	N/A

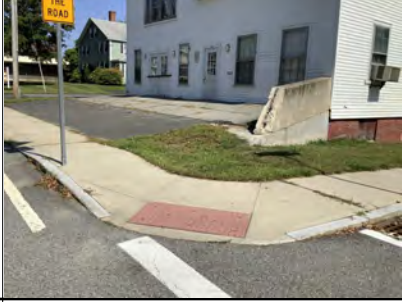
Transition from curb ramp to street not flush	-	Ensure transition from curb ramp to street is flush or free of changes in level.	1	-	\$0
254	Roundabout School Street	Ext.		Diagonal Curb Ramp	N/A

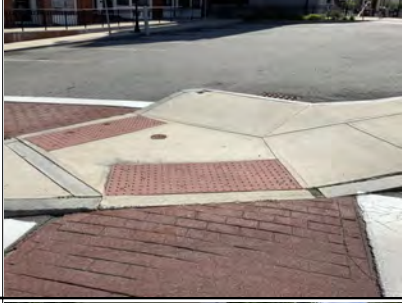
Transition from curb ramp to street not flush	-	Ensure transition from curb ramp to street is flush or free of changes in level.	1	-	\$0

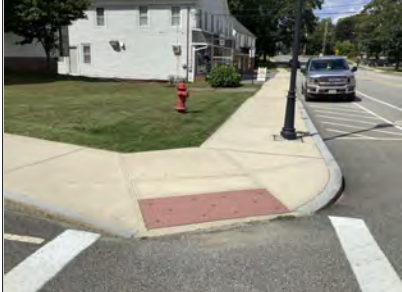
255	Intersection Church Street and Grove Street	Ext.		Diagonal Curb Ramp	N/A

Transition from curb ramp to street not flush	-	Ensure transition from curb ramp to street is flush or free of changes in level.	1	-	\$0

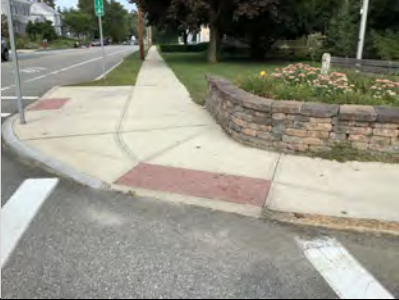
Transition from curb ramp to street not flush	-	Ensure transition from curb ramp to street is flush or free of changes in level.	1	-	\$0
257	Intersection East Main Street and Broad Street	Ext.		Diagonal Curb Ramp	N/A

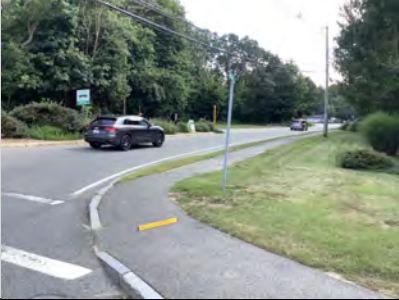
Transition from curb ramp to street not flush Running slope > 1:12 (8.33%) Curb ramp flares > 1:12 (8.33%) (if no landing or < 48") Detectable warnings not provided	- 11.2% 18% -	Ensure transition from curb ramp to street is flush or free of changes in level. Reduce running slope to be no steeper than 1:12 (8.33%). Reduce slope at curb ramp flares to be no steeper than 1:12 (8.33%). Provide detectable warnings on the curb ramp.	1	-	\$0
258	Roundabout Real Estate	Ext.		Diagonal Curb Ramp	N/A

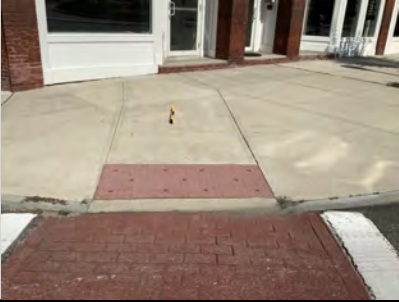
Landing > 1:50 (2.00%)	6%	Reduce slope to be no steeper than 1:50 (2.00%).	1	-	\$0

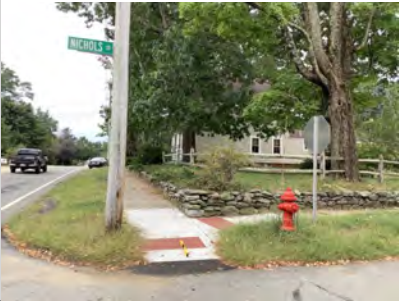
Perpendicular Curb Ramp												
259	Intersection Church Street and Nichols Street	Ext.		Perpendicular Curb Ramp	N/A

Running slope > 1:12 (8.33%) Landing > 1:50 (2.00%)	13.2% 10.6%	Reduce slope to be no steeper than 1:50 (2.00%). Reduce running slope to be no steeper than 1:12 (8.33%).	1	-	\$0
260	Intersection Church Street and Pine Street	Ext.		Perpendicular Curb Ramp	N/A

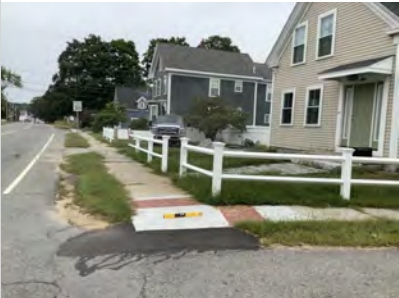
Cross slope > 1:50 (2.00%)	4.8%	Reduce cross slope to be no steeper than 1:50 (2.00%).	1	-	\$0

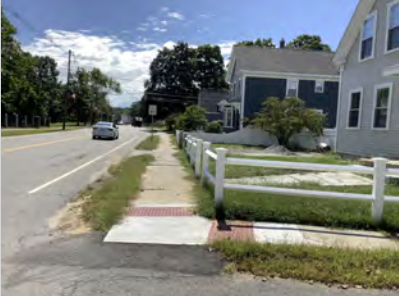
Cross slope > 1:50 (2.00%)	5%	Reduce cross slope to be no steeper than 1:50 (2.00%).	1	-	\$0
262	Intersection Locust Street and Union Street	Ext.		Perpendicular Curb Ramp	N/A

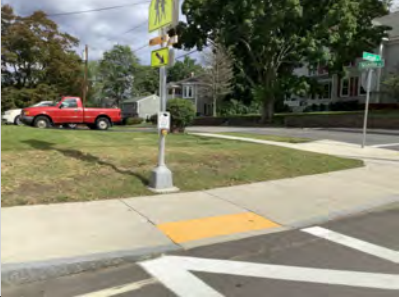
Transition from curb ramp to street not flush	-	Ensure transition from curb ramp to street is flush or free of changes in level.	1	-	\$0
263	Intersection Locust Street and Union Street (School Side)	Ext.		Perpendicular Curb Ramp	N/A

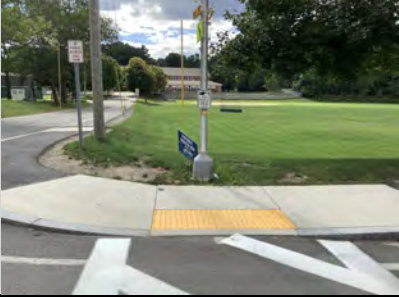
Transition from curb ramp to street not flush	-	Ensure transition from curb ramp to street is flush or free of changes in level.	1	-	\$0
264	Roundabout School Street	Ext.		Perpendicular Curb Ramp	N/A

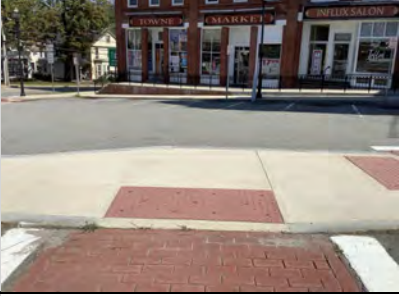
Transition from curb ramp to street not flush	-	Ensure transition from curb ramp to street is flush or free of changes in level.	1	-	\$0

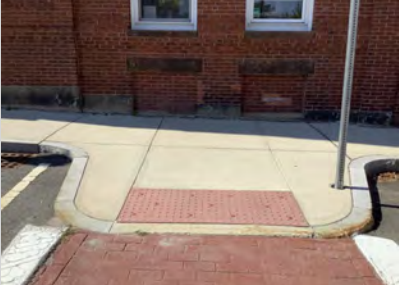
265	Roundabout Church Street	Ext.		Perpendicular Curb Ramp	N/A

Transition from curb ramp to street not flush	-	Ensure transition from curb ramp to street is flush or free of changes in level.	1	-	\$0

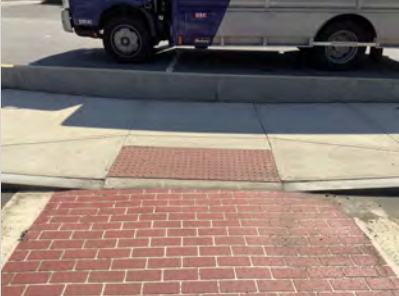
Transition from curb ramp to street not flush	-	Ensure transition from curb ramp to street is flush or free of changes in level.	1	-	\$0
267	Intersection West Main Street and Forest Street	Ext.		Perpendicular Curb Ramp	N/A

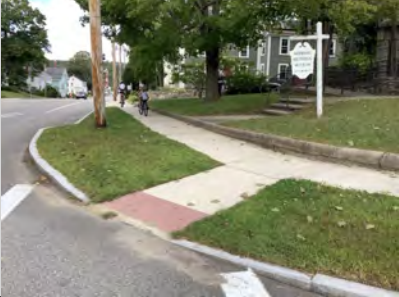
Transition from curb ramp to street not flush	-	Ensure transition from curb ramp to street is flush or free of changes in level.	1	-	\$0
268	West Main Street Public Library Bus Stop	Ext.		Perpendicular Curb Ramp	N/A

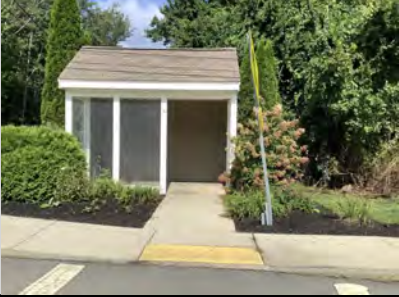
Transition from curb ramp to street not flush	-	Ensure transition from curb ramp to street is flush or free of changes in level.	1	-	\$0
269	West Main Street	Ext.		Perpendicular Curb Ramp	N/A

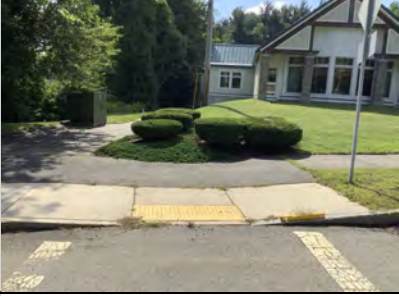
Transition from curb ramp to street not flush Curb ramp flares > 1:10 (10%) Landing > 1:50 (2.00%)	- 11.5% 4.4%	Reduce slope to be no steeper than 1:50 (2.00%). Ensure transition from curb ramp to street is flush or free of changes in level. Reduce slope at curb ramp flares to be no steeper than 1:10 (10%). Reduce slope to be no steeper than 1:50 (2.00%).	1	-	\$0

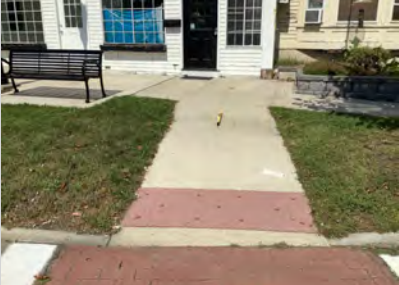
270	Roundabout East Main Street	Ext.		Perpendicular Curb Ramp	N/A

Transition from curb ramp to street not flush Landing > 1:50 (2.00%)	7.4%	Reduce slope to be no steeper than 1:50 (2.00%). Ensure transition from curb ramp to street is flush or free of changes in level. Reduce slope to be no steeper than 1:50 (2.00%).	1	-	\$0

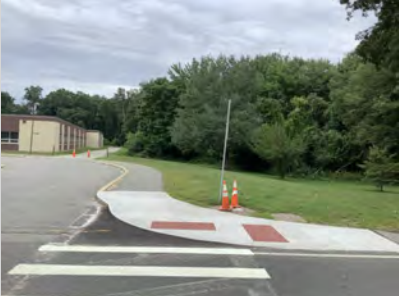
Transition from curb ramp to street not flush Does not prevent accumulation of water Detectable warnings not aligned with crosswalk	- - -	Ensure transition from curb ramp to street is flush or free of changes in level. Repair curb ramp to prevent accumulation of water. Provide detectable warning at edge of sidewalk to align with crosswalk.	1	-	\$0
272	Intersection Church Street and Grove Street	Ext.		Perpendicular Curb Ramp	N/A

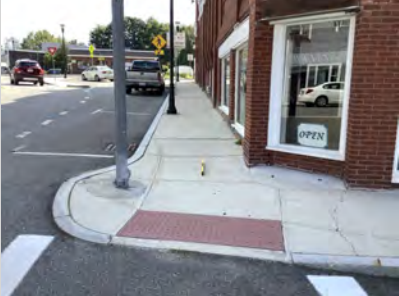
Landing > 1:50 (2.00%)	- 8.4%	Reduce slope to be no steeper than 1:50 (2.00%). Reduce slope to be no steeper than 1:50 (2.00%).	1	-	\$0
Parallel Curb Ramp												
273	Intersection Church Street and Maple Street	Ext.		Parallel Curb Ramp	N/A

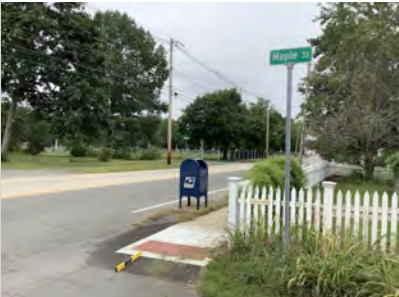
Running slope > 1:12 (8.33%)	13.5%	Reduce running slope to be no steeper than 1:12 (8.33%).	1	-	\$0

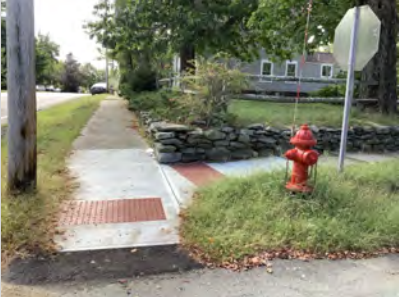
274	Intersection Nichols Street and Church Street	Ext.		Parallel Curb Ramp	N/A

Running slope > 1:12 (8.33%)	9.3%	Reduce running slope to be no steeper than 1:12 (8.33%). Reduce running slope to be no steeper than 1:12 (8.33%).	1	-	\$0
275	Intersection Church Street and Maple Street	Ext.		Parallel Curb Ramp	N/A

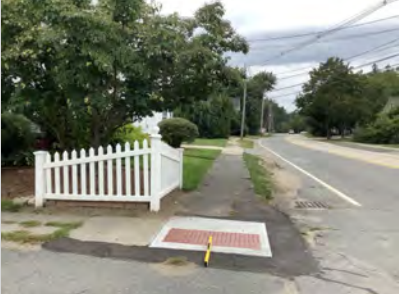
Running slope > 1:12 (8.33%) Transition from curb ramp to street not flush	15% -	Reduce running slope to be no steeper than 1:12 (8.33%). Ensure transition from curb ramp to street is flush or free of changes in level.	1	-	\$0

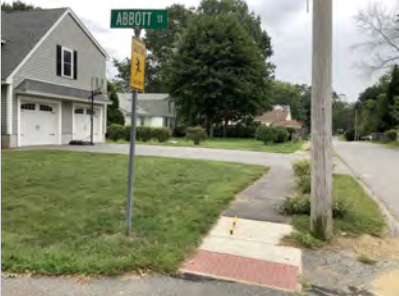
Route < 36" wide Landing > 1:50 (2.00%)	34" 6.9%	Ensure that a clear width of 36" min. is maintained at the accessible route. Reduce slope to be no steeper than 1:50 (2.00%).	1		\$0
277	School Street Town Hall	Ext.		Parallel Curb Ramp	N/A

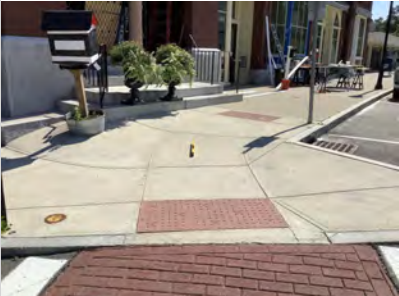
Landing > 1:50 (2.00%)	5.7%	Reduce slope to be no steeper than 1:50 (2.00%).	1	-	\$0
278	Intersection Liberty Street and East Main Street	Ext.		Parallel Curb Ramp	N/A

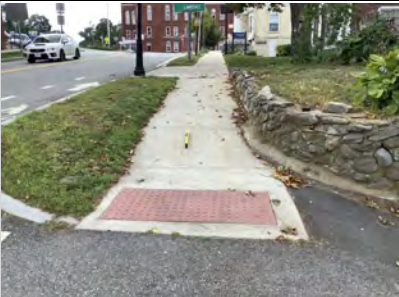
Landing > 1:50 (2.00%)	12.4%	Reduce slope to be no steeper than 1:50 (2.00%).	1	-	\$0
279	Union Street	Ext.		Parallel Curb Ramp	N/A

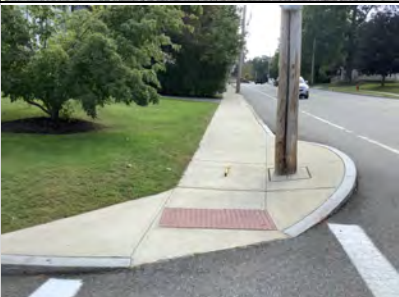
Landing > 1:50 (2.00%)	6.3%	Reduce slope to be no steeper than 1:50 (2.00%).	1	-	\$0
280	Roundabout East Main Street	Ext.		Parallel Curb Ramp	N/A

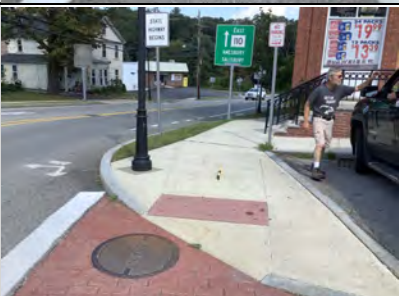
Landing > 1:50 (2.00%) Transition from curb ramp to street not flush	7.7% -	Reduce slope to be no steeper than 1:50 (2.00%). Ensure transition from curb ramp to street is flush or free of changes in level.	1	-	\$0

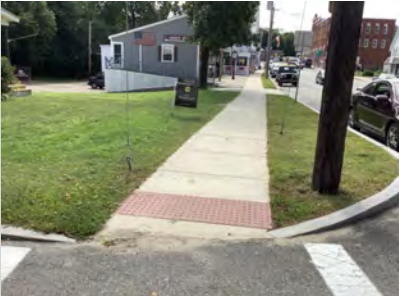
Does not prevent accumulation of water	-	Repair curb ramp to prevent accumulation of water.	1	-	\$0
283	Intersection Church Street and Pine Street	Ext.		Parallel Curb Ramp	N/A	 	Transition from curb ramp to street not flush	-	Ensure transition from curb ramp to street is flush or free of changes in level.	1	-	\$0
284	Intersection Maple Street and Church Street	Ext.		Parallel Curb Ramp	N/A

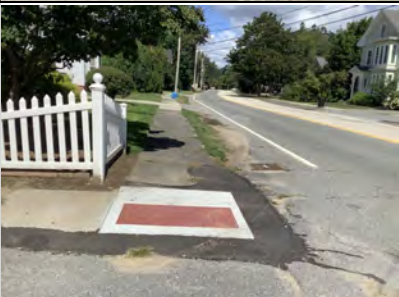
Transition from curb ramp to street not flush	-	Ensure transition from curb ramp to street is flush or free of changes in level.	1	-	\$0

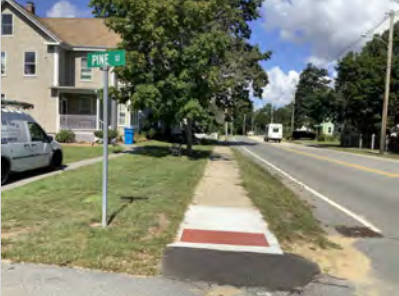
Transition from curb ramp to street not flush	-	Ensure transition from curb ramp to street is flush or free of changes in level.	1	-	\$0
287	School Street Rhythm Café	Ext.		Parallel Curb Ramp	N/A

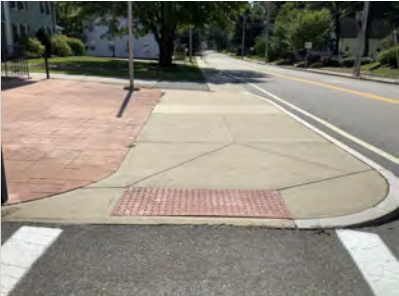
Transition from curb ramp to street not flush	-	Ensure transition from curb ramp to street is flush or free of changes in level.	1	-	\$0
288	School Street Town Hall	Ext.		Parallel Curb Ramp	N/A

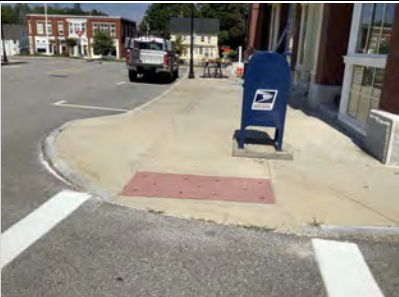
Transition from curb ramp to street not flush	-	Ensure transition from curb ramp to street is flush or free of changes in level.	1	-	\$0
289	East Main Street Cozy Cleaners	Ext.		Parallel Curb Ramp	N/A

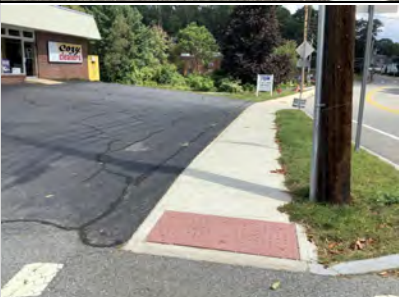
Transition from curb ramp to street not flush	-	Ensure transition from curb ramp to street is flush or free of changes in level.	1	-	\$0

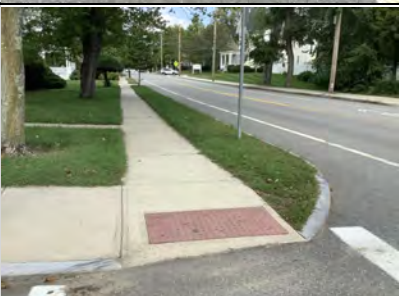
290	Intersection West Main Street and Forest Street	Ext.		Parallel Curb Ramp	N/A

Transition from curb ramp to street not flush	-	Ensure transition from curb ramp to street is flush or free of changes in level.	1	-	\$0

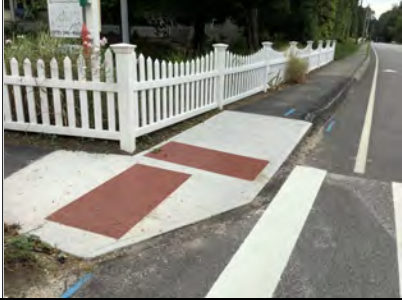
Detectable warnings not aligned with crosswalk	-	Provide detectable warning at edge of sidewalk to align with crosswalk.	1	-	\$0
On-Street Parking												
Parking Space												
293	Roundabout Church Street	Ext.		Parking Space	Marked

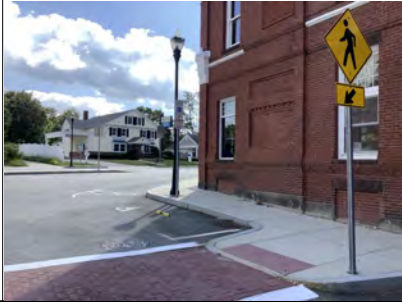
Cross slope at space > 1:50 (2.00%) Sign > 96" above finished grade	3.4% 120"	Reduce running or cross slope to be no steeper than 1:50 (2.00%) in all directions. Provide a sign with the top of the sign 96" max. above the ground.	1	-	\$0
Street Furniture

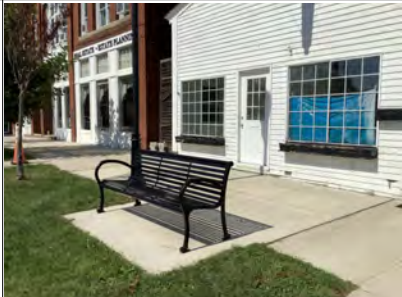
Benches & Seating												
294	Roundabout 10 Merrimac Square	Ext.		Benches & Seating	N/A

Clear floor space adjacent to the bench not provided	-	Ensure that at least 50% of benches at each location have a 30" min. by 48" min. clear floor space adjacent to the bench.	1	-	\$0

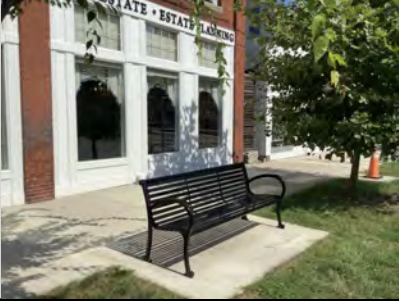
Clear floor space adjacent to the bench not provided	-	Ensure that at least 50% of benches at each location have a 30" min. by 48" min. clear floor space adjacent to the bench.	1	-	\$0
Best Practice												
296	Intersection Lincoln Street and Summer Street	Ext.			N/A

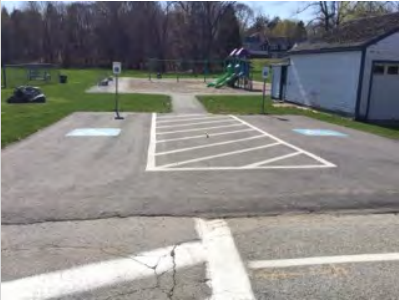
Total # of parking Total # of designated accessible parking spaces Total # of designated van accessible spaces Running or cross slope at access aisle > 1:50 (2.00%) Sign does not have the designation "Van Accessible"	2 1 1 4.2% -	Reduce running or cross slope to be no steeper than 1:50 (2.00%) in all directions. Add the designation "Van Accessible" to the sign located at the van accessible space. (Cost based on 8'x18' of asphalt to correct cross slope at access aisle and for a "Van Accessible" sign.)	1	1940	\$1940

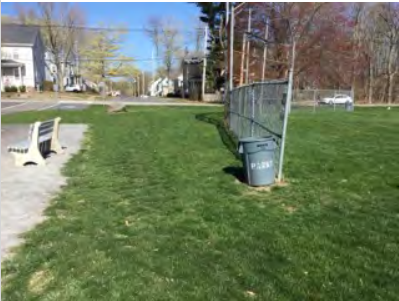
Access to Goods and Services												
Trash / Recycling												
3	Path Near Stevens Field	Ext.		Trash / Recycling	N/A

Trash container not connected to an accessible route	-	Ensure trash container is located on an accessible route. (Relocate trash container.)	1	Labor	\$0
Play and Sport Areas

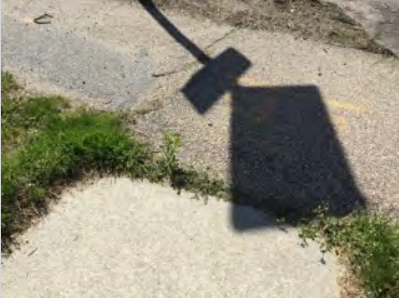
ID	Location	Floor	Room	Element	Type	Photo	Issues	Current Measure	Recommendations	Quantity	Price	Cost Estimation
Approach and Entrance												
Exterior Access Route												
1	At Sidewalk Facing East Main Street	Ext.		Exterior Access Route	Walkway

Surface openings > 1/2"	1"	Repair surface at walkway transition to sidewalk. (Cost based on an concrete patch.)	1	256	\$256
2	Parking to Bocce Ball	Ext.		Exterior Access Route	Exterior

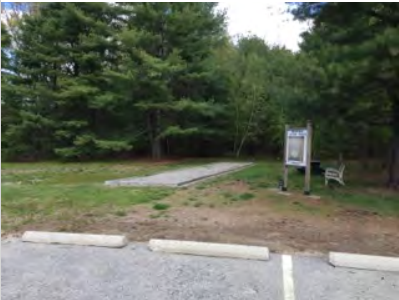
Accessible route not provided	-	Ensure an accessible route is provided between the parking and the bocce ball court. (Cost base on a 48" wide min. x 15' long asphalt route.)	1	600	\$600
3	Picnic Table and Bench Near Booce	Ext.		Exterior Access Route	Exterior

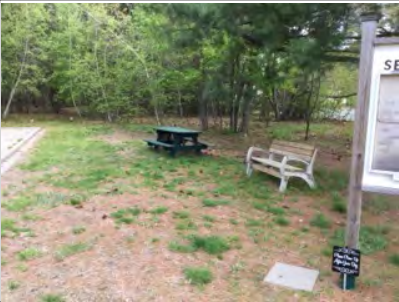
Accessible route not provided	-	Ensure an accessible route is provided to the accessible picnic table one it is provided and to the bench. (Cost base on a 48" wide min. x 15' long asphalt route.)	1	600	\$600

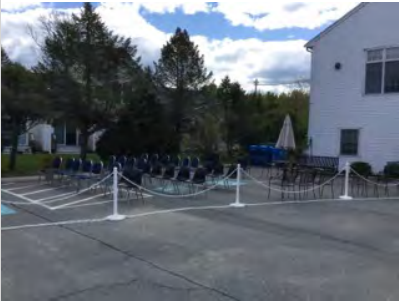
Off-Street Parking Lot or Garage												
4	Accessible Parking Near Main Entrance	Ext.		Off-Street Parking Lot or Garage	N/A

Total # of parking Total # of designated accessible parking spaces Total # of designated van accessible spaces Access aisle not compliant Sign not provided Sign does not have the designation "Van Accessible"	50 2 1 - - =	Remove items that are blocking the accessible parking spaces. Provide a sign with the International Symbol of Accessibility (ISA) at each space with the bottom of the sign 60" min. above the ground and the top 96" max. above the ground. Add the designation "Van Accessible" to the sign located at the van accessible space.	3	500	\$1500

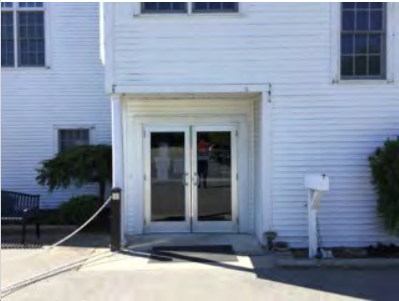
ID	Location	Floor	Room	Element	Type	Photo	Issues	Current Measure	Recommendations	Quantity	Price	Cost Estimation
Entrance												
5	Main Entrance to the Senior Center	Ext.		Entrance	Main Entrance

International Symbol of Accessibility not provided	-	Provide a sign with the International Symbol of Accessibility (ISA).	1	346	\$346
Emergency Exit												
6	Emergency Egress	1		Emergency Exit	N/A

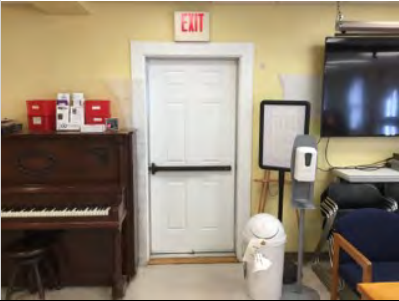
Tactile sign not provided at exit Directional sign to accessible emergency exit not provided	- -	Provide tactile exit signs with raised characters and braille at exit doors. Mount signs between 48"- 60" above the finished floor located on the latch side of the door. Provide a directional sign indicating the location of the nearest accessible emergency exit. When tactile sign is provided, provide clear floor space at sign on latch side.	1	232	\$232
7	Emergency Egress	1		Emergency Exit	N/A

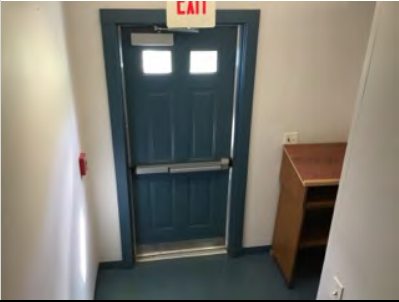
Tactile sign not provided at exit Directional sign to accessible emergency exit not provided	- -	Provide tactile exit signs with raised characters and braille at exit doors. Mount signs between 48"- 60" above the finished floor located on the latch side of the door. Provide a directional sign indicating the location of the nearest accessible emergency exit.	1	232	\$232

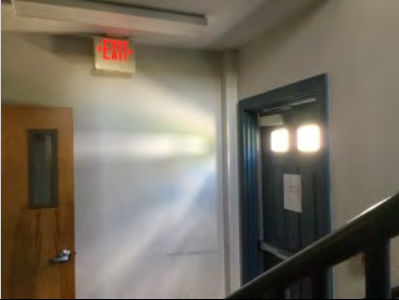
8	Emergency Egress	1		Emergency Exit	N/A

Tactile sign not provided at exit Illuminated Int. Symbol of Acc. not provided (MAAB)	- -	Ensure tactile exit signs with raised characters and braille are provided at exit doors. Mount signs between 48"- 60" above the finished floor located on the latch side of the door. If the exit sign is replaced with an illuminated exit sign, provide an illuminated International Symbol of Accessibility (ISA).	1	232	\$232
Access to Goods and Services

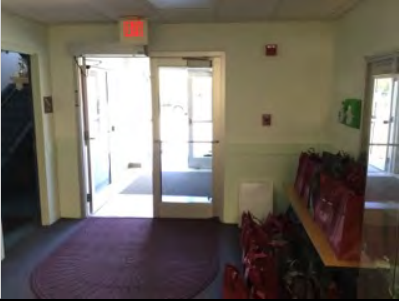
ID	Location	Floor	Room	Element	Type	Photo	Issues	Current Measure	Recommendations	Quantity	Price	Cost Estimation
Means of Egress												
9	Main Entrance and Egress at Parking Lot	1		Means of Egress	N/A

Tactile exit sign not provided Illuminated ISA symbol not provided (MAAB)	- -	Ensure tactile exit signs with raised characters and braille are provided at exit doors. Mount signs between 48"- 60" above the finished floor located on the latch side of the door. If the exit sign is replaced with an illuminated exit sign, provide an illuminated International Symbol of Accessibility (ISA).	1	232	\$232
10	Meeting Hall Accessible Egress	1		Means of Egress	N/A

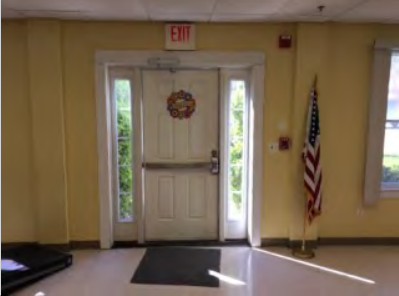
Tactile exit sign not provided Illuminated ISA symbol not provided (MAAB)	- -	Ensure tactile exit signs with raised characters and braille are provided at exit doors. Mount signs between 48"- 60" above the finished floor located on the latch side of the door. If the exit sign is replaced with an illuminated exit sign, provide an illuminated International Symbol of Accessibility (ISA).	1	232	\$232

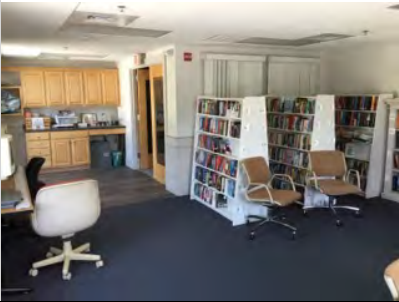
Interior Access Route												
11	Library Shelves	2		Interior Access Route	N/A

Route < 36" wide	24"	Ensure that a clear width of 36" min. is maintained at the accessible route between the bookshelves.	1	Labor	\$0
12	Coat Rod at Meeting Hall and Meeting Room	1 and 2		Interior Access Route	N/A

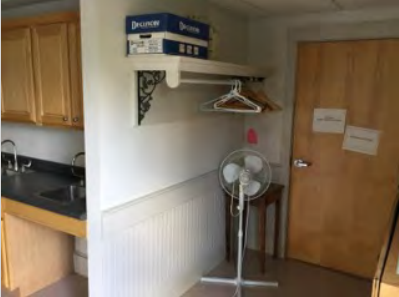
Obstructed by protruding objects	64"	Provide a cane-detectable barrier 27" max. above the finished floor below the protruding end of the coat rod.	2	306	\$612
Doors, Doorways, & Gates												
13	Men's Toilet Room	1		Doors, Doorways, & Gates	Toilet Room

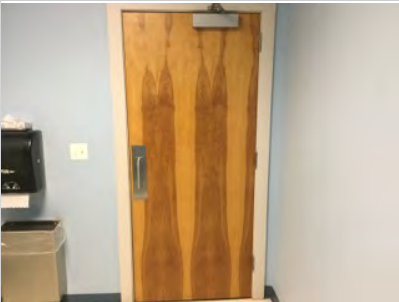
Maneuvering clearance(s) not provided	15"	Relocate trash receptacle to provide 18" min. pull-side maneuvering clearance at the door.	1	Labor	\$0

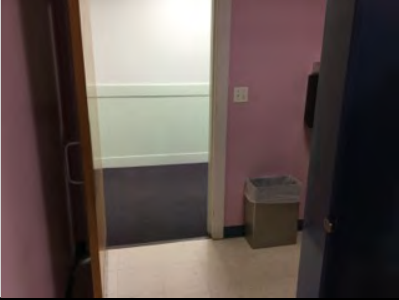
ID	Location	Floor	Room	Element	Type	Photo	Issues	Current Measure	Recommendations	Quantity	Price	Cost Estimation
14	Women's Toilet Room	1		Doors, Doorways, & Gates	Toilet Room

Maneuvering clearance(s) not provided	-	Remove trash can to provide 18" min. pull-side maneuvering clearance at door.	1	Labor	\$0
15	Door to Meeting Hall	1		Doors, Doorways, & Gates	Circulation

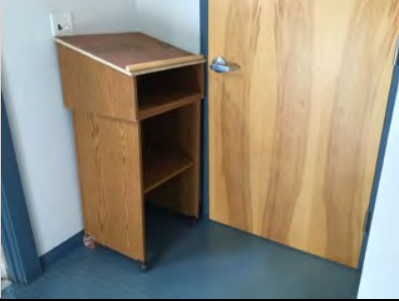
Maneuvering clearance(s) not provided	-	Remove podium to provide 18" min. pull-side maneuvering clearance at door.	1	Labor	\$0
16	Coat Rod at Meeting Room	2		Doors, Doorways, & Gates	Circulation

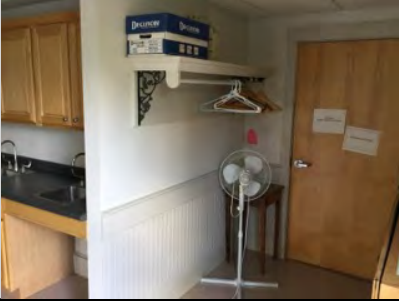
Maneuvering clearance(s) not provided	-	Relocate stored items to provide 18" min. pull-side maneuvering clearance at the door.	1	Labor	\$0
17	Meeting Hall Accessible Egress	1		Doors, Doorways, & Gates	Emergency Egress

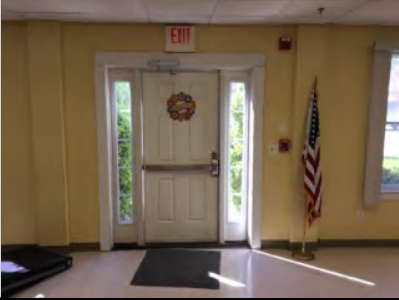
Mat not securely attached	-	Secure the mat.	1	Labor	\$0
18	Meeting Hall Egress	Ext.		Doors, Doorways, & Gates	Emergency Egress

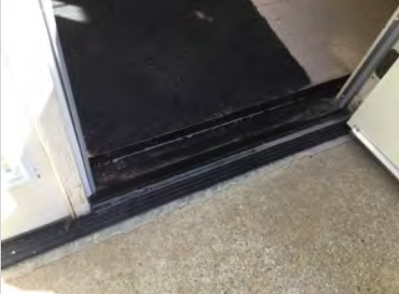
Threshold > 1/2" high	1.5"	Alter the threshold to be 1/2" high max.	1	150	\$150

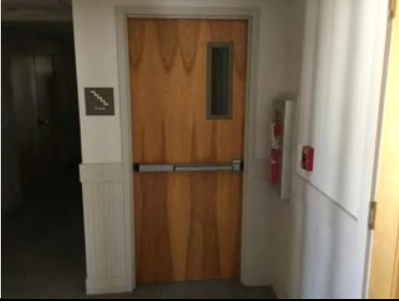
ID	Location	Floor	Room	Element	Type	Photo	Issues	Current Measure	Recommendations	Quantity	Price	Cost Estimation
19	Egress to Stairwell 1	2		Doors, Doorways, & Gates	Emergency Egress

Door requires > 5 lbs. of force to open	16 lbs.	Adjust closers so doors do not require more than 5 pounds of force to open.	1	Labor	\$0
20	Meeting Hall	1		Doors, Doorways, & Gates	Circulation

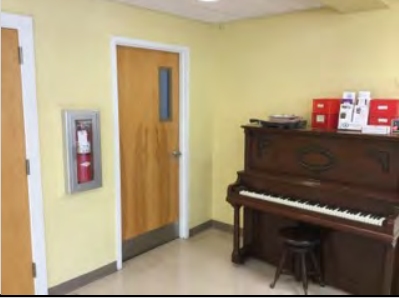
Clear floor space at opener not provided	-	Relocate piano to provide 30" wide min. x 48" deep min. clear floor space at latch side of door.	1	Labor	\$0
Signage												
21	Meeting Hall	Ext.		Signage	Informational

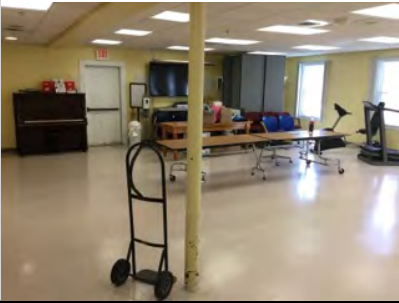
Signage is not provided		Provide a sign with the International Symbol of Access for Hearing Loss to inform visitors of the availability of an assistive listening system.	1	232	\$232
22	Outreach Office	2		Signage	Designation

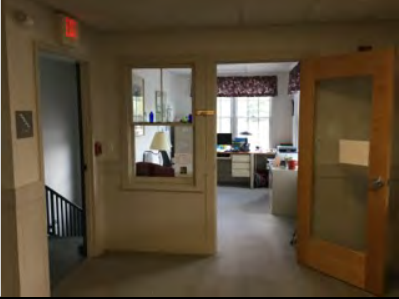
Raised characters not provided on sign Braille not provided on sign	- -	Provide text with raised characters duplicated in braille on sign.	1	232	\$232

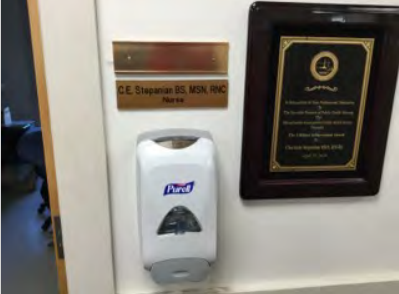
23	Nurse's Office	1		Signage	Designation

Raised characters not provided on sign Braille not provided on sign Sign not located on the latch side of the door	- - -	Provide text with raised characters duplicated in braille on sign. Locate sign at permanent rooms alongside the door on the latch side.	1	232	\$232

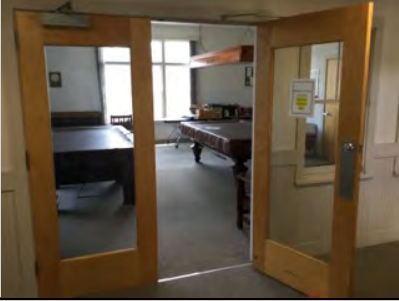
Raised characters not provided on sign Braille not provided on sign Sign not located on the latch side of the door	- - -	Provide text with raised characters duplicated in braille on sign. Locate sign at permanent rooms alongside the door on the latch side.	1	232	\$232
Service Counter												
26	Reception Area	1		Service Counter	N/A

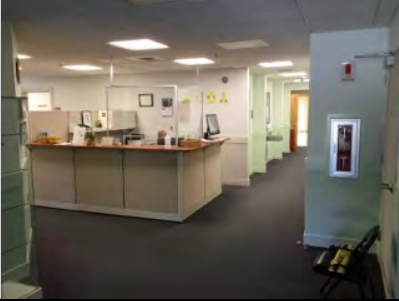
Counter > 36" high	43.5"	Provide a counter that is 36" max. above the ground or finished floor.	1	880	\$880

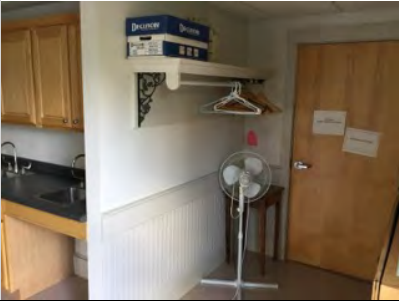
Operable Parts												
27	Coat Rod in Meeting Hall and in Meeting Room	1 and 2		Operable Parts	Clothes Rod/Hooks

Reach < 15" or > 48"(forward/side approach)	69"	Provide a portion of the coat rod or a coat hook between 15"- 48" above the finished floor.	2	256	\$512
Dining or Work Surfaces												
28	Tables in Meeting Hall	1		Dining or Work Surfaces	Dining Surface

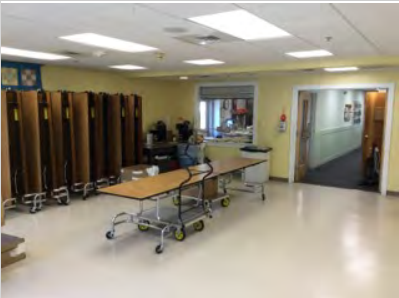
Knee or toe clearance not provided	25.75"	Provide at least 1 dining or work surface with 27" min. knee and toe clearance.	1	1100	\$1100

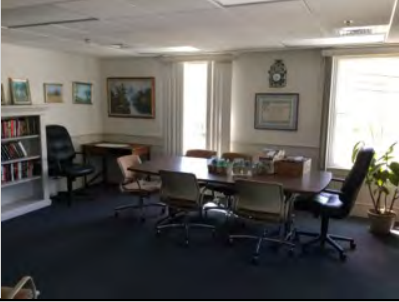
ID	Location	Floor	Room	Element	Type	Photo	Issues	Current Measure	Recommendations	Quantity	Price	Cost Estimation
29	Conference Table in Library	2		Dining or Work Surfaces	Work Surface

Knee or toe clearance not provided	24"	Provide at least 1 work surface with 27" min. knee and toe clearance.	1	1100	\$1100
Picnic Tables												
30	Picnic Table Near Booce	Ext.		Picnic Tables	N/A

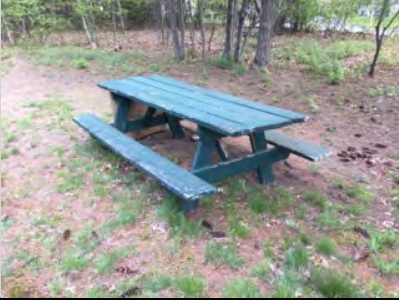
At least 5% accessible spaces not provided	-	Ensure that at least 5% (minimum one) of dining surfaces are accessible.	1	1400	\$1400
Toilet & Bathing Rooms												
Toilet Compartment												
31	Men's Toilet Room Accessible Compartment	1		Toilet Compartment	Accessible Compartment

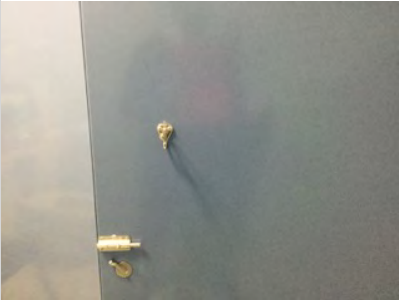
Door has non-compliant hardware Door has malfunctioning self-closing hinge	- -	Provide hardware that can be operable with one hand and not require tight grasping, pinching, or twisting of the wrist. Repair hinge.	1	70	\$70

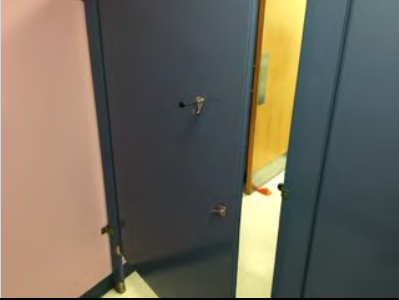
32	Women's Toilet Room Accessible Compartment	1		Toilet Compartment	Accessible Compartment

Door has non-compliant hardware Door has malfunctioning self-closing hinge	= -	Provide hardware that can be operable with one hand and not require tight grasping, pinching, or twisting of the wrist. Repair hinge.	1	70	\$70
33	Women's Toilet Room	2		Toilet Compartment	Accessible Compartment

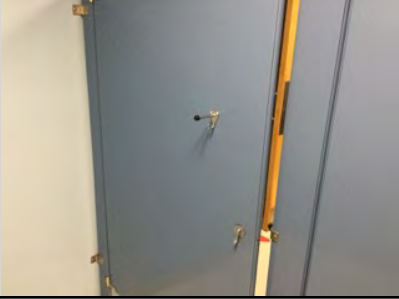
Door has non-compliant hardware Door has malfunctioning self-closing hinge	- -	Provide hardware that can be operable with one hand and not require tight grasping, pinching, or twisting of the wrist. Repair hinge.	1	70	\$70

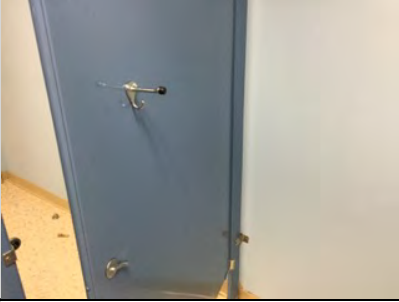
Door has non-compliant hardware Door has malfunctioning self-closing hinge	- -	Provide hardware that can be operable with one hand and not require tight grasping, pinching, or twisting of the wrist. Repair hinge.	1	70	\$70
35	Men's Toilet Room Accessible Compartment	1		Toilet Compartment	Accessible Compartment

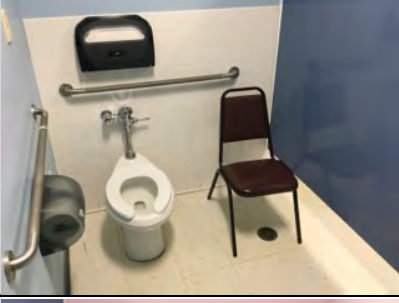
Non-compliant toilet cover dispenser Clearance at toilet < 60" clear width	- -	Relocate toilet cover dispenser so the operable parts are no higher than 42" on the side of the toilet. Provide a wheelchair accessible compartment that is 60" wide min. (Remove chair.)	1	353	\$353
36	Women's Toilet Room Accessible Compartment	1		Toilet Compartment	Accessible Compartment

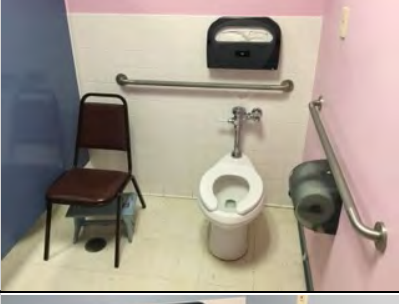
Non-compliant toilet cover dispenser Clearance at toilet < 60" clear width	- -	Relocate toilet cover dispenser so the operable parts are no higher than 42" on the side of the toilet. Provide a wheelchair accessible compartment that is 60" wide min. (Remove chair.)	1	353	\$353

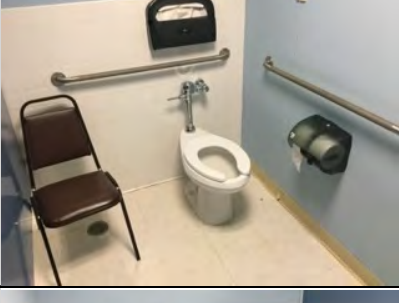
37	Women's Toilet Room	2		Toilet Compartment	Accessible Compartment

Non-compliant toilet cover dispenser Clearance at toilet < 60" clear width	- -	Relocate toilet cover dispenser so the operable parts are no higher than 42" on the side of the toilet. Provide a wheelchair accessible compartment that is 60" wide min. (Remove chair.)	1	353	\$353
38	Men's Toilet Room	2		Toilet Compartment	Accessible Compartment

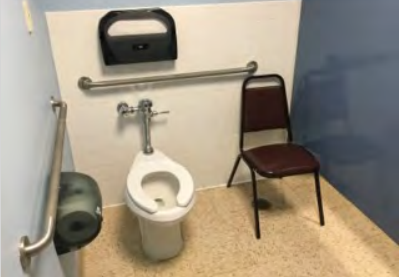
Non-compliant toilet cover dispenser Clearance at toilet < 60" clear width	- -	Relocate toilet cover dispenser so the operable parts are no higher than 42" on the side of the toilet. Provide a wheelchair accessible compartment that is 60" wide min. (Remove chair.)	1	353	\$353

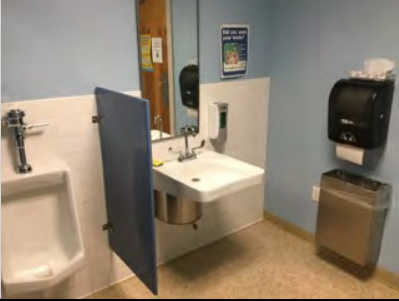
Rim > 17" high	18.5"	Provide at least one urinal with the rim no higher than 17" above the finished floor.	1	3248	\$3248
Additional Access												
Sink												
40	Sink in Meeting Room	2		Sink	Other

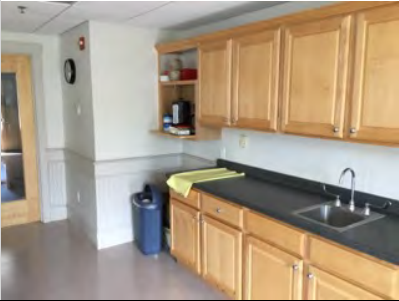
Toe and knee clearances not provided	-	Ensure there is a 27" knee clearance positioned for a forward approach.	1	1686	\$1686
41	Sink in Library	2		Sink	Other

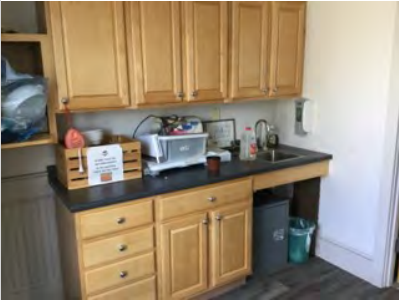
Toe and knee clearances not provided	-	Ensure there is a 27" knee clearance positioned for a forward approach. (Relocate stored items under sink.)	1	Labor	\$0
Play and Sport Areas												
Exercise Machines												
42	Exercise Machines in Meeting Room	1		Exercise Machines	N/A

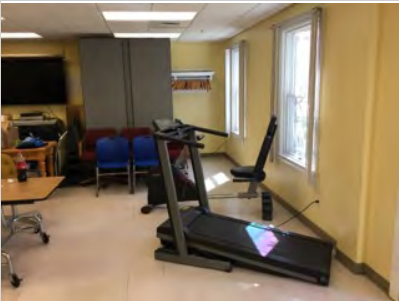
Clear floor space not provided	-	Ensure that one of each type of equipment has a 30" by 48" clear floor space positioned for transfer or for use by an individual seated in a wheelchair. Clear floor space required at exercise machines and equipment shall be permitted to overlap.	1	Labor	\$0

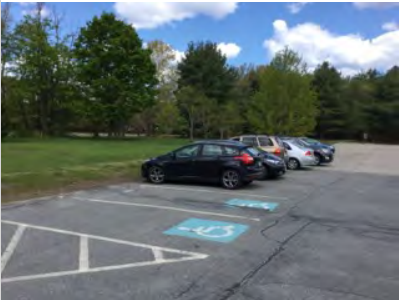
The parking lot has the required number of accessible spaces, these spaces do not need to comply. Since they have the ISA painted in them, however, recommend re-striping to add compliant 60" wide min. access aisles for the full length of the spaces and including signs with the International Symbol of Accessibility (ISA) mounted 60" min. above the ground measured to the bottom of the sign.	1		\$0
Egress												
44	Emergency Egress	Ext.		Egress	N/A

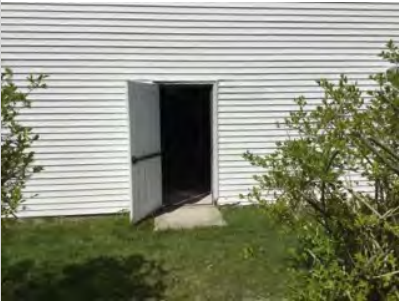
Recommend connecting all egress doors to an accessible route.	1	-	\$0
Podium												
45	By Egress From Meeting Room	1		Podium	N/A

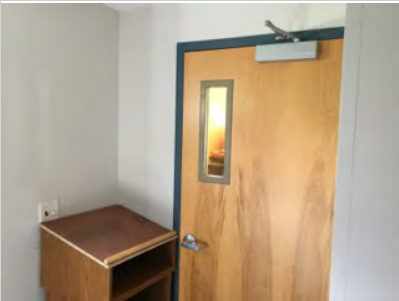
Recommend providing an adjustable height podium with knee and toe clearance.	1		\$0

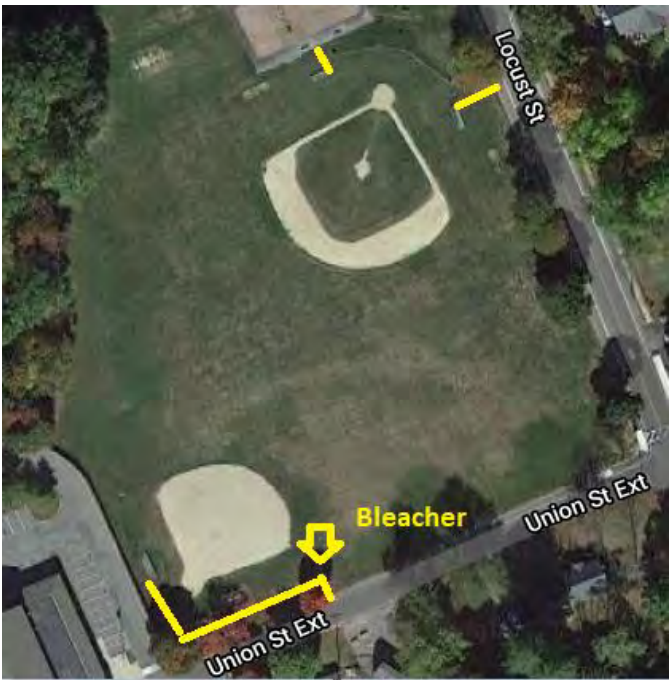
Accessibility issues with a walkway that encircles the park include excessive running and cross slopes and surfaces that are not maintained in operable working condition. There is also lack of an accessible route to the boundary of sport activity and to the team seating areas at both the baseball and softball fields, and lack of an accessible route to a set of bleachers by the softball field. (See Figure 1 at the end of this document.)

Figure 1: The yellow lines indicates the approximate recommended location for an accessible route to the boundary of sport activity and to spectator and player seating at Steven’s Field.

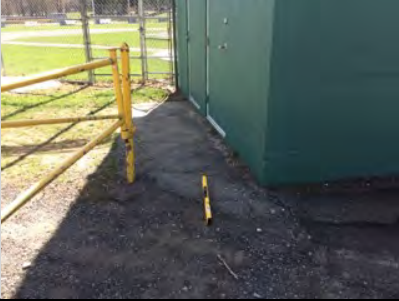
Exterior route < 48" wide Route not maintained in operable working condition	42" -	Ensure that a clear width of 48" min. is maintained at the accessible route to the toilet room entrance. Ensure the accessible route is maintained in operable working condition. (Reposition metal barriers to provide accessible route an maneuvering clearance at both doors. Cost for asphalt to provide an accessible route.)	1	400	\$400
2	Counter Next to Concession Stand Window	Ext.		Exterior Access Route	Exterior

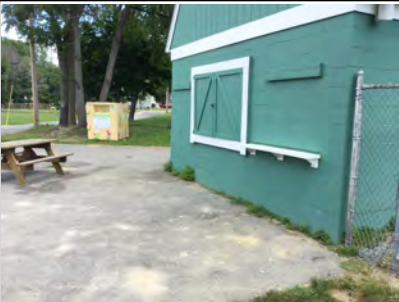
Route obstructed by protruding objects	8"	Provide a cane-detectable barrier 27" max. above the ground at the service counter.	1	306	\$306
3	Locust Street Sidewalk to Locust Street Playground from Union Street. Ext.	Ext.		Exterior Access Route	Walkway

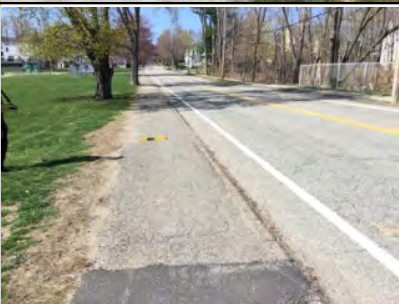
Cross slope > 1:50 (2.00%)	5.6%	Reduce cross slope to be no steeper than 1:50 (2.00%). (Cost based on asphalt to reduce cross slope.)	1	240	\$240

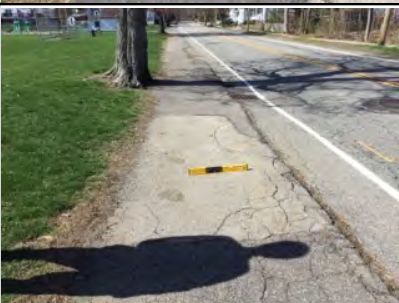
4	Locust Street Sidewalk to Locust Street Playground from Union Street. Ext.	Ext.		Exterior Access Route	Walkway

Cross slope > 1:50 (2.00%) Route not maintained in operable working condition	4.1% -	Reduce cross slope to be no steeper than 1:50 (2.00%). Ensure the accessible route is maintained in operable working condition. (Cost based on asphalt to reduce cross slope and repair surface.)	1	720	\$720
5	Locust Street Sidewalk to Locust Street Playground from Union Street. Ext.	Ext.		Exterior Access Route	Walkway

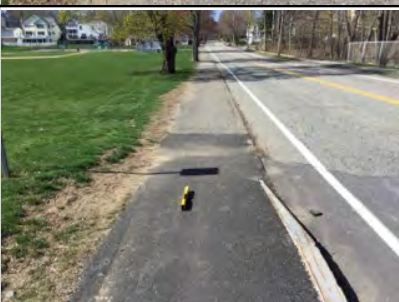
Running slope > 1:20 (5%)	8.7%	Reduce running slope to be no steeper than 1:20 (5%). (Cost based on asphalt to reduce running slope.)	1	240	\$240

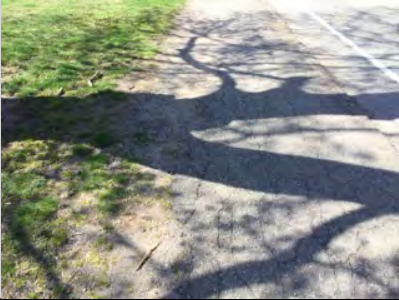
Route not maintained in operable working condition	-	Ensure the accessible route is maintained in operable working condition. (Cost based on asphalt to repair surface.)	1	720	\$720
7	Locust Street Sidewalk to Locust Street Playground from Union Street. Ext.	Ext.		Exterior Access Route	Walkway

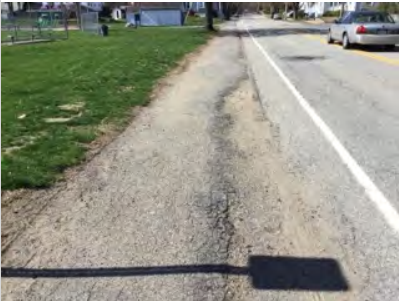
Route not maintained in operable working condition	-	Ensure the accessible route is maintained in operable working condition. (Cost based on asphalt to repair surface.)	1	960	\$960
Access to Goods and Services												
Doors, Doorways, & Gates												
8	Entry to Men's and Women's Toilet Rooms	Ext.		Doors, Doorways, & Gates	Toilet Room

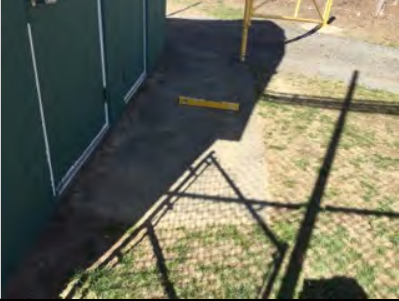
Maneuvering clearance(s) not provided	45.5"	Provide clear floor space at door (door landing) that is at least 5' deep, has a slope no greater than 2.00% in all directions (1:50) and that provides at least 18" pull-side maneuvering clearance on the latch side of the door. (Cost based on 5'x10' of asphalt to provide the required maneuvering clearance at the door.)	2	500	\$1000

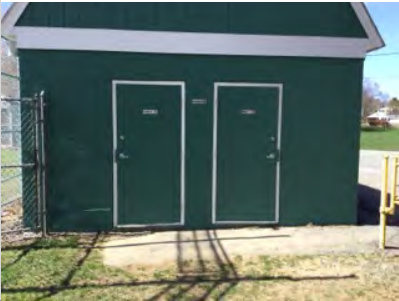
9	Men's and Women's Toilet Room Doors	Ext.		Doors, Doorways, & Gates	Toilet Room

Threshold > 3/4" high	3"	Alter the threshold to be 3/4" high max. beveled.	2	150	\$300
Signage												
10	Women's Toilet Room	1		Signage	Designation

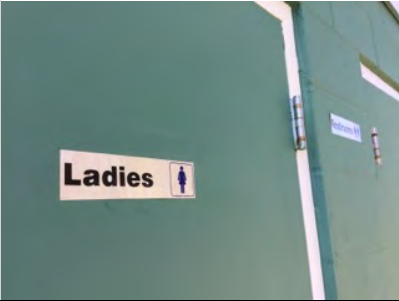
Raised characters not provided Braille not provided Sign not located on the latch side of the door International Symbol of Acc. not provided	- - -	Provide text with raised characters duplicated in braille. Locate sign at permanent rooms alongside the door on the latch side. Once the toilet room is made accessible, provide a sign with the International Symbol of Accessibility (ISA).	1	232	\$232

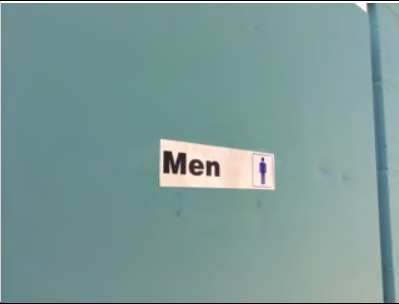
Raised characters not provided Braille not provided Sign not located on the latch side of the door International Symbol of Acc. not provided	- - -	Provide text with raised characters duplicated in braille. Locate sign at permanent rooms alongside the door on the latch side. Once the toilet room is made accessible, provide a sign with the International Symbol of Accessibility (ISA).	1	232	\$232
Service Counter												
12	Counter Next to Concession Stand Window	Ext.		Service Counter	N/A

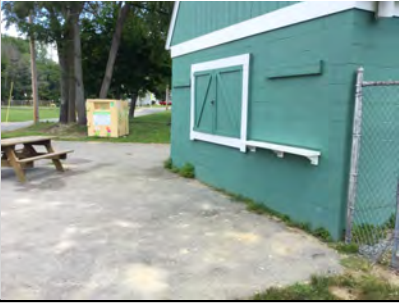
Counter > 36" high	38.25"	Provide a counter that is 36" max. above the ground.	1	880	\$880
Picnic Tables												
13	Picnic Tables Near Concession Stand	Ext.		Picnic Tables	N/A

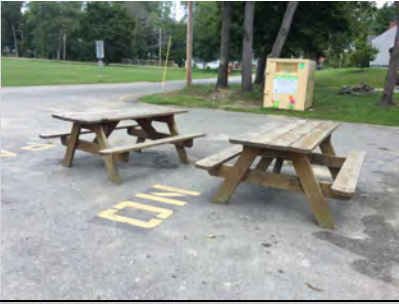
Number of accessible seating spaces Toe or knee clearance at table not provided	- -	Provide at least one accessible picnic table in each area where picnic tables are provided.	1	1400	\$1400

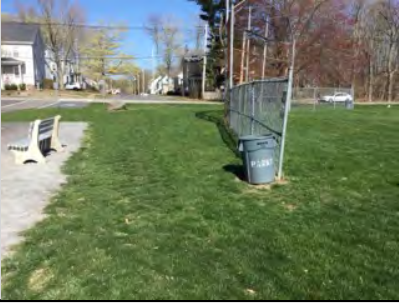
Trash / Recycling												
14	Near Playground and Team Seating Area 2 at Baseball Field	Ext.		Trash / Recycling	N/A

Trash container not connected to an accessible route	-	Ensure trash container is located on an accessible route.	1	Labor	\$0
Toilet & Bathing Rooms

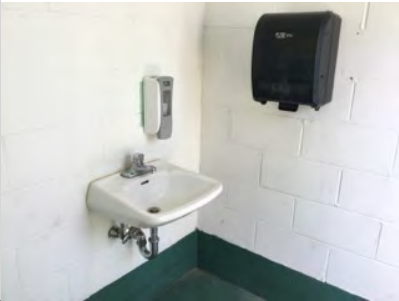
Toe or knee clearances not provided Exposed plumbing underneath	25.75" -	Provide at least one lavatory with knee and toe clearance positioned for a forward approach. Insulate or otherwise configure pipes to prevent contact for at least one lavatory.	1	1778	\$1778
16	Men's Toilet Room	1		Lavatory	N/A

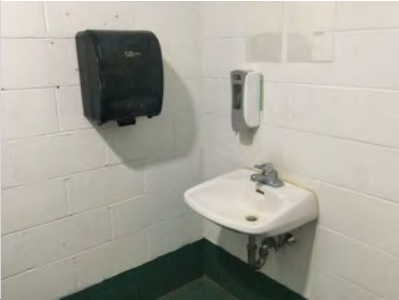
Exposed plumbing underneath	-	Insulate or otherwise configure pipes to prevent contact for at least one lavatory.	1	92	\$92
Single-User Toilet												
17	Women's Toilet Room	1		Single-User Toilet	N/A

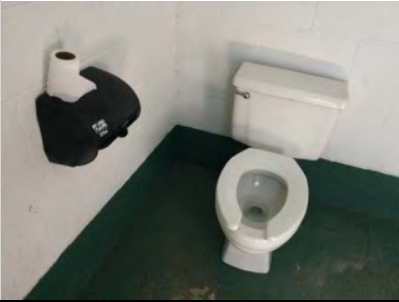
Toilet seat < 17" or > 19" high Flush control not on open side Centerline < 16" or > 18" Grab bar not provided	15.5" - 24.5" -	Install a toilet with a seat between 17"- 19" high above the finished floor. Relocate the flush control to the open side. Relocate toilet so that the centerline is 16"- 18" from the side wall. Provide one grab bar 42" long on the side wall of the toilet and one on the rear wall. Ensure toilet paper dispenser is not mounted above the grab bar.	1	4100	\$4100

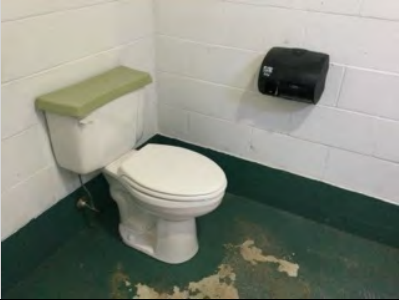
18	Men's Toilet Room	1		Single-User Toilet	N/A

Centerline < 16" or > 18" Grab bar not provided	24.5" -	Relocate toilet so that the centerline is 16"- 18" from the side wall. Provide one grab bar on the side wall of the toilet and one on the rear wall. Ensure toilet paper dispenser is not mounted above the grab bar.	1	3726	\$3726
Play and Sport Areas

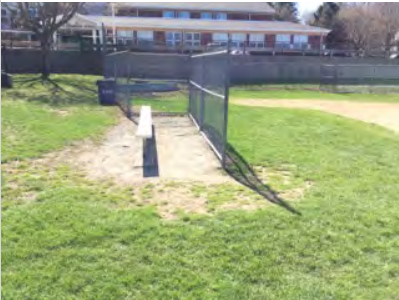
Accessible spaces are not provided at team seating Not connected to an accessible-route	- -	Provide a 36" x 48" stable, firm and slip resistant clear floor space at both softball field team seating benches. Provide an accessible route to the field. (Cost for asphalt at the end of both softball field team seating benches included in ID #21. See Figure 1 in the narrative report for approximate location of asphalt.)	1	-	\$0
20	Team Seating 1 and 2 - Baseball Field Near Playground	Ext.		Field	Baseball

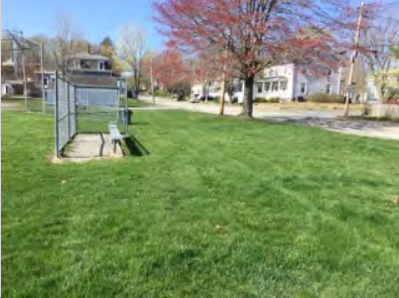
Accessible spaces are not provided at team seating Not connected to an accessible-route	- -	Provide a 36" x 48" stable, firm and slip resistant clear floor space at both baseball field team seating benches. Provide an accessible route to the boundary of sport activity at the baseball field. (Cost for an asphalt route to both baseball team seating areas and to the boundary of sport activity. See Figure 1 in the narrative report for approximate location of asphalt.)	1	2240	\$2240
