Town of Merrimac, Massachusetts

PART A – Executive Summary

September 2021

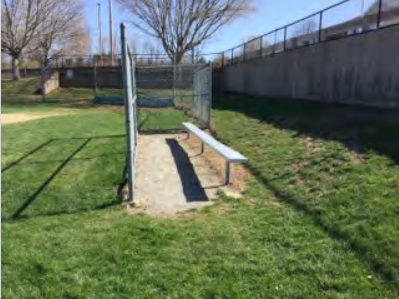
21	Team Seating 2 - Softball Field Near Donaghue School	Ext.		Field	Softball

Accessible spaces are not provided at team seating No accessible route to all areas of sport activity	- -	Provide an accessible route to both team seating areas at the softball field and to the boundary of sport activity. (Cost based on a 4' wide min. x 240' asphalt route between the bleachers and the two softball field team seating areas with a 5% max. running and 2% max. cross slope. See Figure 1 in the narrative report for the approximate location of the accessible route.)	1	9600	\$9600
Bleachers												
22	Bleachers - Softball Field Near Donaghue School	Ext.		Bleachers	N/A

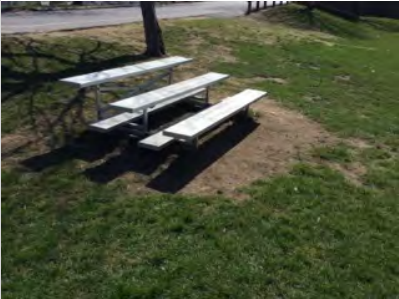
Total number of seats in the facility Min. # of designated wheelchair spaces not provided Seating spaces < 36" x 48" (single space) Seats not connected by accessible route	12 - - -	Provide a 36" by 48" clear floor space next to the first row of bleachers. Provide a stable, firm and slip resistant accessible route to the spectator seating area with a maximum running slope of 1:20 (5.00%) and a maximum cross slope of 1:50 (2.00%). (Cost for 4'x15' of asphalt from paved route behind bleachers to bleacher seating included in ID #21.)	1	-	\$0

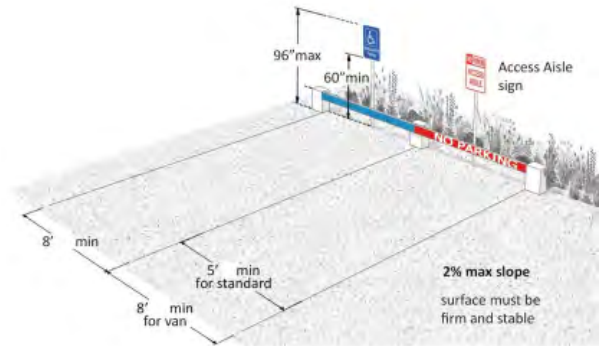
Figure 1: The following figure shows an example of how to identify and designate an accessible parking space at an unpaved parking lot.

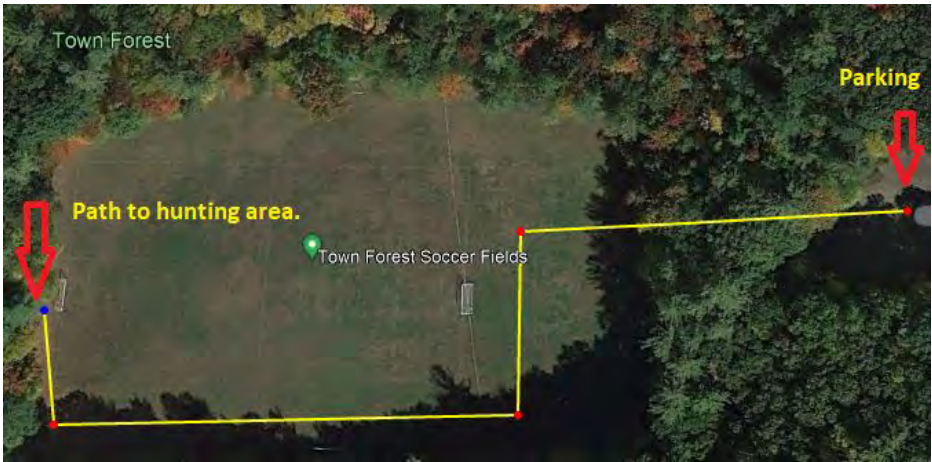
Figure 2: The yellow line shows the approximate location of the suggested accessible route from the parking area to amenities including to a bench and to the boundary of the areas of sport activity at the soccer field and at the start of the path to the hunting grounds.

- Renovate and provide exterior accessible routes: \$28,800
- Provide an accessible portable toilet: \$4,600
- Renovate parking: \$1,850

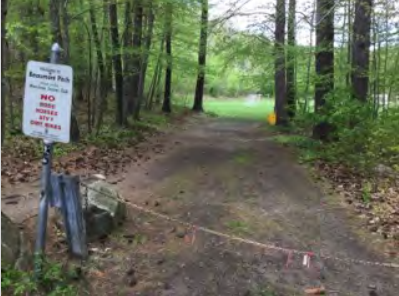
ID	Location	Floor	Room	Element	Type	Photo	Issues	Current Measure	Recommendations	Quantity	Price	Cost Estimation
Approach and Entrance												
Exterior Access Route												
1	Route to the Fields From the Parking Lot	Ext.		Exterior Access Route	Exterior

Not provided from all site arrival points	-	Ensure an accessible route is provided from all points of arrival. (Ensure chain blocking path to field is either removed or can be removed with out requiring tight grasping, pinching or twisting of the wrist during hours when the field is open to the public.)	1	Labor	\$0
2	Route to the Fields From the Parking Lot	Ext.		Exterior Access Route	Exterior

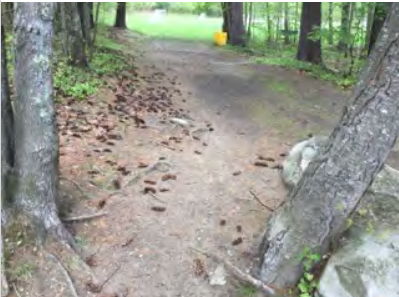
Level changes > 1/4"	1.5"	Alter change in level to be 1/4" high max. (Cost included in ID #7.)	-	Labor	\$0
3	Start of Route to Hunting Grounds Area	Ext.		Exterior Access Route	Exterior

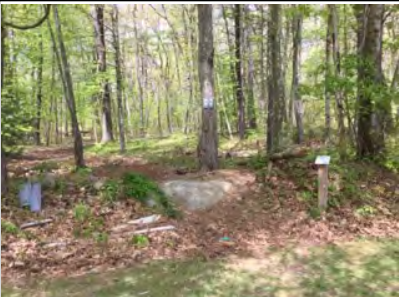
Surface is not stable, firm, and slip-resistant Accessible route not provided	- -	Ensure a stable, firm and slip resistant accessible route is provided to the boundary of the path to the hunting grounds. Ensure the route is 4' wide min. and that it has a running slope of 1:20 (5.0%) max. and a cross slope of 1:50 (2.0%) max. (Cost included in ID #7.)	1	-	\$0

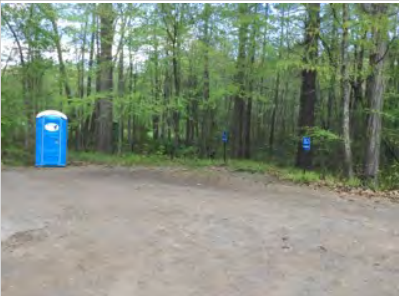
Off-Street Parking Lot or Garage												
4	Parking Lot	Ext.		Off-Street Parking Lot or Garage	Visitor

Total # of parking Total # of designated accessible parking spaces Total # of designated van accessible spaces Access aisle not provided Sign does not have the designation "Van Accessible" Sign bottom < 60" above finished grade	25 1 1 - - 45.5"	Provide a van accessible parking space 96" wide min. with a marked access aisle 96" wide min. Add the designation "Van Accessible" to the sign located at the van accessible space. Locate both signs with the bottom of the sign 60" min. and 96" max. above the ground.	1	1850	\$1850
Access to Goods and Services

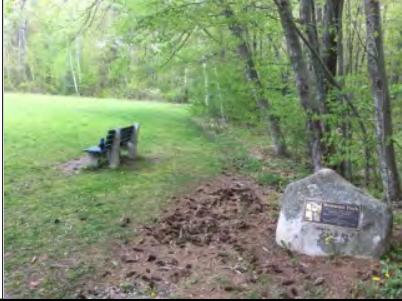
ID	Location	Floor	Room	Element	Type	Photo	Issues	Current Measure	Recommendations	Quantity	Price	Cost Estimation
Benches												
5	Near Parking Lot by Start of Soccer Fields	Ext.		Benches	N/A

No accessible route to one bench in this area	-	Provide an accessible route to the sign on the rock and to at least one bench in each area where benches are provided. (Cost included in ID #7.)	1	-	\$0
Toilet & Bathing Rooms												
Portable Toilet												
6	Parking Lot	Ext.		Portable Toilet	N/A

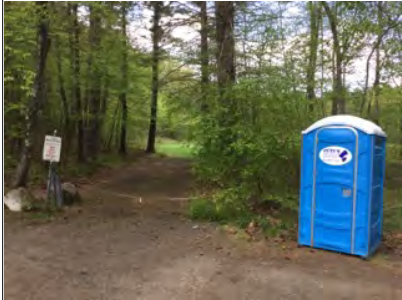
Accessible portable toilets not provided	-	Ensure that at least 5% of portable toilets is accessible.	1	4600	\$4600
Play and Sport Areas												
Field												
7	Path to Boundary of Sport Activity at Soccer Field and to Start of Path to Hunting Grounds	Ext.		Field	Soccer

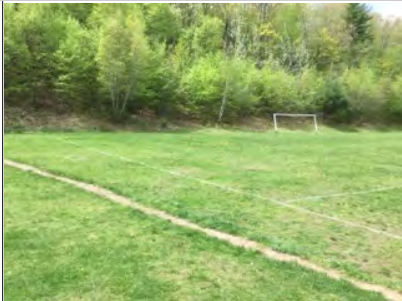
Not connected to an accessible-route No accessible route to all areas of sport activity	- -	Provide an accessible route from the parking area to all amenities including the boundary of sport activity at the soccer field and the start of the trail to the hunting grounds. See Figure 1 in the report narrative. Ensure path has a running slope of 1:20 (5.0%) max. and a cross slope of 1:50 (2.0%) max. (Cost estimate for a 4' wide min. x 900' long stone dust path.)	1	28800	\$28800

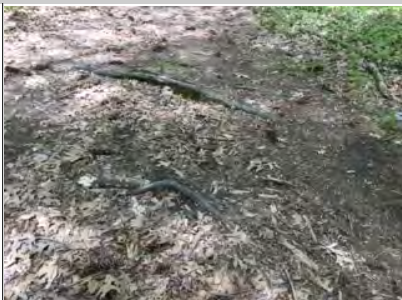
Best Practice												
Route to Hunting Grounds Area												
8	Path to Hunting Grounds	Ext.		Route to Hunting Grounds Area	Exterior

Recommend providing information indicating that the route to the hunting grounds is inaccessible due to the terrain on the Town's website and on any other websites or materials prepared by the Town that describe Town Forest Fields or the hunting grounds.	1	-	\$0

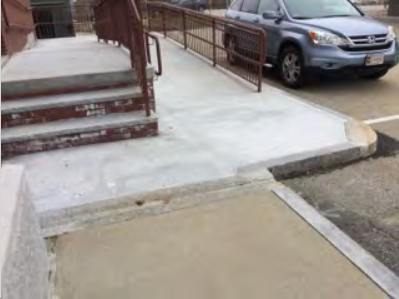
ID	Location	Floor	Room	Element	Type	Photo	Issues	Current Measure	Recommendations	Quantity	Price	Cost Estimation
Approach and Entrance												
Exterior Access Route												
1	To Ramp - South Side Accessible Entrance/Exit	Ext.		Exterior Access Route	Exterior

Level changes > 1/4"	.5"	Alter change in level to be 1/4" high max.	1	256	\$256
Off-Street Parking Lot or Garage												
2	To Ramp - South Side Accessible Entrance/Exit	Ext.		Off-Street Parking Lot or Garage

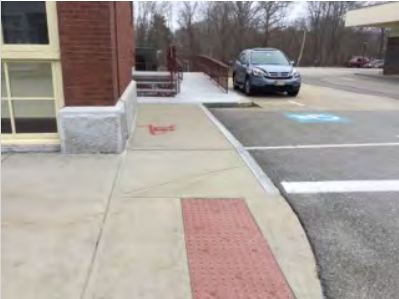
Sign not provided	-	Provide a sign with the International Symbol of Accessibility (ISA) with the bottom of the sign 60" min. above the ground and the top 96" max. above the ground.	1	500	\$500
Access to Goods and Services												
Means of Egress												
3	To Main Exit/ Entrance	1		Means of Egress	N/A

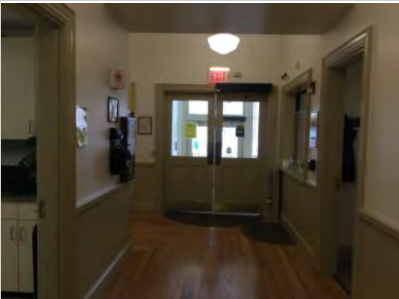
Illuminated ISA symbol not provided (MAAB)	-	If the exit sign is replaced with a new illuminated exit sign, provide an illuminated International Symbol of Accessibility (ISA).	1	-	\$0

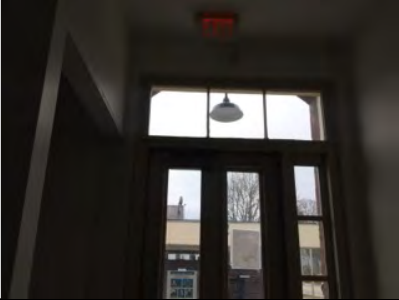
4	To Ramp and Stair, South Side	1		Means of Egress

Illuminated ISA symbol not provided (MAAB)	-	If the exit sign is replaced with a new illuminated exit sign, provide an illuminated International Symbol of Accessibility (ISA).	1	-	\$0

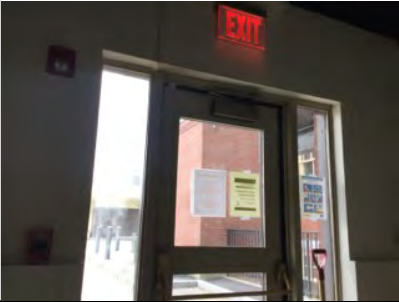
ID	Location	Floor	Room	Element	Type	Photo	Issues	Current Measure	Recommendations	Quantity	Price	Cost Estimation
5	Exit - Stair Near Elevator	G		Means of Egress	N/A

Illuminated ISA symbol not provided (MAAB)	-	If the exit sign is replaced with a new illuminated exit sign, provide an illuminated International Symbol of Accessibility (ISA).	1	-	\$0
Interior Access Route												
6	Town Hall Auditorium	2		Interior Access Route	N/A

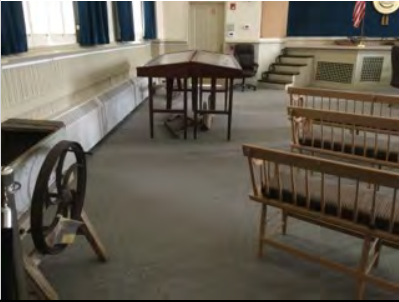
Route < 36" wide	23"	Ensure that a clear width of 36" min. is maintained at the accessible route. (Reposition furniture.)	1	Labor	\$0
7	Town Hall Auditorium	2		Interior Access Route	N/A

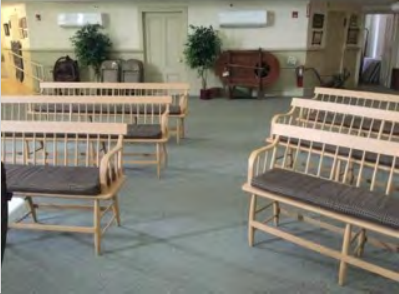
Route < 36" wide	33"	Ensure that a clear width of 36" min. is maintained at the accessible route.	1	Labor	\$0
8	Dispenser by Fire Extinguisher	1		Interior Access Route	N/A

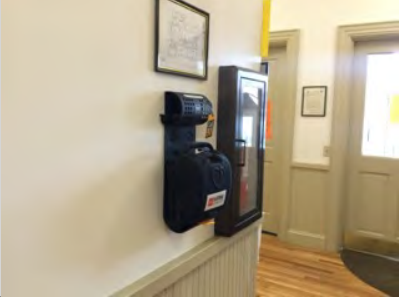
Obstructed by protruding objects	6"	Provide a cane-detectable barrier 27" max. above the ground.	1	306	\$306

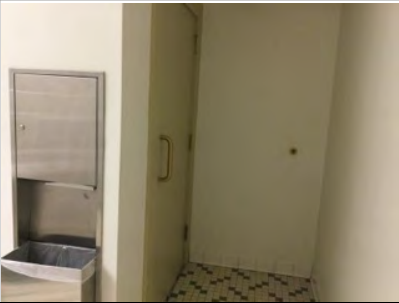
Doors, Doorways, & Gates												
9	Men's Toilet Room	G		Doors, Doorways, & Gates

Maneuvering clearance(s) not provided	42.75"	Provide an automatic door opener.	1	3060	\$3060

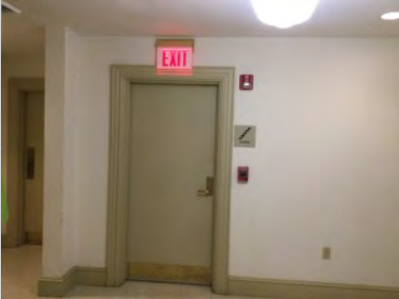
ID	Location	Floor	Room	Element	Type	Photo	Issues	Current Measure	Recommendations	Quantity	Price	Cost Estimation
15	Stair Near Elevator	G		Doors, Doorways, & Gates	Other

Door requires > 5 lbs. of force to open	11 Lbs.	Adjust closers so doors do not require more than 5 pounds of force to open.	1	Labor	\$0
16	Stair Near Elevator	1		Doors, Doorways, & Gates	Other

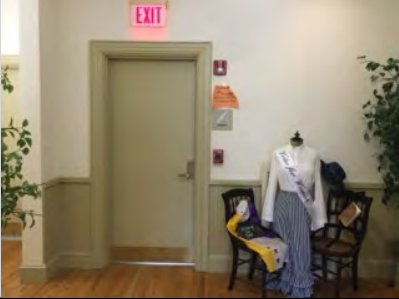
Door requires > 5 lbs. of force to open	15 Lbs.	Adjust closers so doors do not require more than 5 pounds of force to open.	1	Labor	\$0
17	Stair Near Elevator	2		Doors, Doorways, & Gates	Other

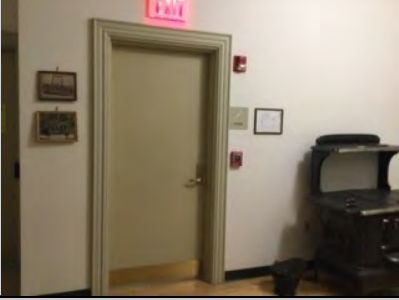
Door requires > 5 lbs. of force to open	14 Lbs.	Adjust closers so doors do not require more than 5 pounds of force to open.	1	Labor	\$0
Stairways												
18	Near Town Hall Auditorium - Stair to South Side Accessible Exit/Entrance	2		Stairways	Egress

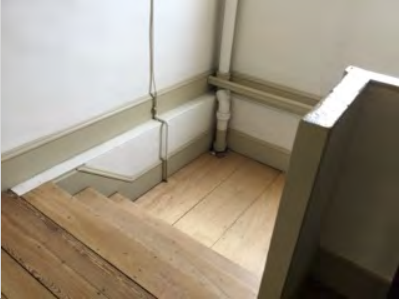
Handrail not provided on both sides	-	Provide handrail on both sides. (Cost based on two 6' long handrails with real extensions.)	1	528	\$528

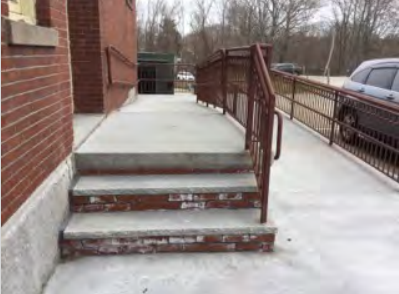
19	Stair to South Side Accessible Entrance	Ext.		Stairways	Egress

Handrail not provided on both sides	-	Provide handrail on one side. (Cost based on a 5' wall mounted metal handrail.)	1	370	\$370

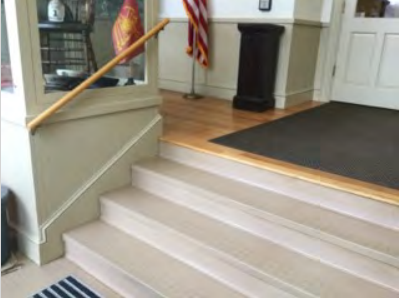
ID	Location	Floor	Room	Element	Type	Photo	Issues	Current Measure	Recommendations	Quantity	Price	Cost Estimation
20	By Main Entrance	1		Stairways	Egress

Handrail not provided on both sides Handrails do not extend 12" from stairs	- -	Provide handrail on one side. Top: Ensure handrails extend horizontally above the landing for 12" min. beginning above the first riser nosing. Bottom: Ensure handrails extend to one tread depth beyond the last riser. (Cost based on one new handrail and two wooden handrail extensions.)	1	928	\$928
21	Stair to South Side Accessible Exit	1		Stairways	Egress

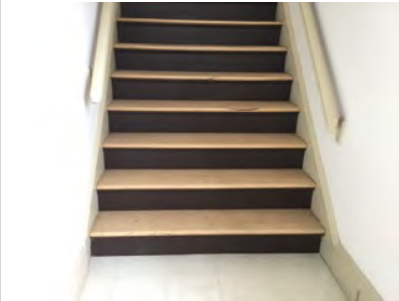
Handrails do not extend 12" from stairs	-	Ensure handrails extend to one tread depth beyond the last riser.	1	400	\$400
Platform Lift or LULA Elevator												
22	Platform Lift by Main Entrance	1		Platform Lift or LULA Elevator	Interior

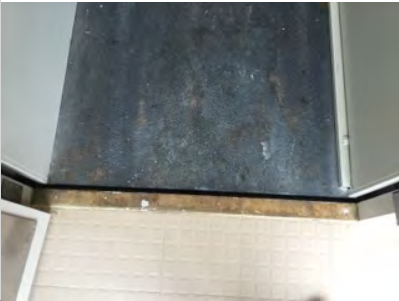
Not in operable working condition	-	Close gap at lift entrance to remove change in level.	1	Labor	\$0

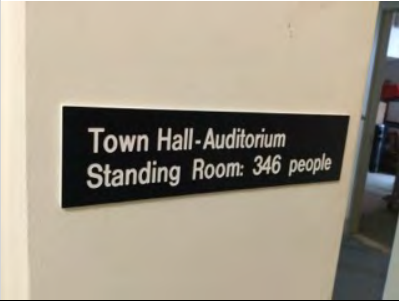
Signage												
23	Town Hall Auditorium	2		Signage	Designation

Raised characters not provided on sign Braille not provided on sign	- -	Provide text with raised characters duplicated in braille on sign.	1	232	\$232
24	Selectmen's Office Meeting Room B	1		Signage	Designation

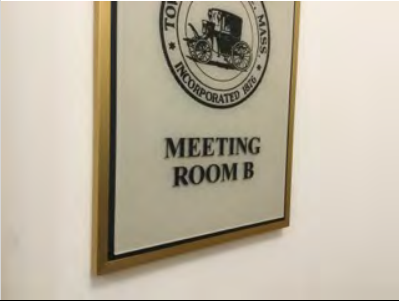
Sign not located on the latch side of the door	-	Locate sign at permanent rooms alongside the door on the latch side.	1	Labor	\$0

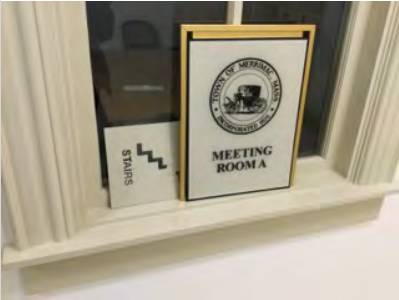
ID	Location	Floor	Room	Element	Type	Photo	Issues	Current Measure	Recommendations	Quantity	Price	Cost Estimation
25	Meeting Room A	G		Signage	Designation

Sign not located on the latch side of the door	-	Locate sign at permanent rooms alongside the door on the latch side. Properly install both signs.	1	Labor	\$0
26	Stairway to South Side Accessible Exit	1		Signage	Informational

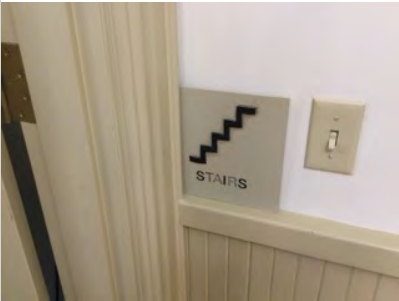
Sign not affixed to the wall.		Attach sign to wall.	1	Labor	\$0
Operable Parts												
27	Town Hall Auditorium	2		Operable Parts	Other

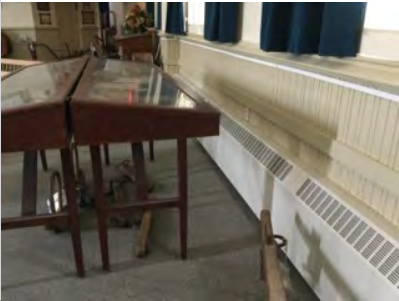
Element not on an accessible route	19.25"	Ensure the displays are located on an accessible route.	1	Labor	\$0
28	Near Town Clerk's Office	1		Operable Parts	Clothes Rod/Hooks

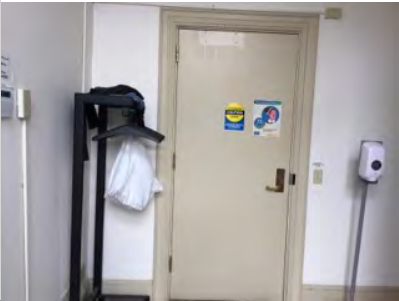
Side reach > 54"	59"	Provide a clothes rod or coat hook positioned between 15" - 48" above the finished floor.	1	256	\$256
Dining or Work Surfaces												
29	Meeting Room C	1		Dining or Work Surfaces	Work Surface

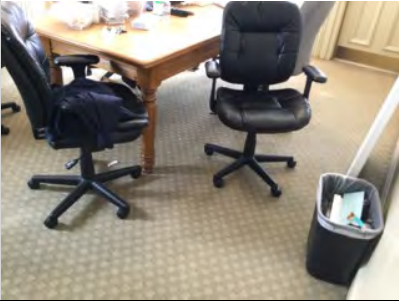
Knee or toe clearance not provided	23.5"	Provide at least 1 work surface with 27" min. knee and toe clearance.	1	700	\$700

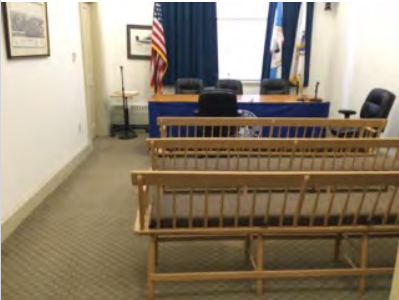
ID	Location	Floor	Room	Element	Type	Photo	Issues	Current Measure	Recommendations	Quantity	Price	Cost Estimation
Assembly Area												
30	Selectmen's Office Meeting Room B	1		Assembly Area	N/A

Assistive listening devices not provided	-	If audible communication is integral to the use of the space, provide an assistive listening system.	1	1214	\$1214
31	Town Hall Auditorium	2		Assembly Area	N/A

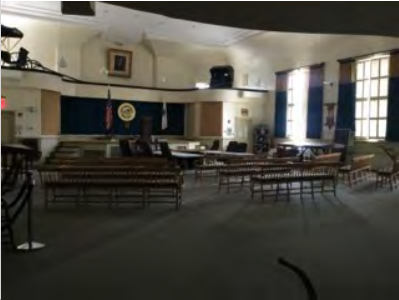
Assistive listening devices not provided	-	If audible communication is integral to the use of the space, provide an assistive listening system.	1	1214	\$1214
Toilet & Bathing Rooms												
Toilet Compartment												
32	Men's Toilet Room	G		Toilet Compartment	Accessible Compartment

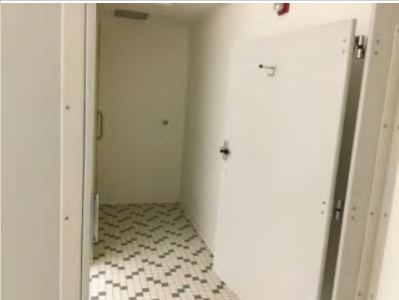
Door has non-compliant hardware Door has malfunctioning self-closing hinge Coat hook > 48"	- - 60.75"	Provide hardware that can be operable with one hand and not require tight grasping, pinching, or twisting of the wrist. Repair hinge. Lower coat hook so that it is no higher than 48".	1	220	\$220

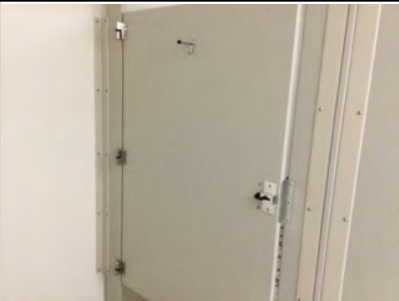
33	Women's Toilet Room	G		Toilet Compartment	Accessible Compartment

Door has non-compliant hardware Door has malfunctioning self-closing hinge Coat hook > 48"	- - 63"	Provide hardware that can be operable with one hand and not require tight grasping, pinching, or twisting of the wrist. Repair hinge. Lower coat hook so that it is no higher than 48".	1	220	\$220
34	Women's Toilet Room	1		Toilet Compartment	Accessible Compartment

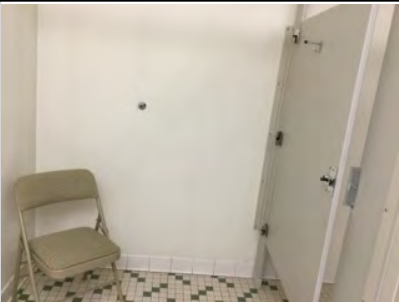
Door has non-compliant hardware Door has malfunctioning self-closing hinge Coat hook > 48"	- - 63.25"	Provide hardware that can be operable with one hand and not require tight grasping, pinching, or twisting of the wrist. Repair hinge. Lower coat hook so that it is no higher than 48".	1	220	\$220

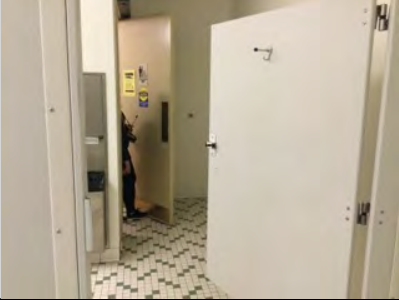
ID	Location	Floor	Room	Element	Type	Photo	Issues	Current Measure	Recommendations	Quantity	Price	Cost Estimation
35	Men's Toilet Room	1		Toilet Compartment	Accessible Compartment

Door has non-compliant hardware Door has malfunctioning self-closing hinge Coat hook > 48"	- - 63"	Provide hardware that can be operable with one hand and not require tight grasping, pinching, or twisting of the wrist. Repair hinge. Lower coat hook so that it is no higher than 48".	1	220	\$220
36	Women's Toilet Room	2		Toilet Compartment	Accessible Compartment

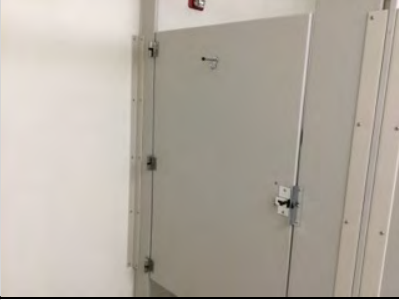
Coat hook > 48"	63"	Lower coat hook so that it is no higher than 48".	1	150	\$150
37	Women's Toilet Room	G		Toilet Compartment	Accessible Compartment

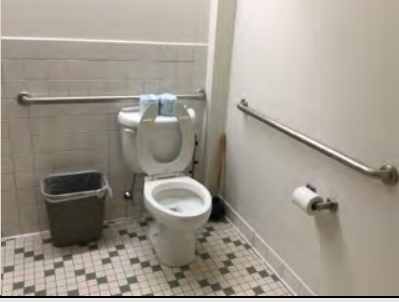
Centerline < or > 18" (MAAB)	20.25"	Relocate toilet so the centerline is 18" from the side wall.	1	2828	\$2828
Additional Access												
Drinking Fountains												
38	Drinking Fountain Near Elevator	G		Drinking Fountains	Low

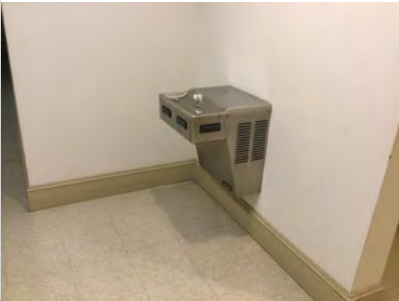
No drinking fountain provided for standing users	-	Provide an additional drinking fountain for standing users or install a Hi-Lo drinking fountain.	1	4028	\$4028

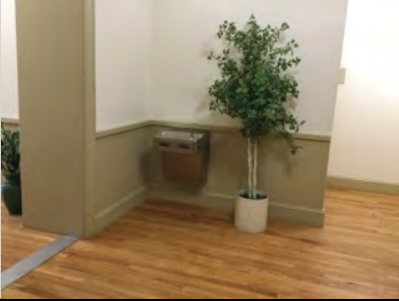
39	Drinking Fountain Near Elevator	1		Drinking Fountains	Low

No drinking fountain provided for standing users	-	Provide an additional drinking fountain for standing users or install a Hi-Lo drinking fountain.	1	4028	\$4028
